RESERVE ANALYSIS REPORT

The Sample Condominium

Boston, Massachusetts

April 8, 2020

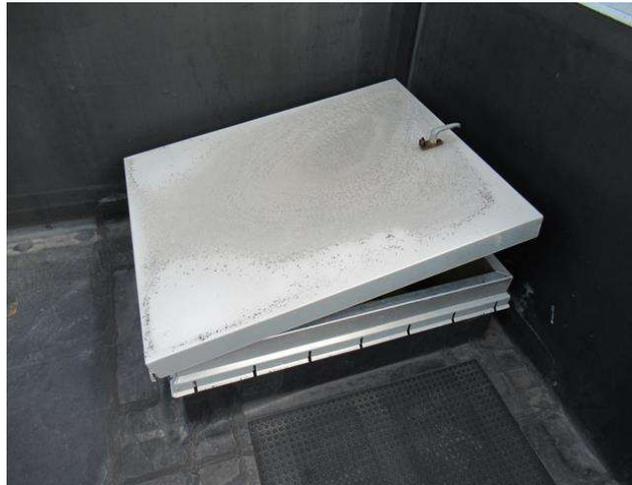
Component covers replacement of roof access hatch. Bilco Type E hatch with aluminum cover measures approximately 36" x 36" and is in good condition. Pricing for new hatch includes safety rail system and Bilco E-50TB 36X36 Thermally Broken Roof Hatch.

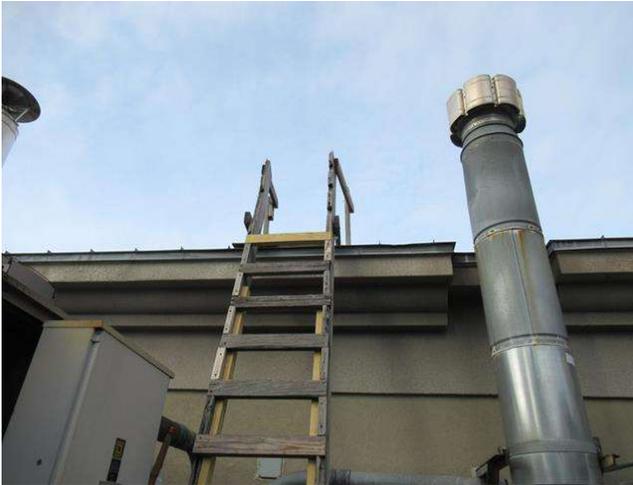
Component covers replacement of current failing pressure-treated wood ladder to access chillers from upper roof area. Wood ladder is decayed and splitting. Safety is poor. Client has a \$3500 proposal from Mike's Welding for permanent steel ladder.

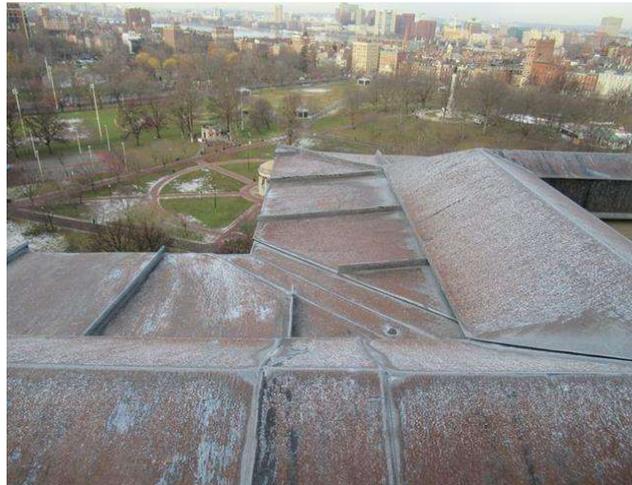
Component covers galvanized steel standing seam parapet wall caps. Unpainted galvanized steel appeared to be in good condition at site visit. No leaking issues reported. However, areas should be checked for brown staining as described below. White spatter pattern should be checked also. Useful life of 40+ years assumes that brown staining will not reduce service life. Replacement of parapet wall caps is currently unfunded.

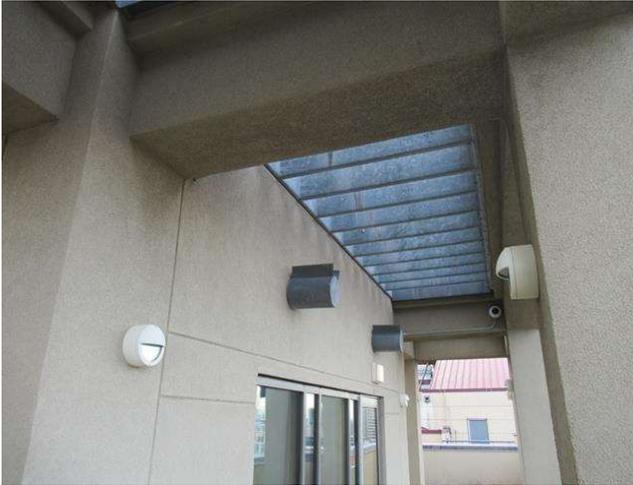
Component covers galvanized steel pergola panels above common roof terrace. Unpainted galvanized steel appeared to be in good condition at site visit. Useful life of 40+ years assumes any brown staining will not reduce service life. Replacement of pergola panels is currently unfunded and listed only for inventory purposes. Pergola panels should be inspected in conjunction with parapet wall caps.

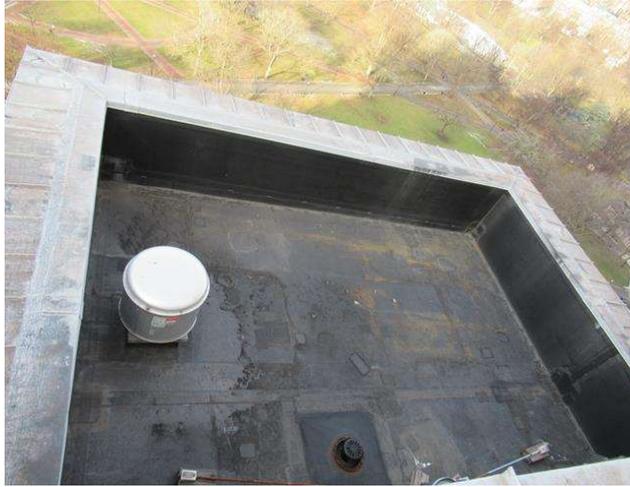
Component covers replacement of EPDM (ethylene propylene diene terpolymer) membrane roof over 19th floor hallway area. Roof is original to construction.

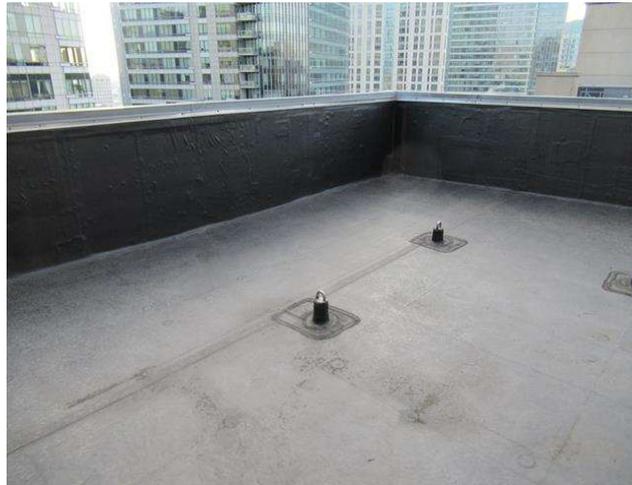
Component covers replacement of EPDM (ethylene propylene diene terpolymer) membrane roof adjacent to boiler room at southeast corner. Placed-in-service date per client.

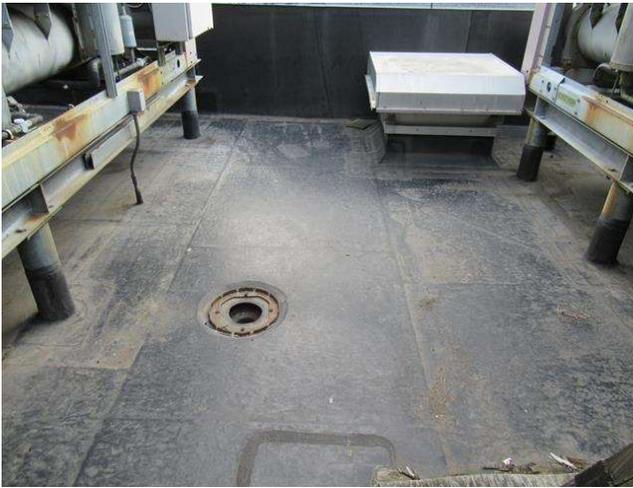
Component covers replacement of EPDM (ethylene propylene diene terpolymer) membrane roof over boiler room (and under chillers). Roof is original to construction.

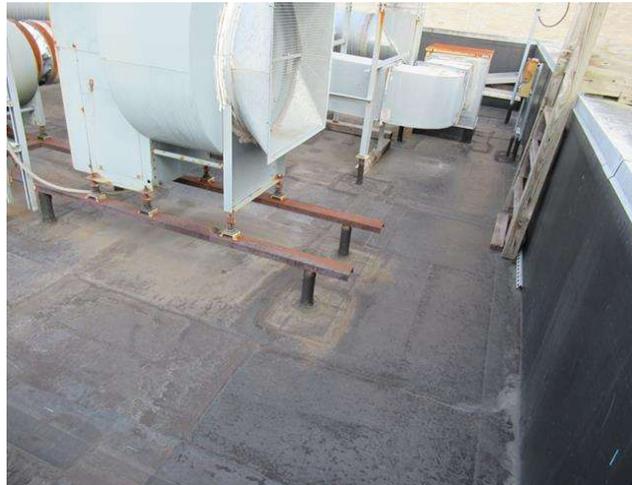
Component covers replacement of EPDM (ethylene propylene diene terpolymer) membrane roof over elevator machine room. Roof is original to construction.

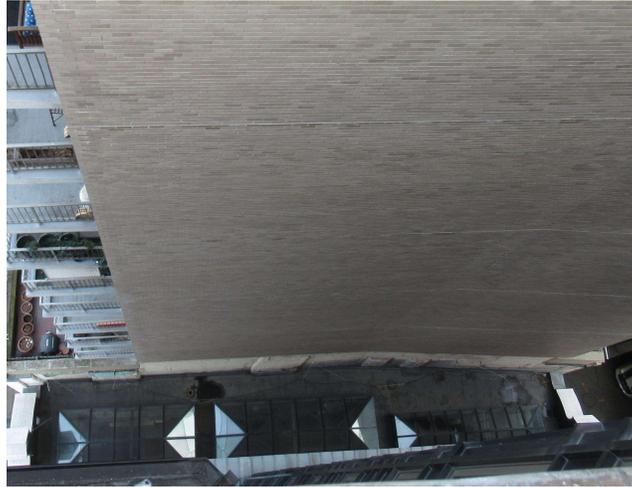
Component covers replacement of EPDM (ethylene propylene diene terpolymer) membrane roof over opera corridor. Roof is original to construction.

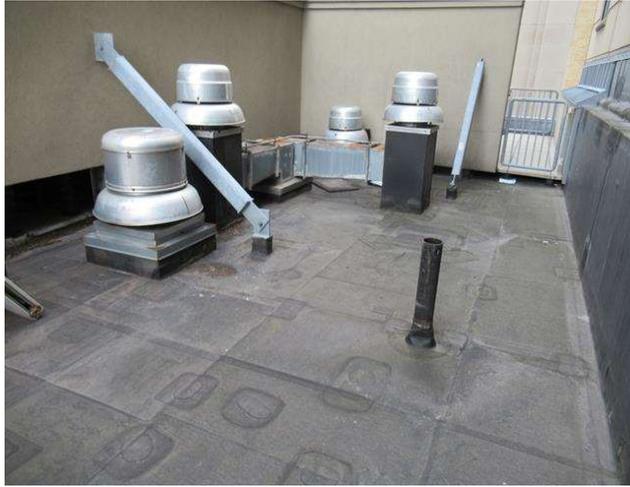
Component covers replacement of EPDM (ethylene propylene diene terpolymer) membrane roof under 9th floor roof terrace. Roof is original to construction.

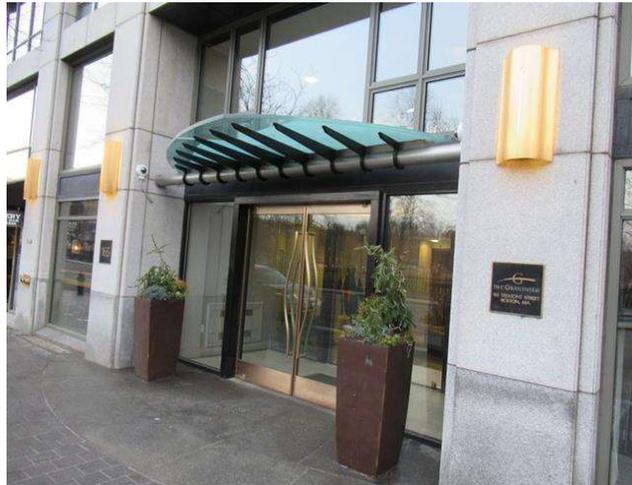
Component covers replacement of awning over main entry doors. Awning was in good condition at site visit.

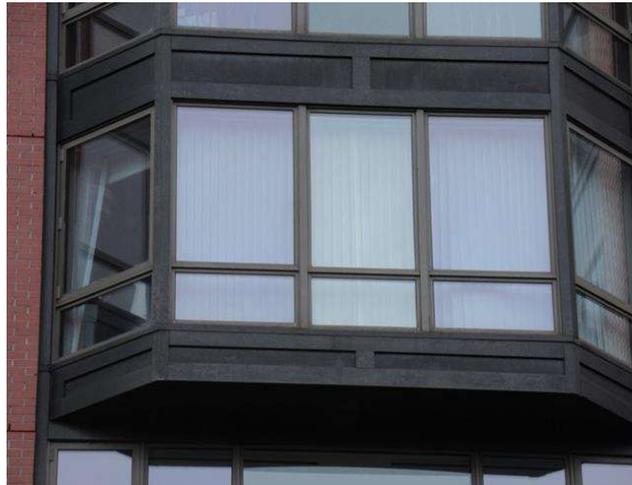
This component covers replacement of prefinished aluminum bay window and wall structures (frames & infill panels). Aluminum structure was in generally good condition at site visit. Per client, aluminum has been cleaned periodically.

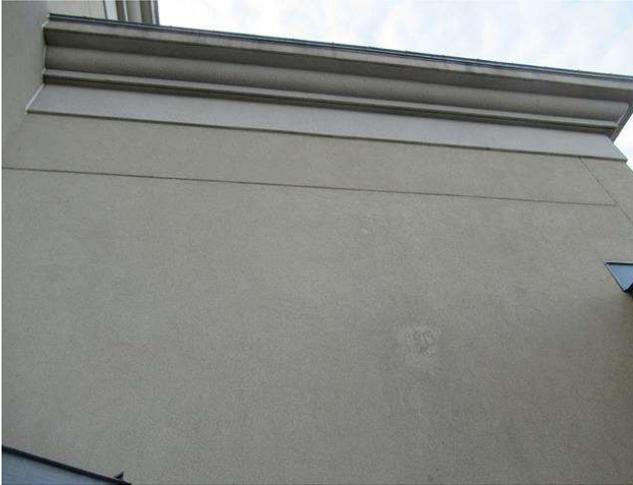
Component covers estimated periodic inspection and maintenance allowance of Exterior Insulation and Finish Systems (EIFS) siding. EIFS appears to be face-sealed. Sealants should be inspected and repaired regularly. Building manager currently performs most maintenance in-house.

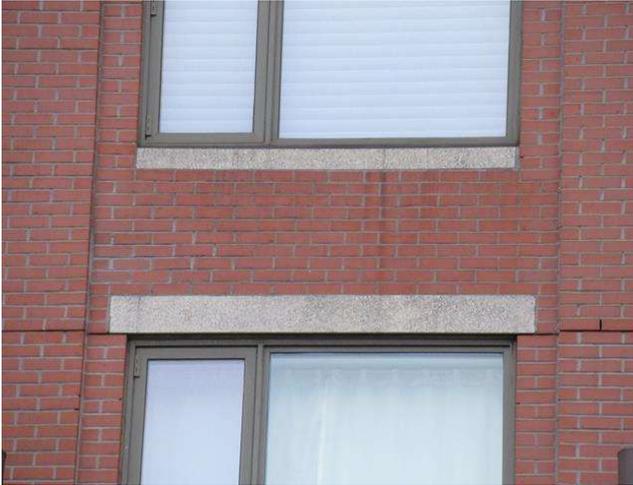
This component covers the recommended inspection and major masonry repairs after initial 25 year inspection and repair. Initial inspections should guide the frequency and extent of major and minor repairs. A percentage of brick is expected to be repaired every 15 years. Component includes any repairs required for cast stone cornices.

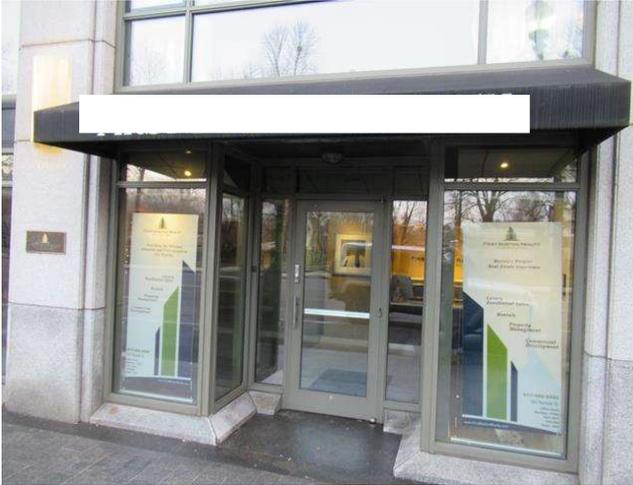
Component represents exterior aluminum frame full view commercial doors to opera connector, commercial units, (3) unit terraces, and common roof terrace. Doors were in good condition during site visits with no issues reported by client. Doors will have significantly different usage and will not all need to be replaced concurrently. Allowance set up to periodically replace doors. As infrastructure ages, allowance should be adjusted in future reserve study updates.

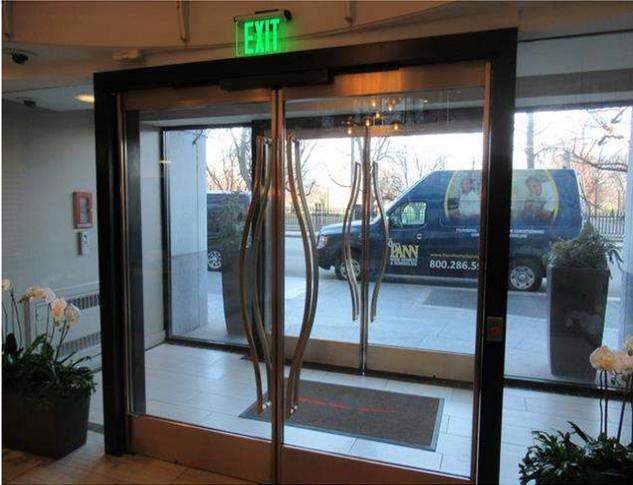
Component allowance for periodic minor repairs and adjustments to exterior and vestibule double counter-balanced bronze main entry doors. Doors were in good condition during site visit and no problems were reported by client.

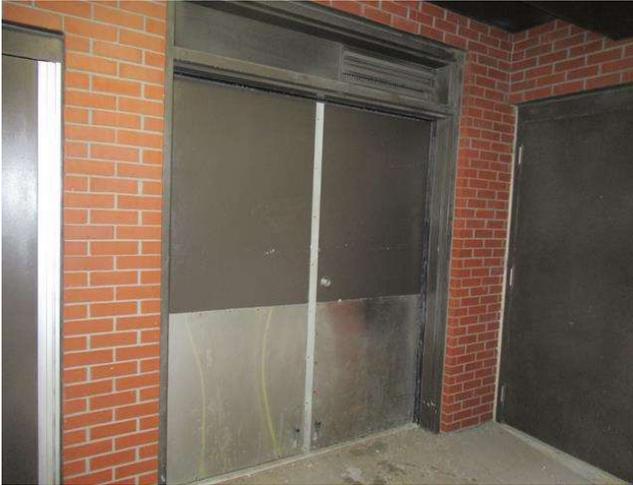
Component covers high use double steel 72" x 84" trash room doors. Doors were in fair condition during site visit. Due to high use with dumpsters moving through, doors will likely have reduced service life. Remaining life extended to reflect better than average trash door wear at association.

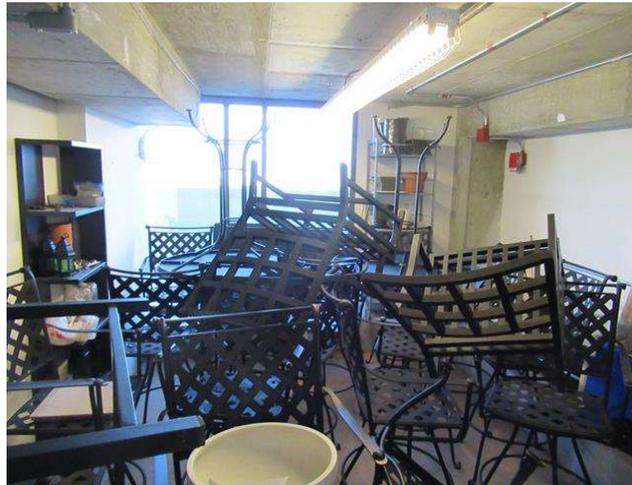
Component covers cast aluminum roof terrace furnishings. Furnishings were stored and not easily accessible at site visit. Allowance estimated. The actual date this component was placed into service is not available. For budgeting purposes, this date has been estimated based on its condition at our most recent site visit.

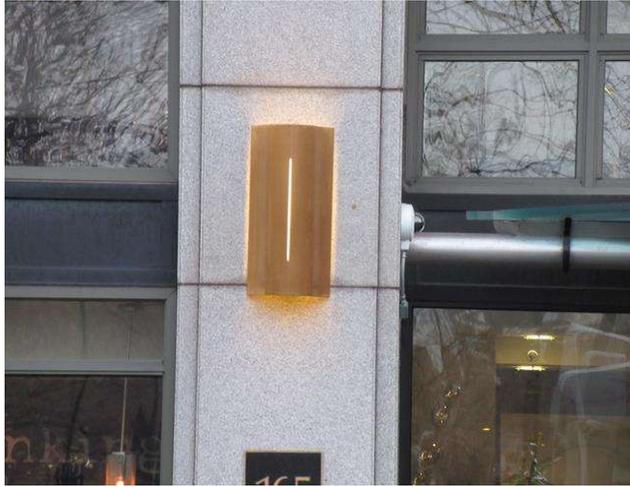
Component covers wall and ceiling mounted exterior lighting. Lighting was in good condition at site visit. Front façade exterior cannon uplighting is listed as separate component.

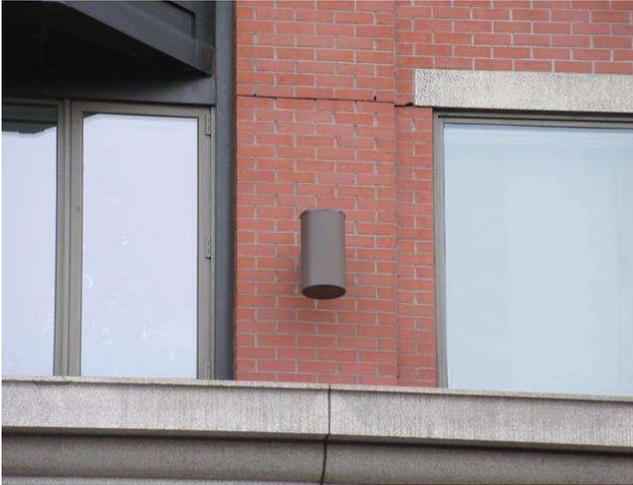
Component covers front façade exterior cannon uplighting. Lighting was replaced with new LED fixtures in 2019. Number of lights was reduced from 10 to 8 due to cost of changing bulbs. Cost, per client, was \$16,200 including lifts to access lights. Due to numerous complications during recent installation, it is anticipated that cost to replace lights will be lower in future.

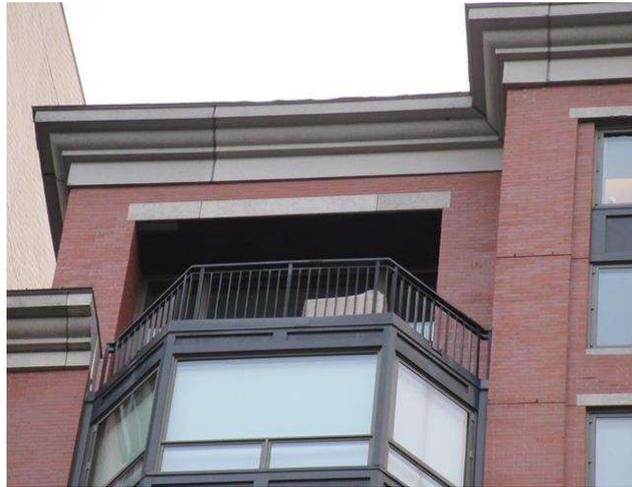
Component covers black steel railings located on two penthouse roof terraces and on 4 projecting bay window roofs on front elevation. Railings appeared to be in good condition as observed from ground at site visit. Per client, railings are in good condition. It is assumed that railings are painted galvanized steel.

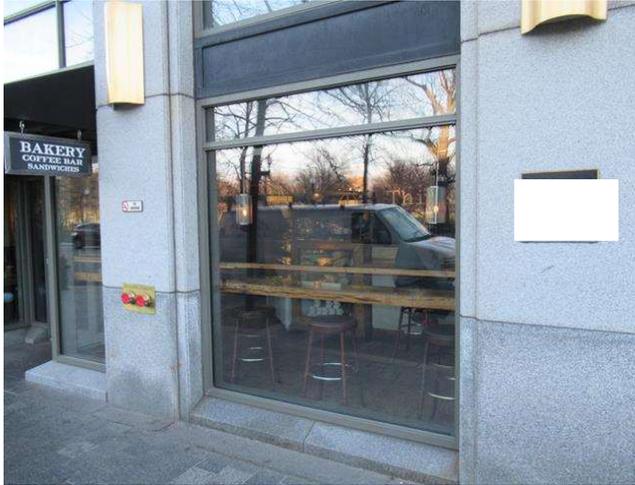
Component represents exterior commercial aluminum-framed common store front windows in lobby, second floor common area, commercial units, and common roof terrace. Windows were in good condition during site visit and no problems were reported by client. Quantity per prior reserve study.

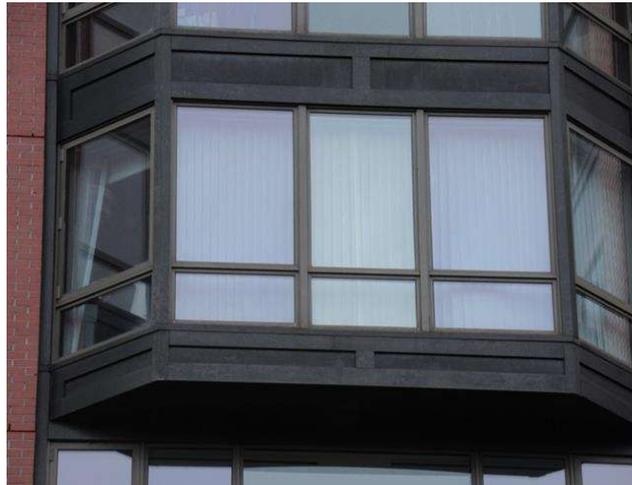
Component covers exterior residential aluminum window frames. Window frames were in good condition during site visit and no problems were reported by client.

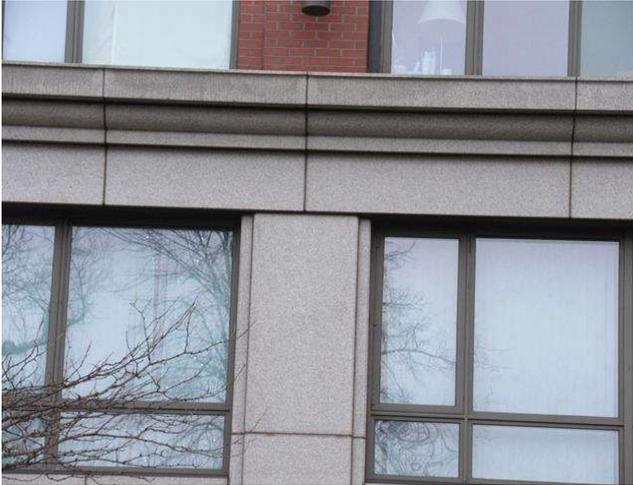
Component covers replacement of insulated glass within existing window frames. Window glass units are experiencing periodic seal failures resulting in condensation between the glass panes, per client. Premature failures are potentially the result of transportation damage before windows were originally installed. Annual cost for replacements is about \$35-40,000, per client, for approximately 28 window glass units. Average cost is about \$1350 per glass unit. To date, approximately 120 glass units have been replaced. This is about 10% of the overall total of 1073 glass units in the building.

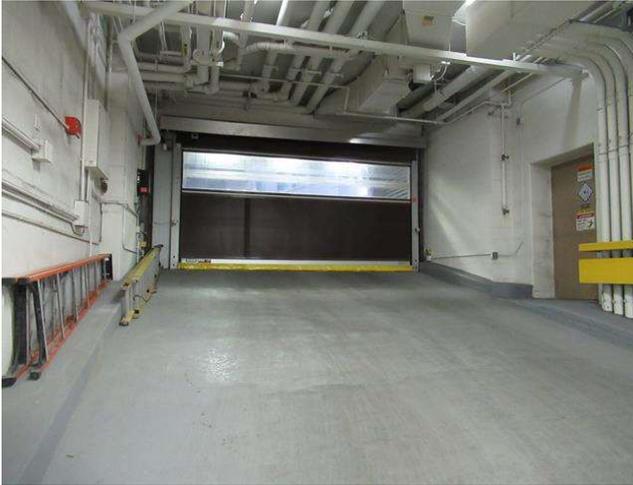
Component covers periodic repairs of reinforced concrete walls and floors starting in 2026. As infrastructure ages, allowance should be adjusted in future reserve study updates.

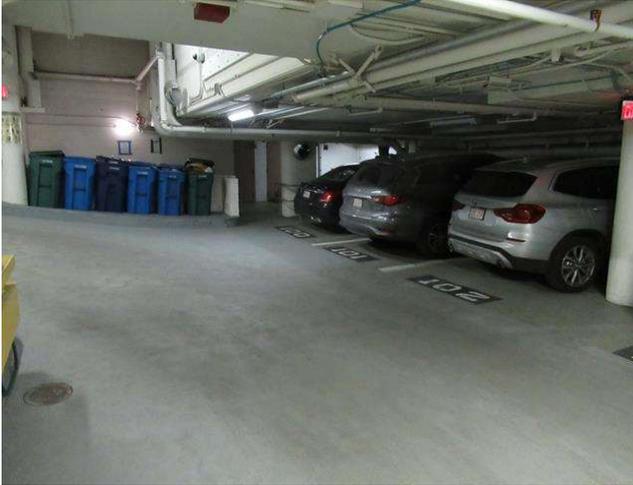
Component covers floor coating on traffic lane of parking garage from entrance down to lowest level. Elastomeric membrane re-applied in 2015. Quantity per prior reserve study.

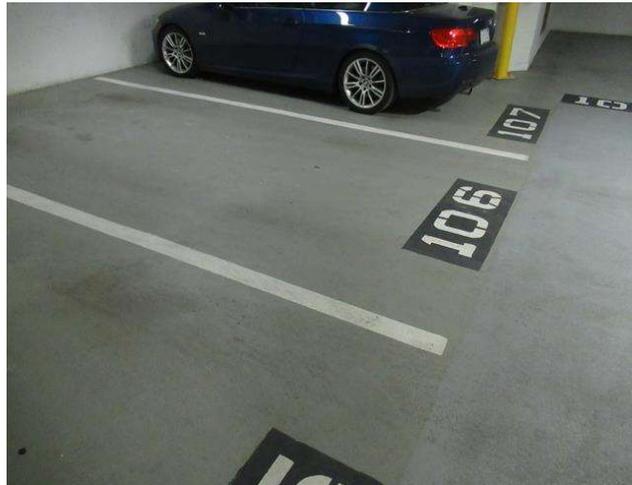
Component covers re-painting parking stall numbers and lines.

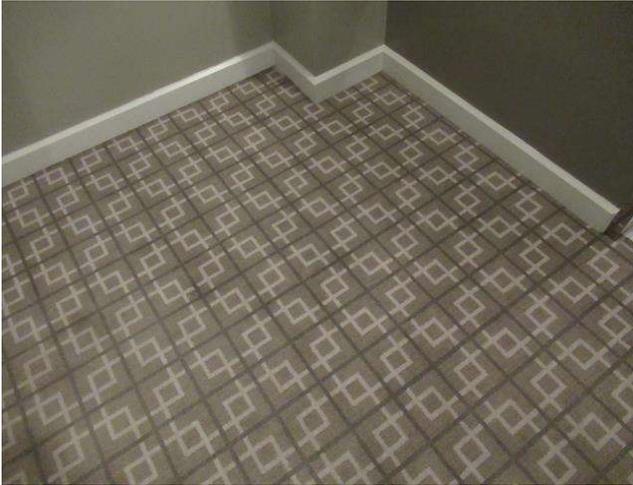
Component covers carpet flooring in unit and common hallways. Luxury-grade wool carpeting was installed in 2016. Carpet is difficult to clean because water cannot be used. Only spot cleaning is practical. Quantity per prior reserve study.

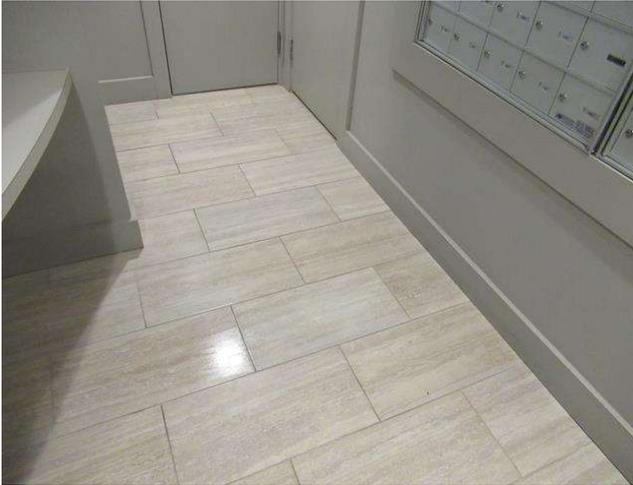
Component covers ceramic tile in main lobby areas. Tile was in good condition. No loose or cracked tiles were observed. Cost for removal of existing tile is difficult to estimate. Cost of materials chosen to replace the current tile can also vary widely. Quantity per prior reserve study. Useful life set at 20 years because the tile will likely be replaced for aesthetic reasons rather than wear.

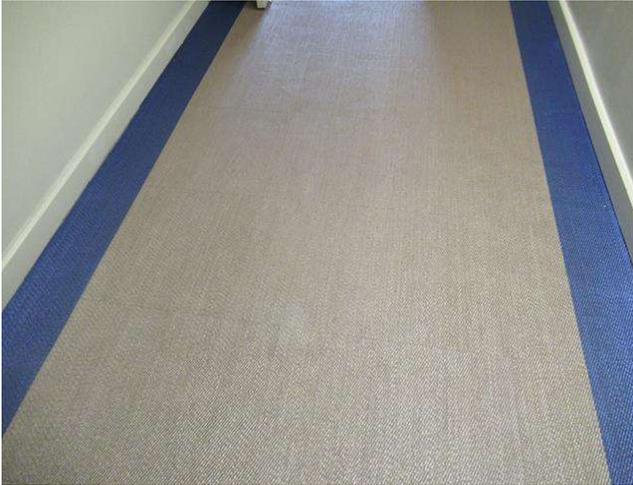
Component covers vinyl Chilewich type tiles in parking garage elevator lobbies and 19th floor hallway. Chilewich was in good condition. Quantities include 15% waste factor.

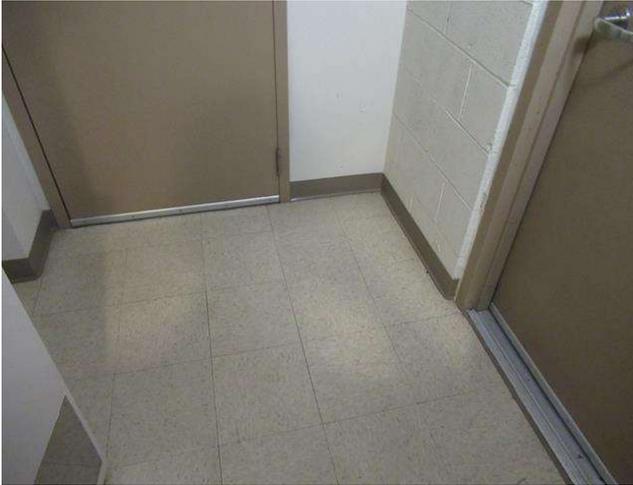
Component covers vinyl composition tiles (VCT) in trash rooms, stairwell vestibules, and rear hallway on first floor. VCT was in good to fair condition. Quantities include 15% waste factor.

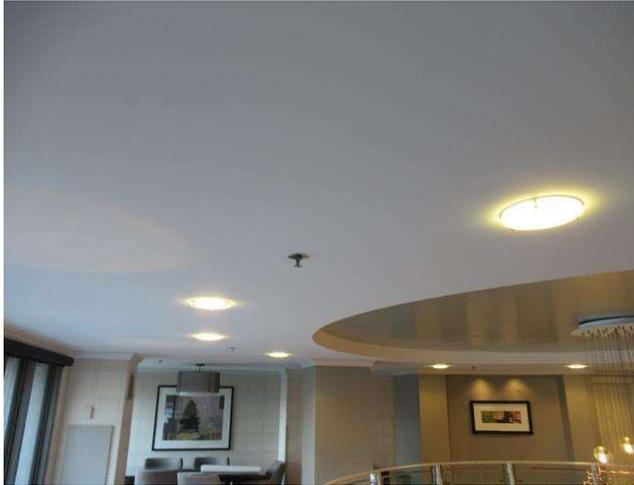
Component covers 2nd floor common lounge area lighting. Lighting was in good condition at site visit.

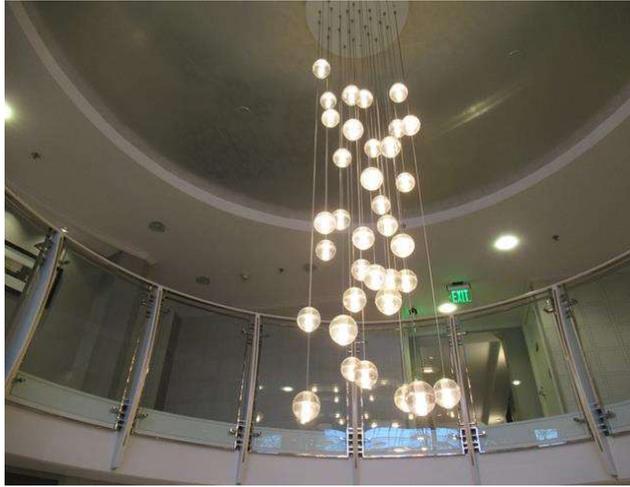
Component covers interior lobby area lighting. Lighting was in good condition at site visit.

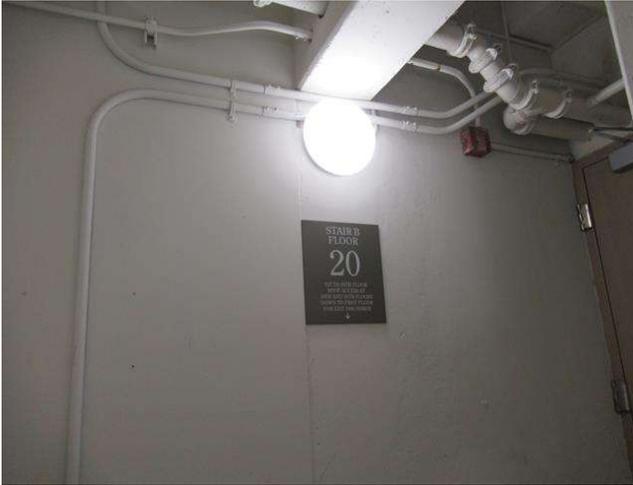
Component covers stairwell and trash room lighting in building. Lighting was in good condition at site visit. Dimming system and emergency backup not included.

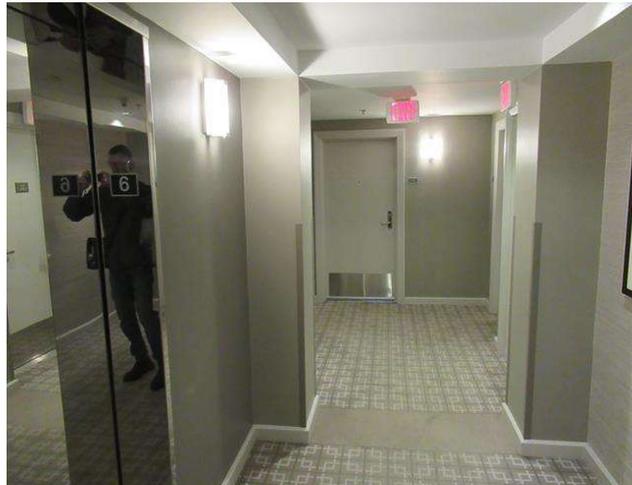
Component covers interior unit hallway and elevator lobby lighting on all floors. Lighting was in good condition at site visit.

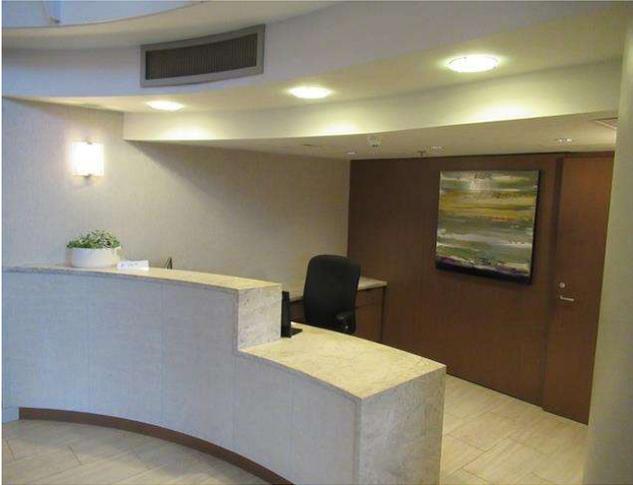
Component covers renovation of main lobby and adjoining 2nd floor lounge. Spaces were renovated in 2016 and in good condition at site visit. Flooring, furnishings, and lighting are covered by separate components. No cost details available from 2016 renovation.

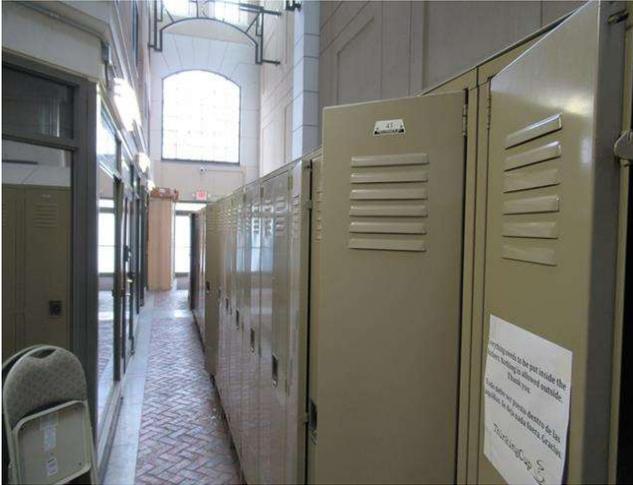
Component covers interior components of opera corridor. Finishes are durable and in good condition. Low-use area. Component is currently unfunded and listed for inventory purposes only. Funding can be added by client if desired.

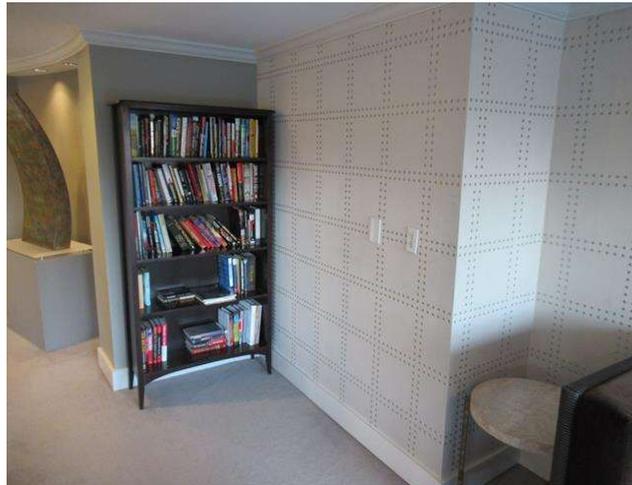
Component covers wallpaper/wall coverings in 2nd floor common area and elevator lobbies. Wall coverings were in good condition at site visit. Cost of wall coverings can vary widely based on selections. No data available for 2016 renovation.

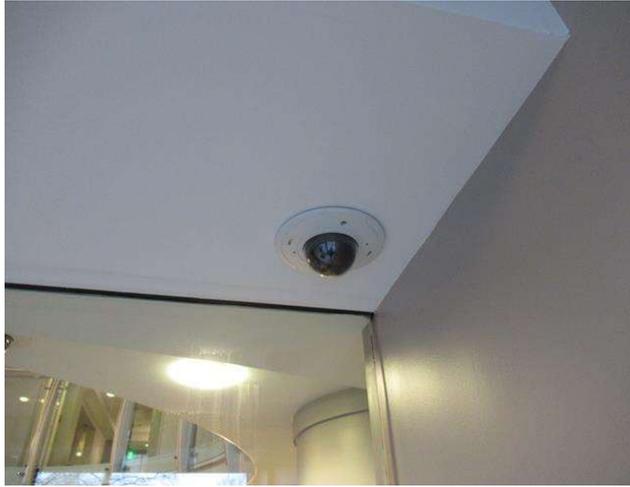
Component covers periodic upgrade of access, security, & surveillance systems. Systems are serviced by a single vendor and were upgraded in 2016. System uses Cat-5 wiring, per client. Specific information not available. Allowance should be adjusted based on association experience and needs in future reserve study updates.

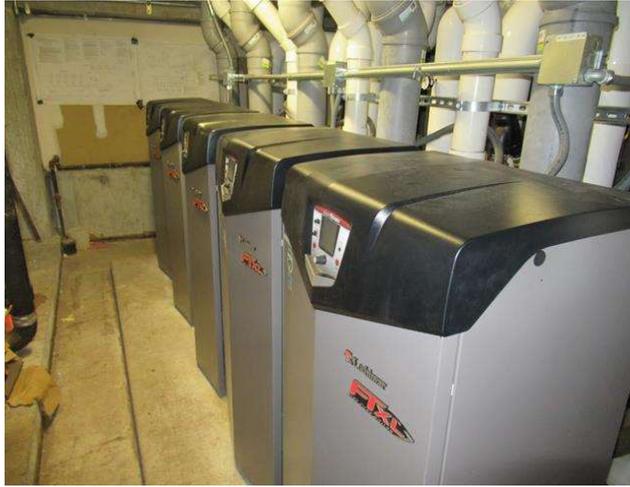
Component covers Lochinvar FTXL, Fire-Tube, high-efficiency, condensing boilers installed in November 2018 as part of a comprehensive boiler room modernization. Boilers provide hot water for building space heating and domestic water heating through indirect tanks listed separately. Contractor provided costs for this work per prior reserve study.

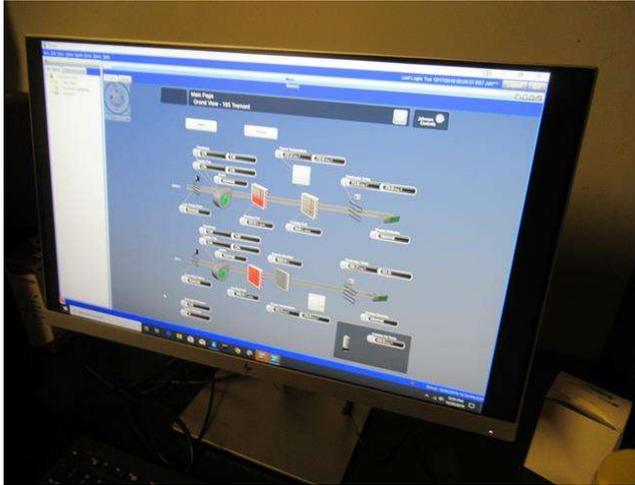
Johnson Controls Metasys® Building Automation System (BAS). Installed 2008. Periodic allowance for software upgrades and as-needed component replacements. Allowance per prior reserve study.

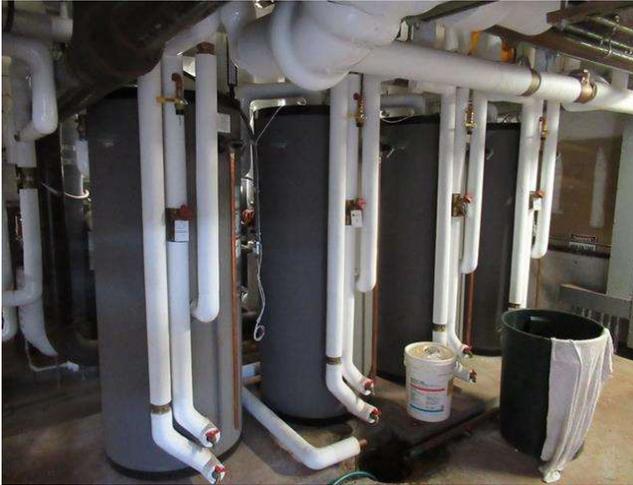
Component covers 119 gallon indirect domestic water heater tanks. Useful life typically 10-15 years depending on city water quality. Next replacement of tanks should be less costly than \$6250 indicated in prior reserve study.

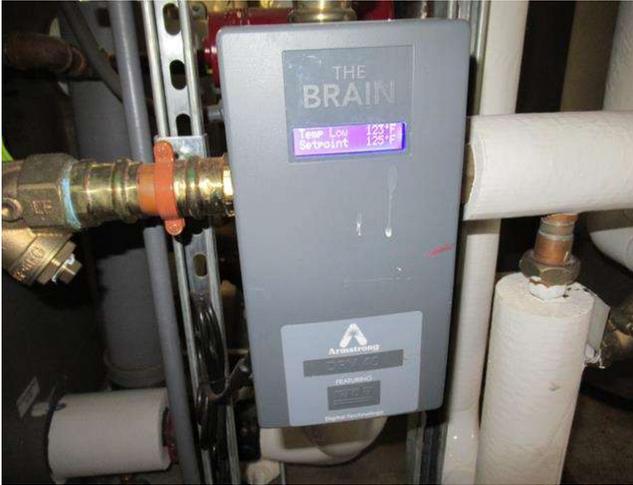
Component covers thermostatic mixing valve to control temperature of domestic hot water supplied to building. Valve installed in November 2018 as part of a comprehensive boiler room modernization. Contractor provided costs for this work per prior reserve study. Replacement costs will likely be lower for replacement because of numerous startup issues that should not be repeated.

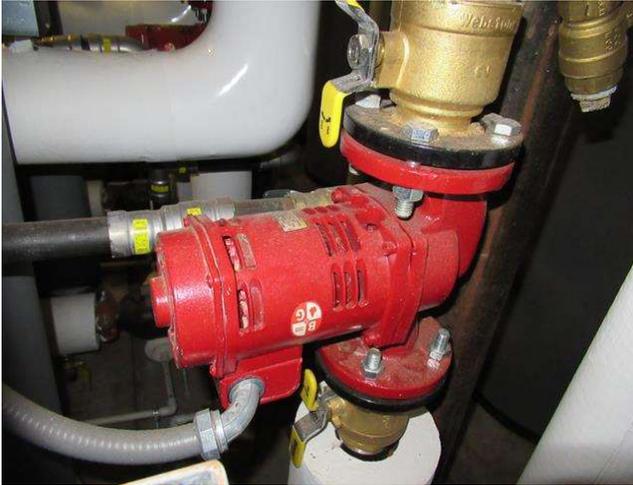
Component covers pump circulating hot water through the building. Pump was installed in November 2018 as part of a comprehensive boiler room modernization. Contractor provided costs for this work per prior reserve study. A second replacement pump is available, but was never installed.

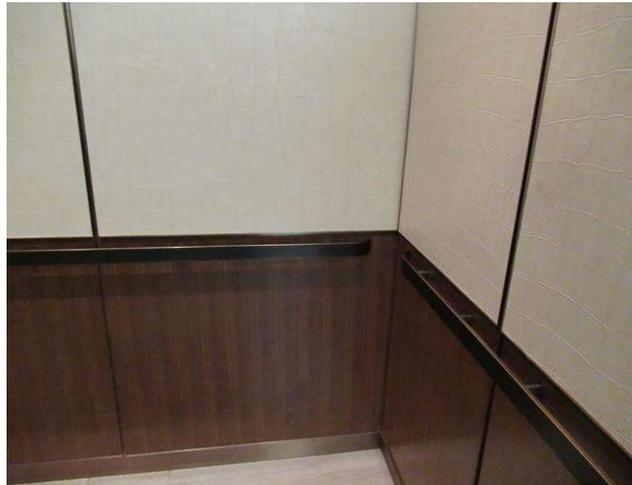
Component cover refurbishment of (2) elevator cabs. Cabs were in good condition at site visit. Frequency of cab refurbishment is mainly an aesthetic decision. Cabs were refurbished in 2016 at a cost of \$16,000 each, per prior study.

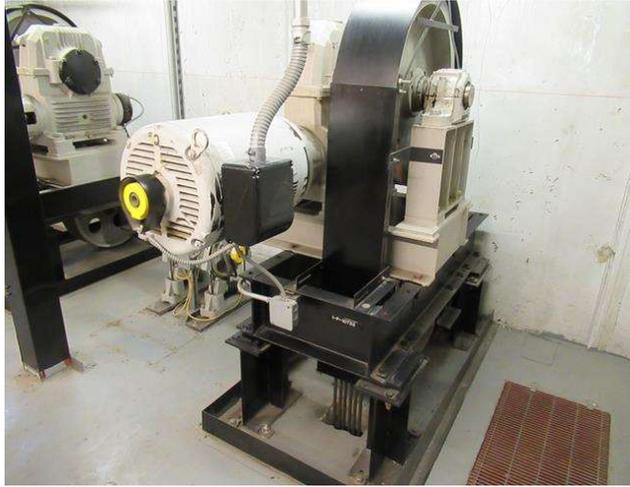
Component covers modernization of (2) machine traction elevators. Fujitec elevators were functioning normally at site visit. Pricing from similar associations.

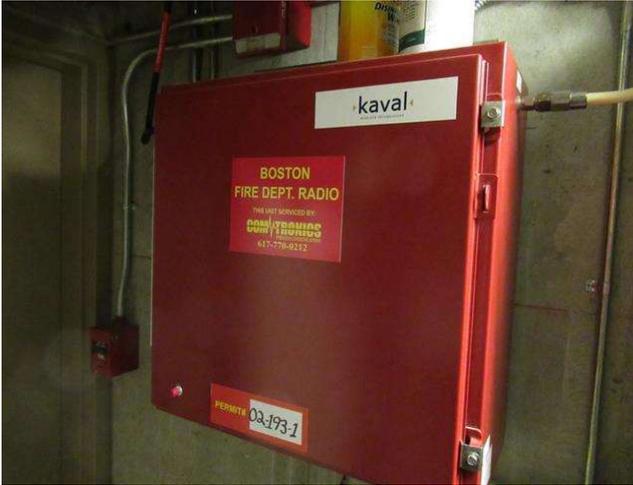
Component covers bidirectional antenna (BDA) system for emergency responder communication. No issues reported. Antenna is original, per client. Price per similar association.

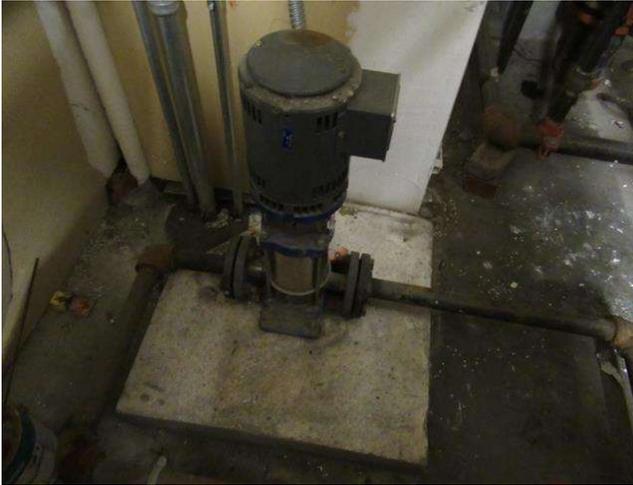
Component covers fire sprinkler jockey pump. Pump maintains wet sprinkler pipes at approximate target pressure to aid in sensing if a sprinkler head discharges. Jockey pump eliminates need for main fire pump to run to maintain system pressure. If sprinkler system has low leak/loss rate, pump may only run once a week.

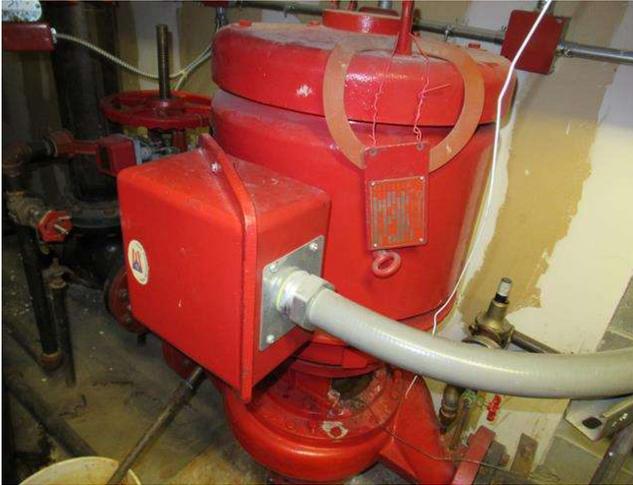
Component covers replacement of Fairbanks Morse 66-HP, 750-GMP vertical in-line centrifugal fire pump & controller. No issues reported. Remaining life extended to reflect pump rebuild component listed separately.

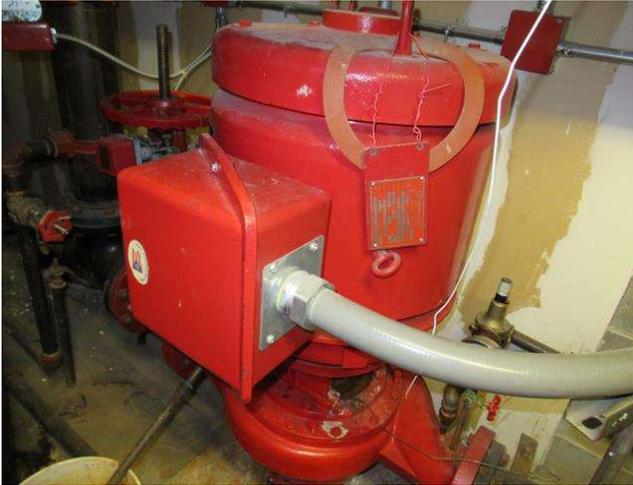
Component covers rebuild of Fairbanks Morse 66-HP, 750-GMP vertical in-line centrifugal fire pump & controller. No issues reported. Replacement of pump is listed as separate component. Pricing per prior reserve study.

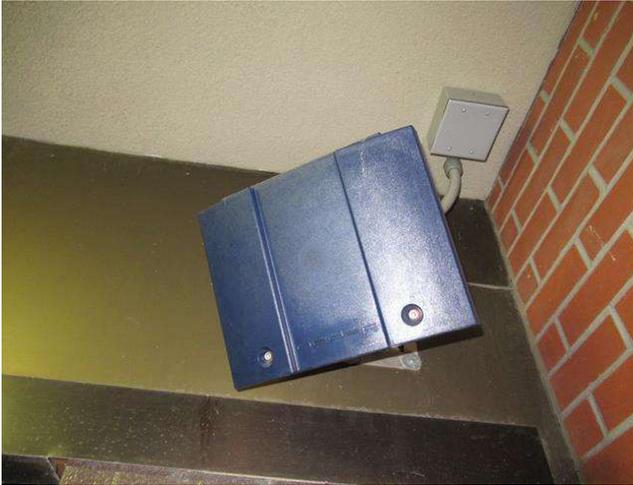
Component covers replacement of Nedap RFID (Radio-frequency identification) sensor for parking garage access system. No issues reported. Component does not currently cover window buttons or tags on individual vehicles. These could be add if desired.

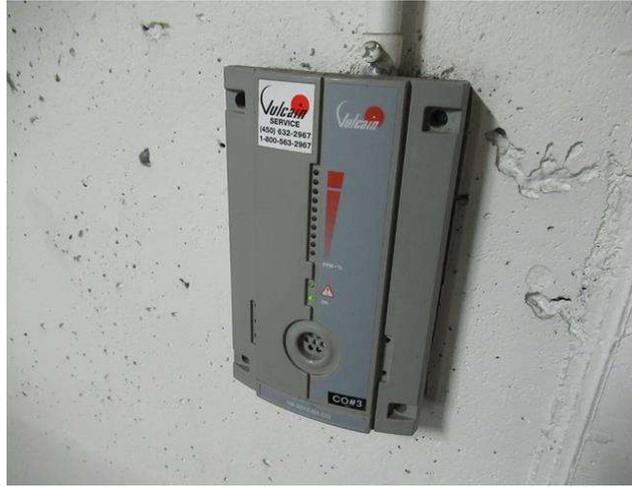
Component covers Honeywell VA201T Vulcain Gas Detection Transmitter/carbon monoxide detectors and 301C Controller in parking garage.

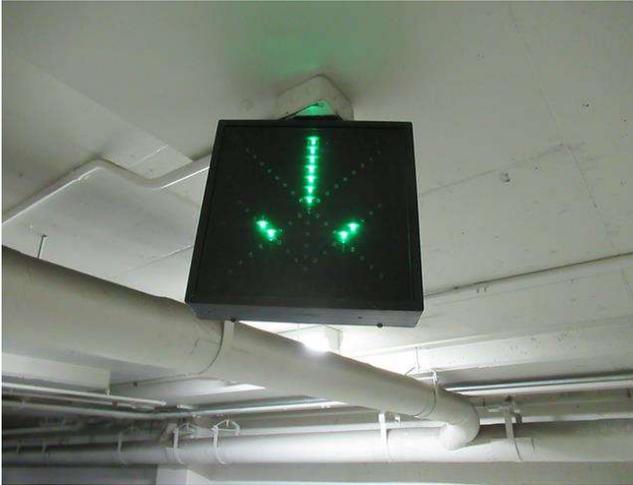
Component covers replacement of Signal-tech arrow/X signs to increase garage driving safety. Two of the three signs were not displaying green arrow correctly at site visit.

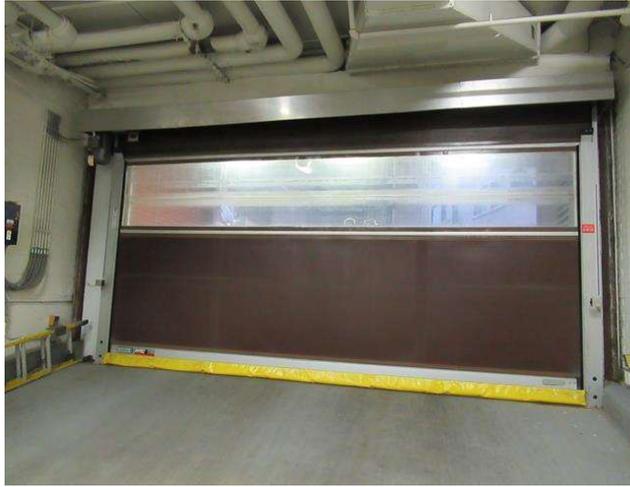
Component covers Rytec Predador NXT overhead garage door at entrance to parking garage. Current number of cycles is about 213,600. Door is in good condition at site visit and operating normally. Door was installed in 2013 and cycles average about 30,500 annually. Door is rated for 1,000,000 cycles with normal preventative repairs and maintenance. At current cycle rate, life could be 25+ years. More conservative 20 year useful life used.

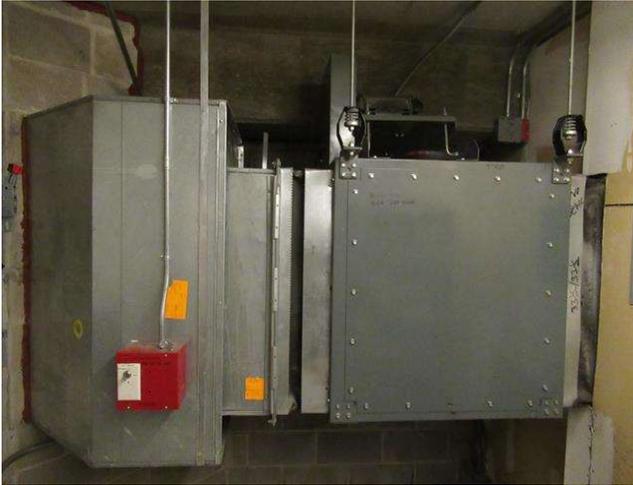
Component covers periodic overhaul & replacement allowance for parking garage supply and exhaust fans. Quantity per prior reserve study. Fans were in good condition at site visit and likely have low use. Overhaul includes fan motors, belts, and bearings. Fan capacities range from 3,000 to 10,800 CFM. As infrastructure ages, allowance should be adjusted in future reserve study updates.
