RESERVE ANALYSIS REPORT

Sample Community Association

Sample, Massachusetts Version 1 December 12, 2017

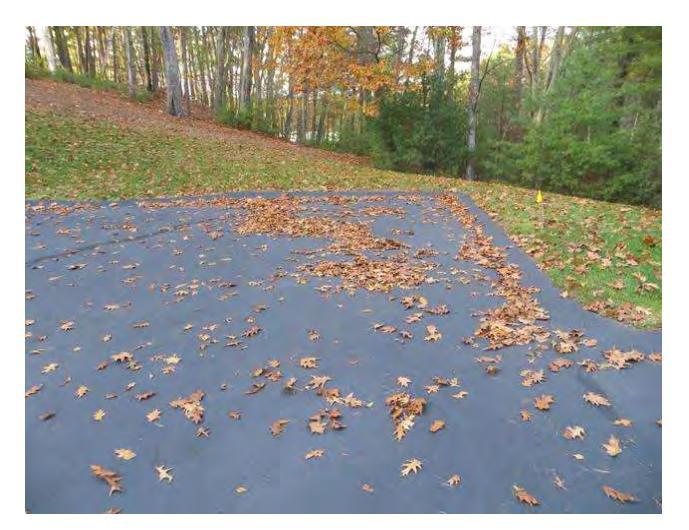
Component covers roadway and parking area asphalt berm/curbing. Asphalt berms were in good condition during site inspection. Asphalt berms/curbs are sufficient to allow for a 1-1/2" overlay in most areas. Some berm installation by hand may be required.

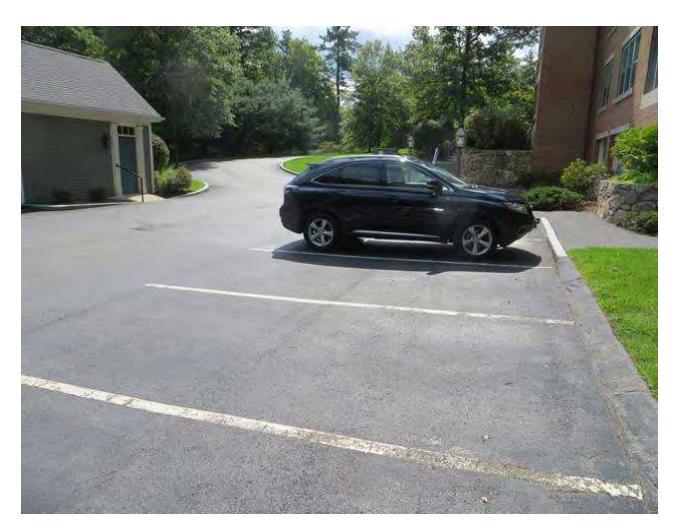
Component covers asphalt roadway and parking area maintenance. Asphalt was in good condition with some cracks evident during site inspection. Cracks have been sealed to limit water intrusion. Pavement should be evaluated annually.

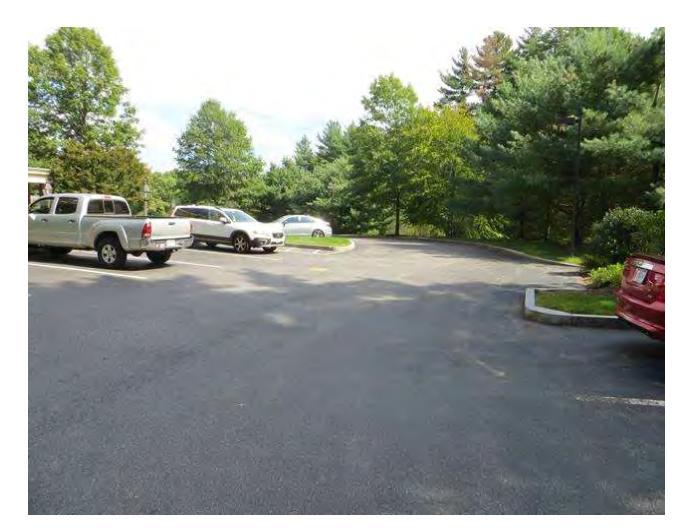
Component covers asphalt roadway and parking areas. Asphalt was in good condition with some cracks evident during site inspection. Cracks have been sealed to limit water intrusion. No significant puddling was observed. Therefore, no significant regrading of streets and parking lots will be required. Favorable soil conditions at the site will limit damage due to freeze thaw cycles. Service life set to 25 years to reflect good condition of asphalt after 16 years and evidence of preventative maintenance.

Pavement should be evaluated annually. Crack sealing maintenance should be evaluated annually and listed as separate component.

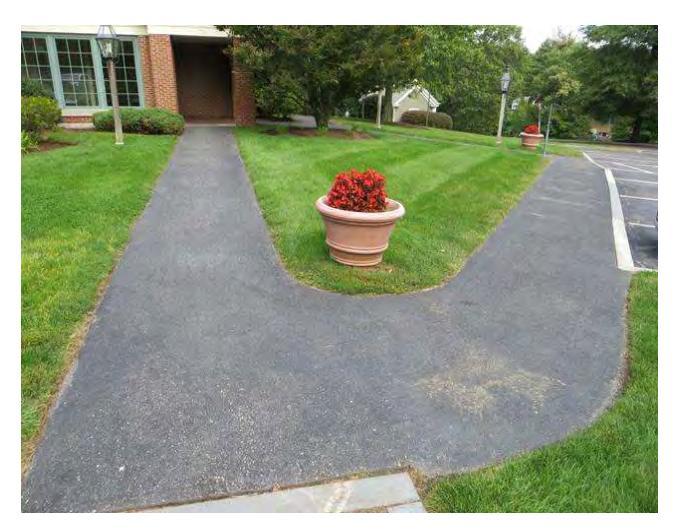
Component covers asphalt sidewalks. Asphalt was in good condition during site inspection. Favorable soil conditions at the site will limit damage due to freeze thaw cycles. Service life set to 25 years to reflect good condition of asphalt after 16 years.

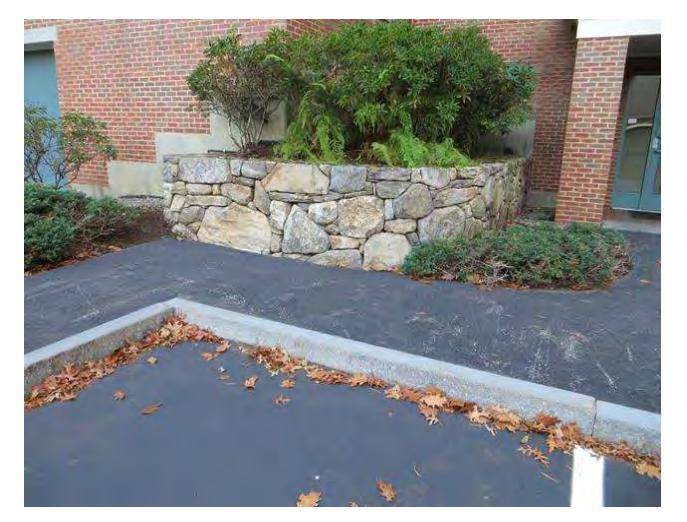
Component covers granite curbing of roadway and parking areas. Curbs were in good condition during site inspection. No damage or displaced sections were observed. Component listed for inventory purposes.

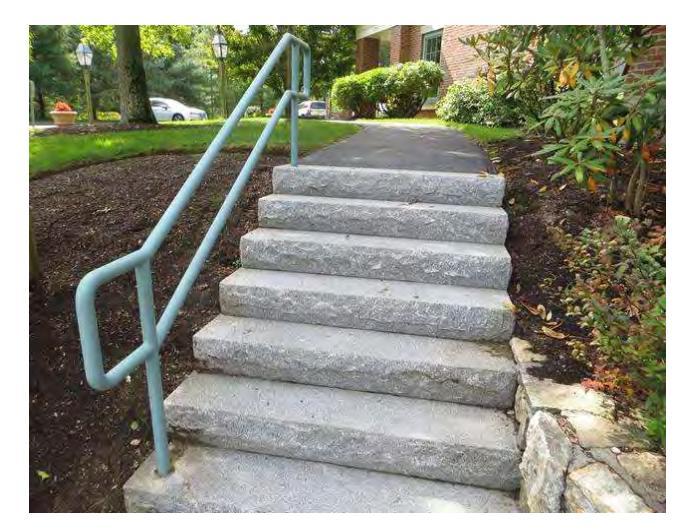
Component covers granite steps adjacent to main building. Steps were in good condition during site inspection. Some displacement of steps will occur over time due to freeze-thaw cycles. Due to safety concerns, repairs should be made immediately funded from operations. Component is included for inventory purposes.

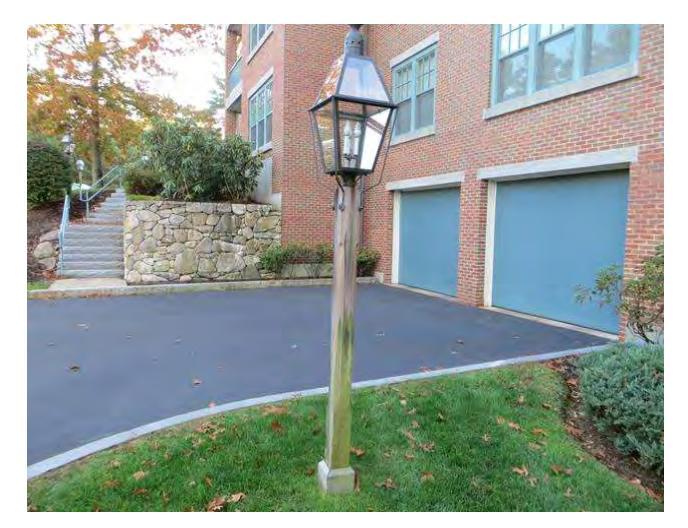
Component covers site lighting. Lighting was in good condition at site visit and no issues were reported. Converstion of lighting to LED bulbs should be considered.

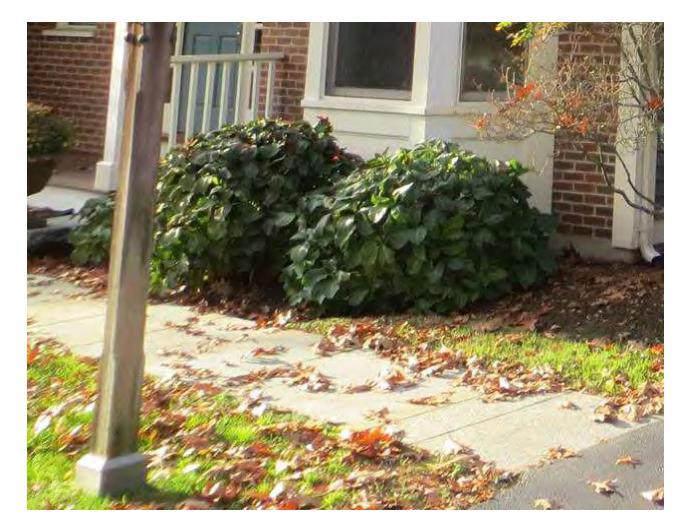
Component covers resetting bluestone and paver sidewalks. Stone paving materials can be reused but will need to be reset periodically due to winter frost action. Brick pavers will eventually need to be replaced.

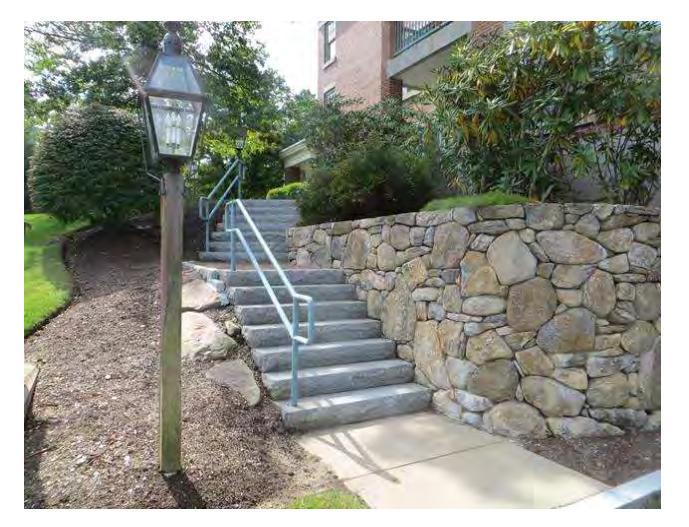
Component covers stone retaining walls adjacent to buildings and along sidewalk of Forest Ridge Road. Walls were in good condition during site inspection. Some degradation of retaining walls will occur over time due to freeze-thaw cycles. Component is set up to repair 10% of retaining wall area every 5 years. Stones are reused so cost is essentially labor and minor materials. As association gains experience with frequency of stone wall repairs, component cost and frequency should be updated.

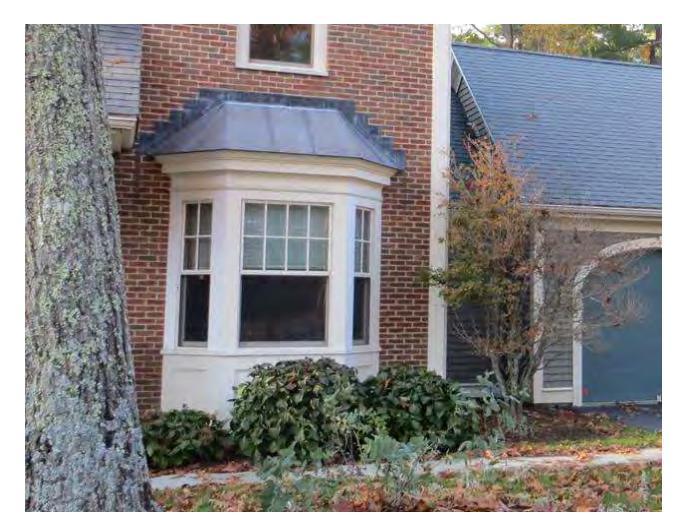
Component covers replacement of copper gatehouse bay window roof. Roof appeared to be in good condition for its age during site visit. No issues were reported by management.

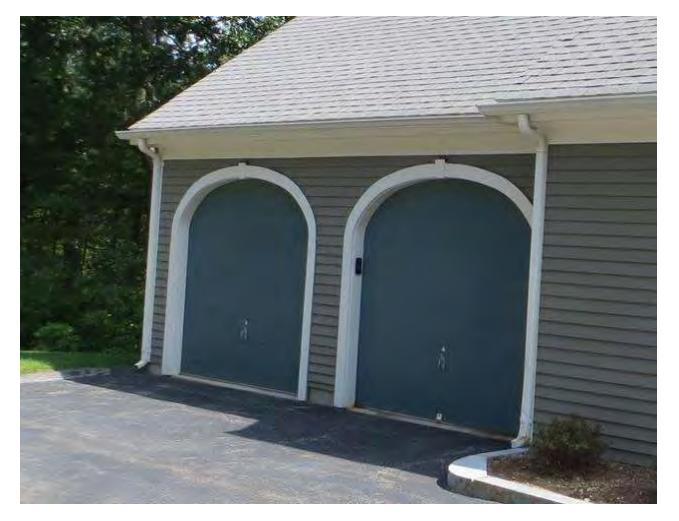
Component covers replacement of aluminum gatehouse and trash/recycle/garage gutters and downspouts. Gutters were in good condition during site visit. However, gutter at front door porch on gate house was clogged and dripping. Decay observed on wood soffit and fascia indicates a continual problem. Gutter should be cleaned and soffit/fascia repaired.

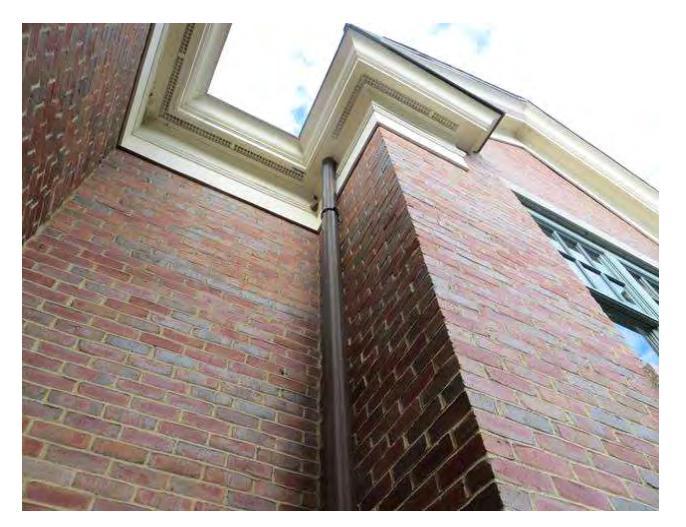
Component covers replacement of red copper downspouts on main building. Downspouts were in good condition during site visit. Lead-coated copper built-in gutters are covered in main roof copper component.

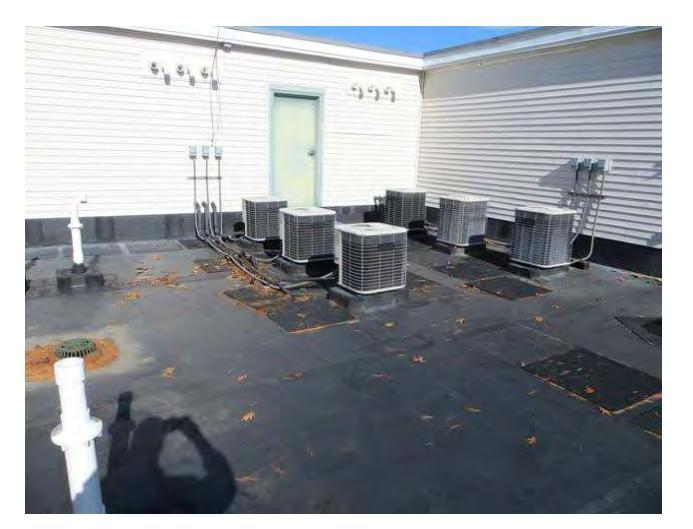
Roof of main building is comprised of flat EPDM membrane and sloped asphalt shingle areas. Component covers replacement of flat EPDM membrane. Roof appeared to be in good condition for its age during site visit. No issues were reported by management. Minor leaf debris noted during site visit should be cleaned. Some areas of minor ponding were observed. Typical specifications require any ponding to evaporate in 24-48 hours. Ponding water can cause deterioration of roof membrane and seams. Mechanical vent and other penetrations appear in good condition and properly installed. Main equipment area of flat roof is accessible with stairs. Additional main roof flat areas are not easily accessible and were measured from building construction plans. Condition of these areas could not be evaluated.

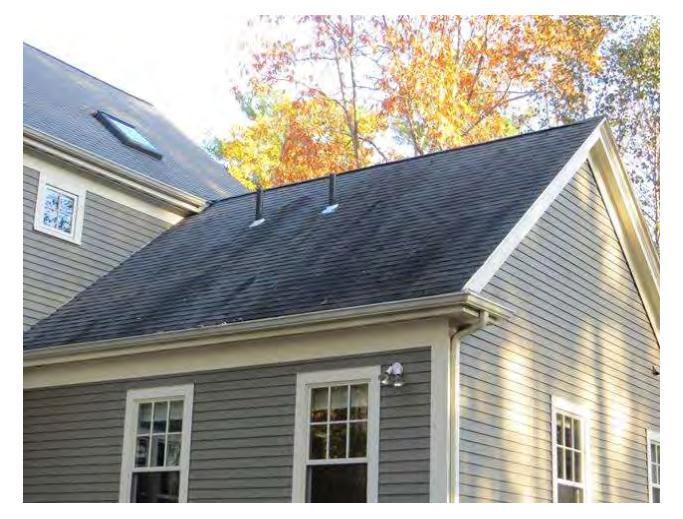
Component covers replacement of asphalt architectural shingle gatehouse roof. Roof appeared to be in good condition for its age during site visit. No issues were reported by management. North-facing roof planes exhibited some algae growth due to moist conditions. Consider installing zinc strips on roof to reduce growth.

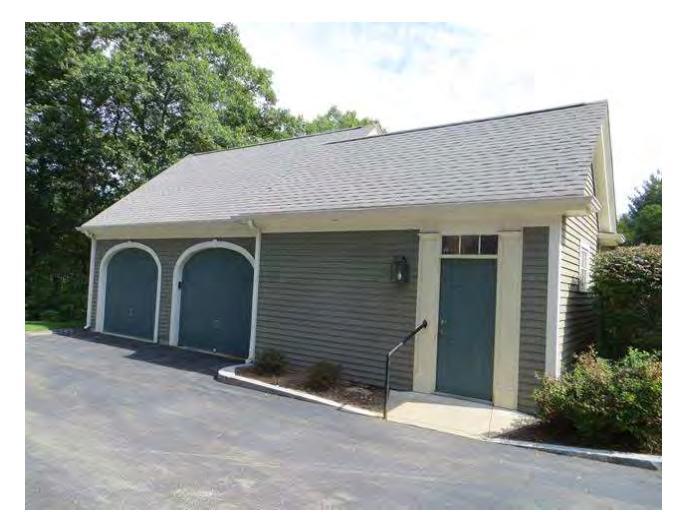
Component covers replacement of asphalt architectural shingle trash/recycle/garage roof. Roof appeared to be in good condition for its age during site visit. No issues were reported by management.

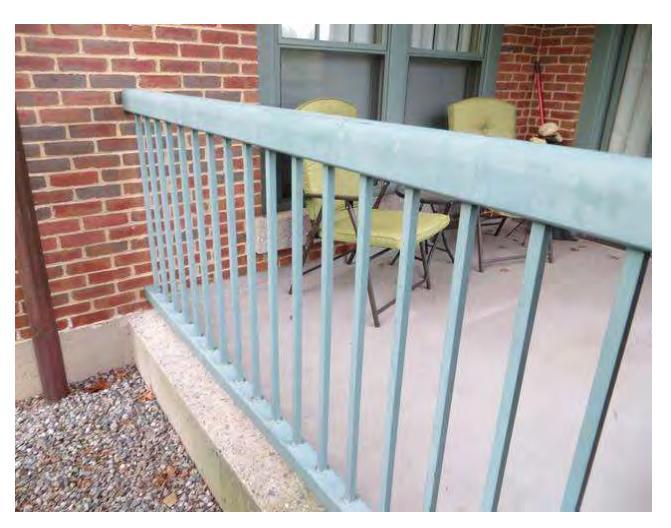
Component covers replacement of aluminum balcony railings on main building. Railings were in generally good condition during site visit. Railings are currently in need of painting. Proper maintenance will enable railings to achieve their useful life.

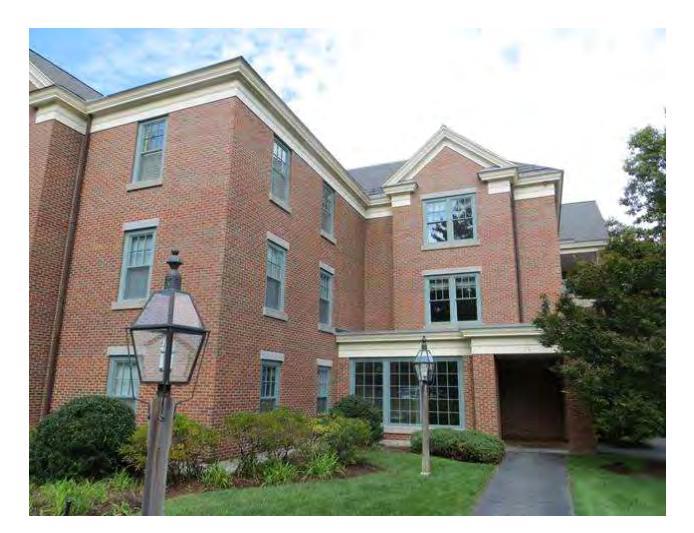
This component covers brick inspection, sealing, and repairs on a 5 year interval for brick areas of main building and gatehouse. Cost for component currently set at 2% of brick gross area. As association gains experience with brick as it ages, allowance budget should be adjusted. Periodic maintenance mainly involves caulking windows and other penetrations. Exterior should be monitored for leaks and minor issues addressed. Depending on porosity of brick, surface may need periodic sealing.

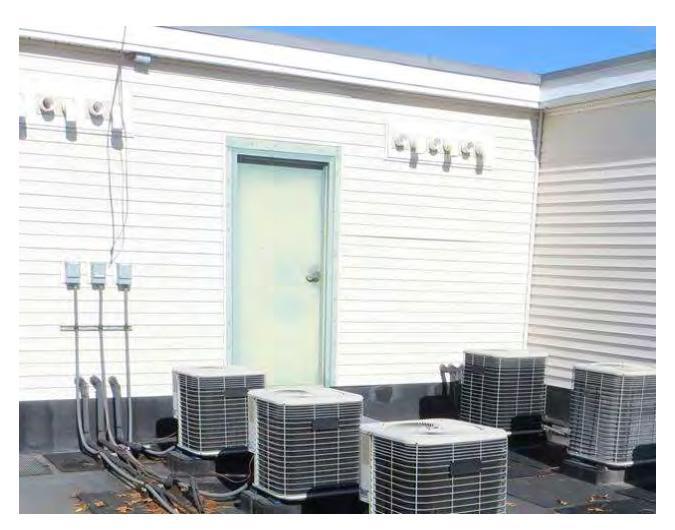
This component covers exterior steel doors located in flat roof equipment area of main building. Doors were in good condition during site visit, but in need of painting.

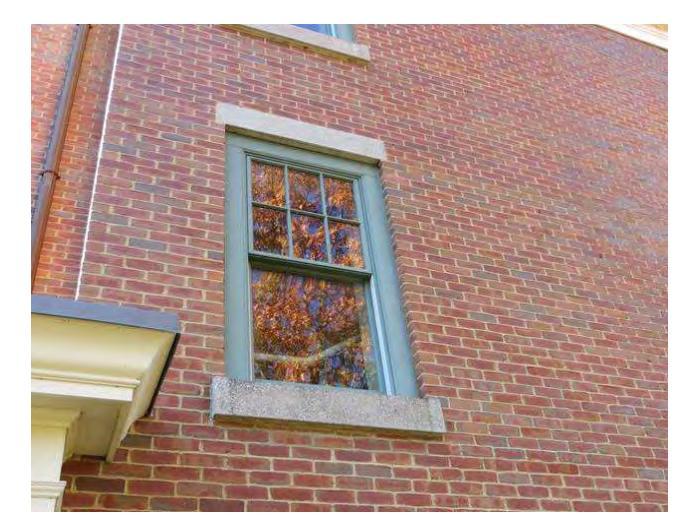
This component covers Pella aluminum-clad windows located in common areas of main building and trash/recycle/garage building. Windows were in good condition during site visit, but main building windows will soon need exterior painting.

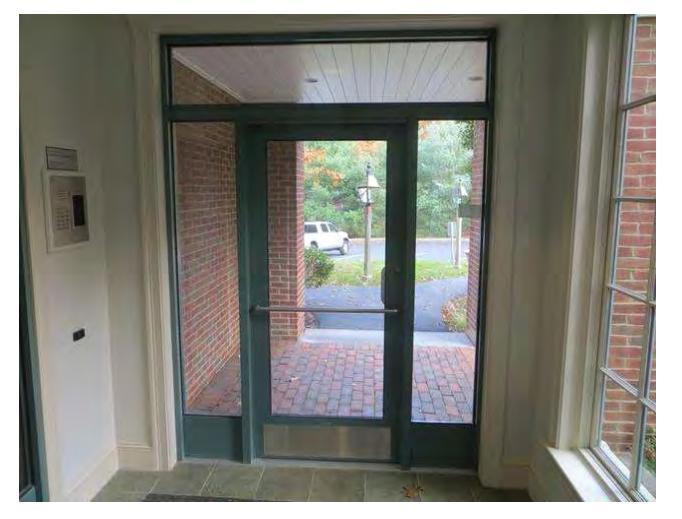
This component covers exterior Kawneer aluminum storefront entry doors and fixed glass windows located in main building at bottom of stairwells. Doors were in good condition during site visit. Both exterior doors are protected under portico. Interior vestibule door at main entry is not exposed to elements.

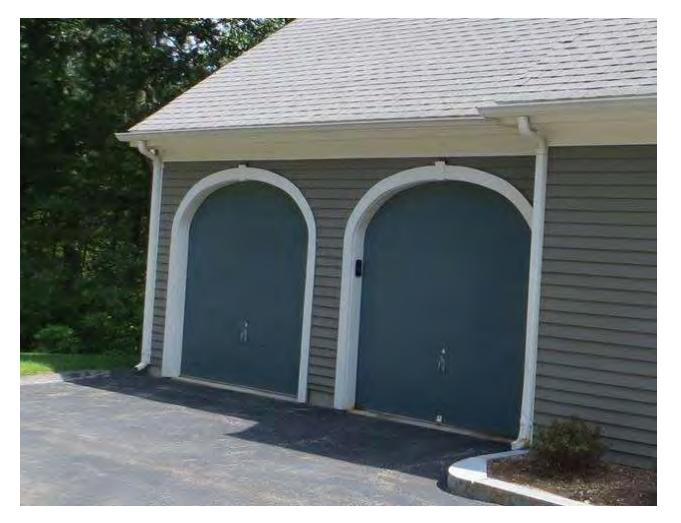
This component covers steel 9' x 8' overhead flush doors servicing trash/garage building and gatehouse. Doors were in good condition during site visit. Replacement pricing includes openers.

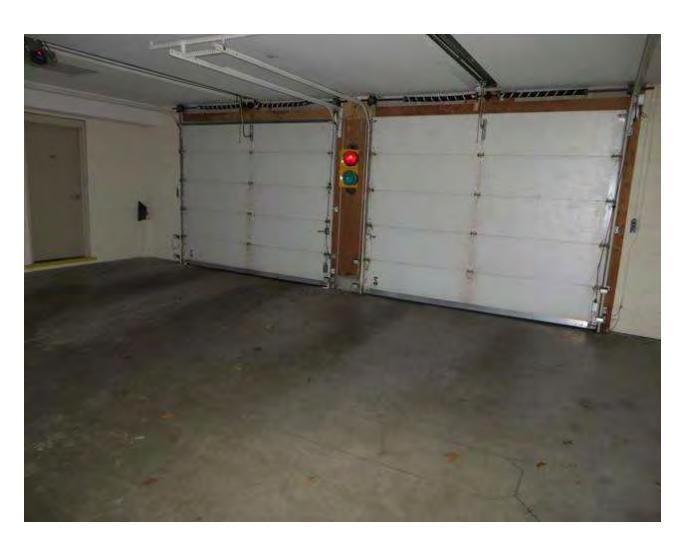
This component covers steel 10' x 8' overhead doors servicing parking garage of main building. Doors were in good condition during site visit. Replacement pricing includes openers.

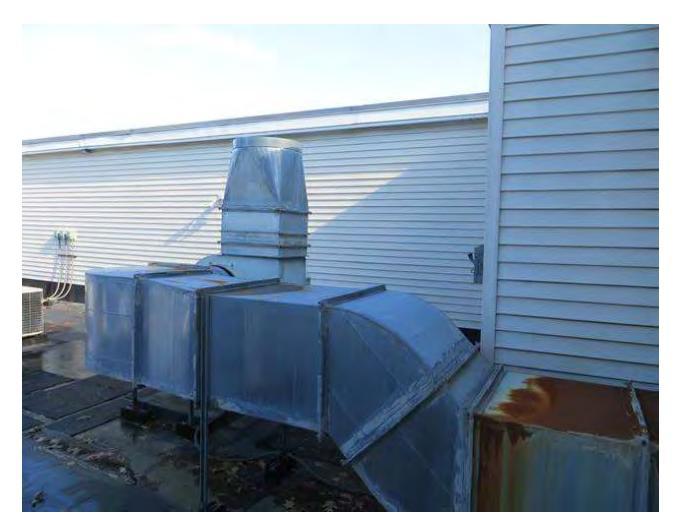
This component covers vinyl siding replacement in flat roof equipment area. Siding is not visible from ground so aesthetic characteristics are less critical. Siding was in good condition during site visit.

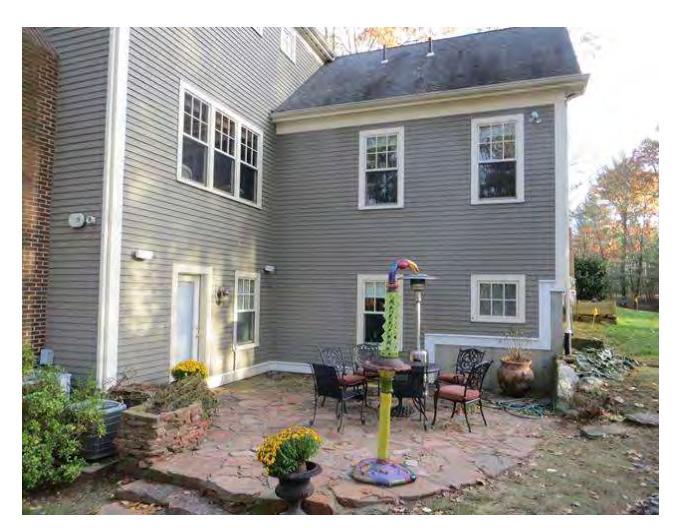
Component covers wood siding inspection and repair on a 5 year interval. Wood siding areas are located on gatehouse and trash/recycle/garage building. Repairs costs equaling 7% of siding areas anticipated every 5 years. As association gains experience with wood siding aging, allowance should be adjusted. As the building ages, a second component for major repairs on a 10 year interval may be needed.

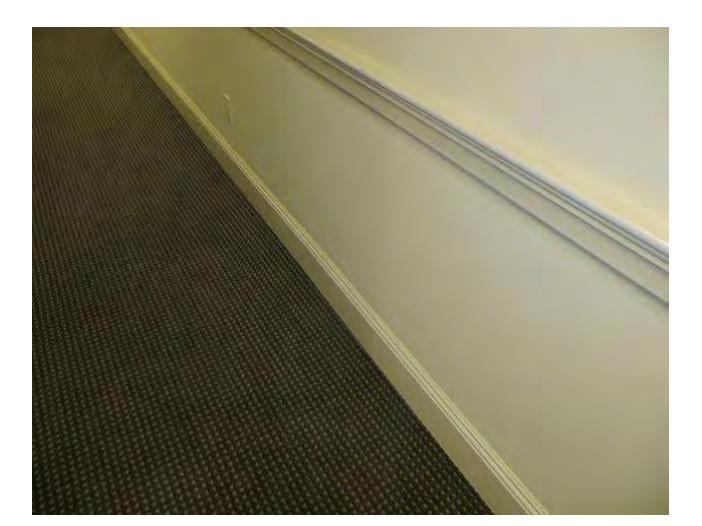
This component covers common area carpet in main building. Carpet was in good condition during site visit. A proper cleaning program will enable carpets to achieve their useful life.

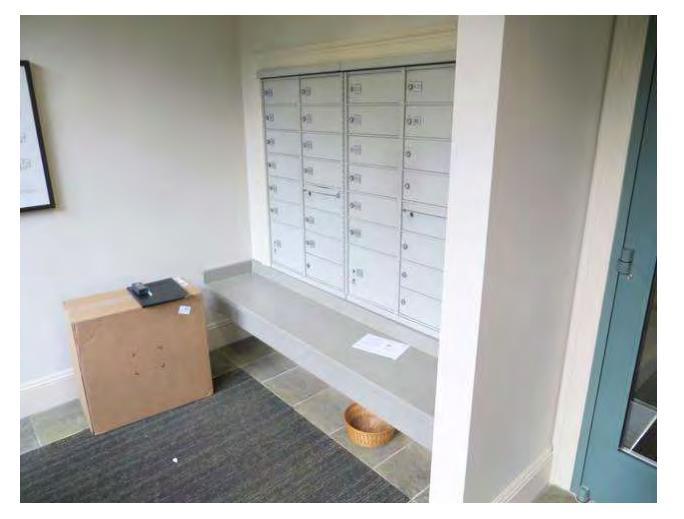
This component covers tile floor perimeter in common vestibule areas in main building. Tile was in good condition during site visit. Small job premium applies. Cost includes removing old tile.

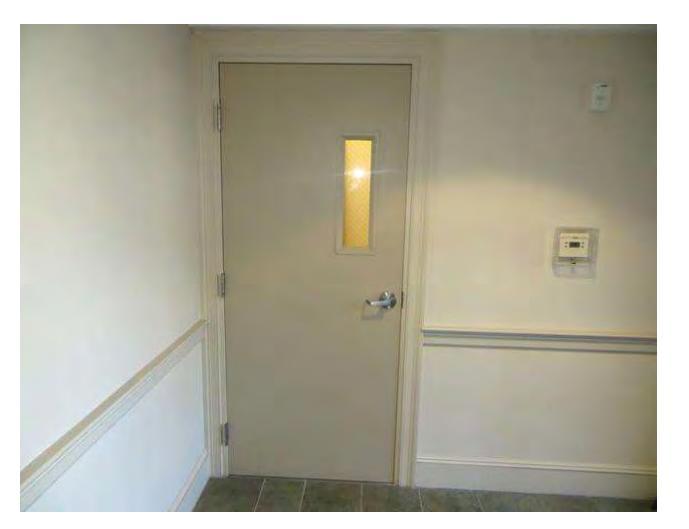
This component covers common area interior doors located in main building. Doors were in good condition during site visit. Extended useful life 5 years based on low number of units in building.

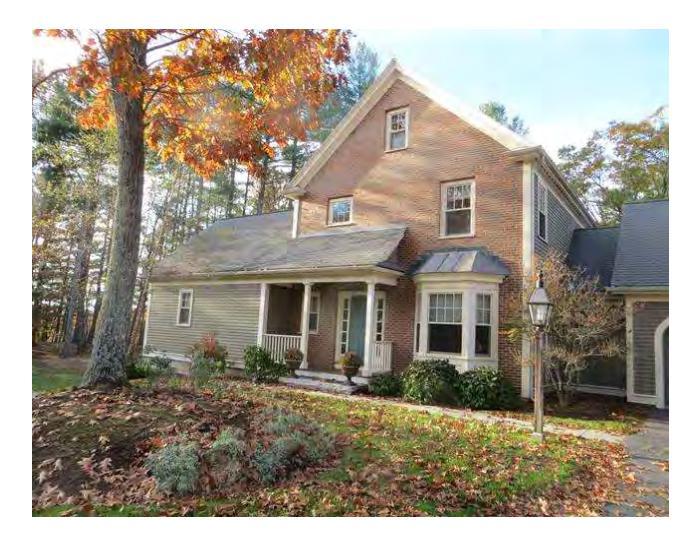
Component covers exterior painting on gatehouse and trash/recycle/garage building. Paint was in generally good condition during site visit. Wood trim on gatehouse need some repair.

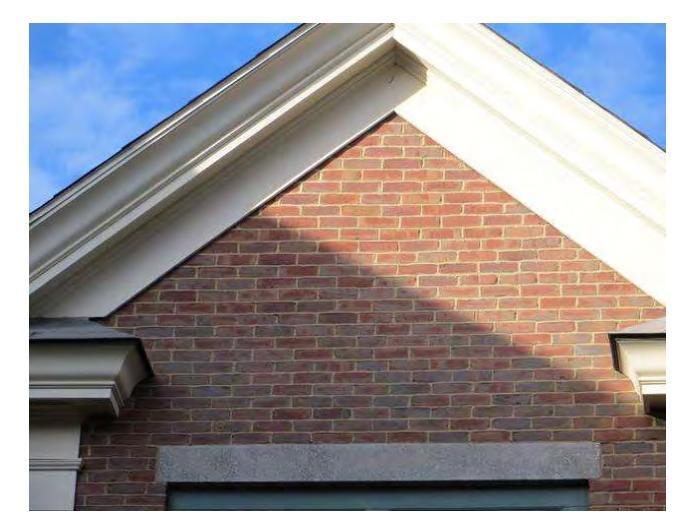
Component covers exterior painting on main building. Paint was in generally good condition during site visit. Railings are currently in need of painting. In order to paint the railings, screen panels will need to be removed and reinstalled by unit owners.

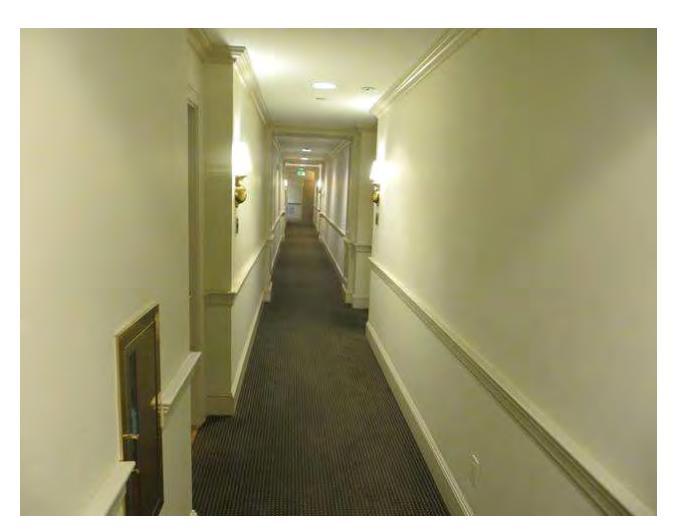
Component covers interior painting of main building common areas. Paint was in generally good condition during site visit. Wall painting area in unit hallways includes painting millwork.

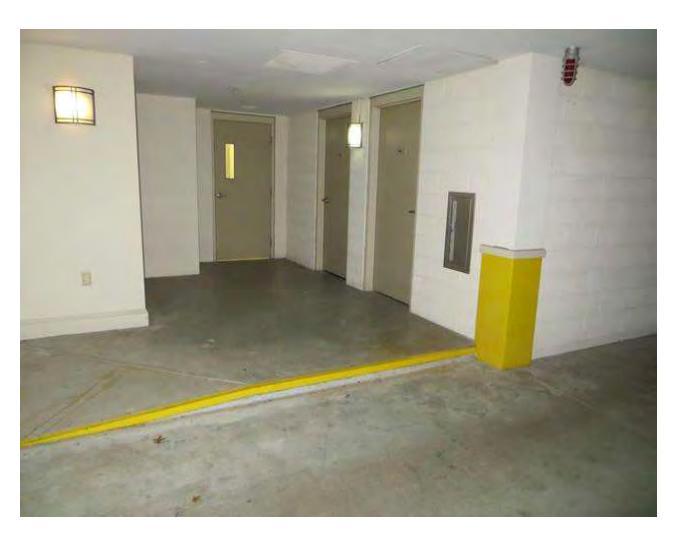
Component covers interior lighting of main building parking garage and storage hall areas. Lighting was in good condition during site visit. Upgrade to LED lamps should be considered.

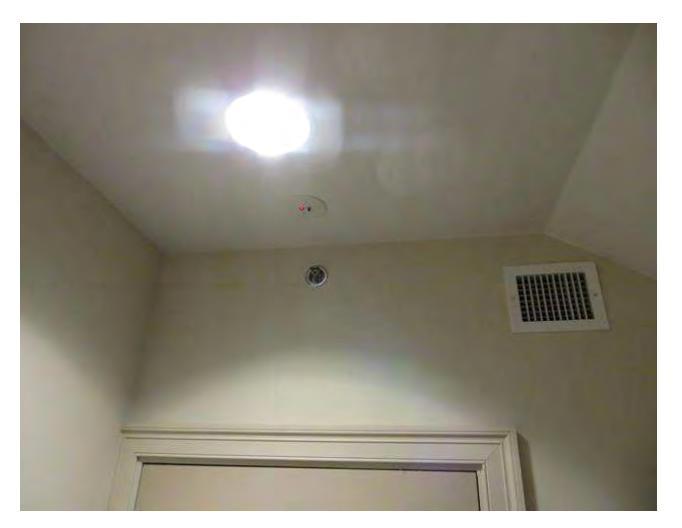
Component covers interior lighting of main building stairwell areas. Lighting was in good condition during site visit. Upgrade to LED lamps should be considered.

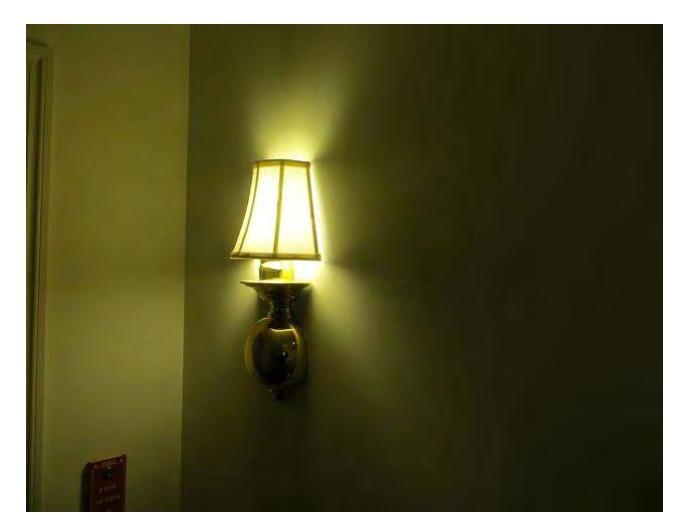
Component covers interior lighting of main building hallway areas. Lighting was in good condition during site visit. Upgrade to LED lamps should be considered.

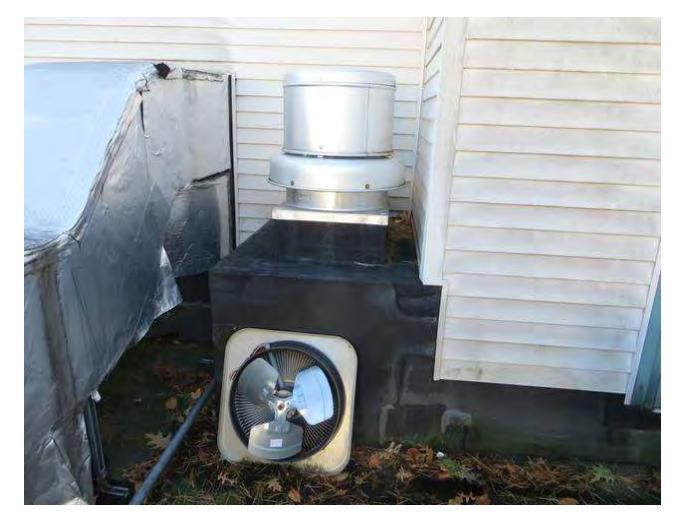
Component covers unit bathroom exhaust fan located on roof. Greenheck GB-141-LMDX-QD fan appeared to be in average condition with no issues reported.

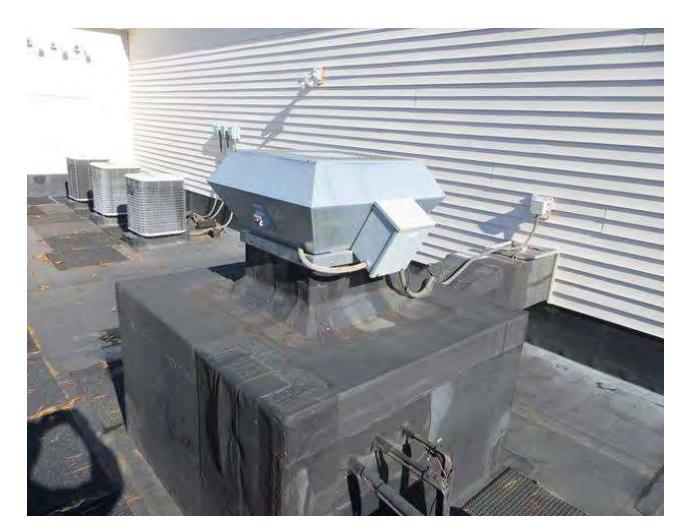
Component covers unit dryer exhaust booster fans located on roof. Fan labels were not readable. Fans appeared to be in average condition with no issues reported.

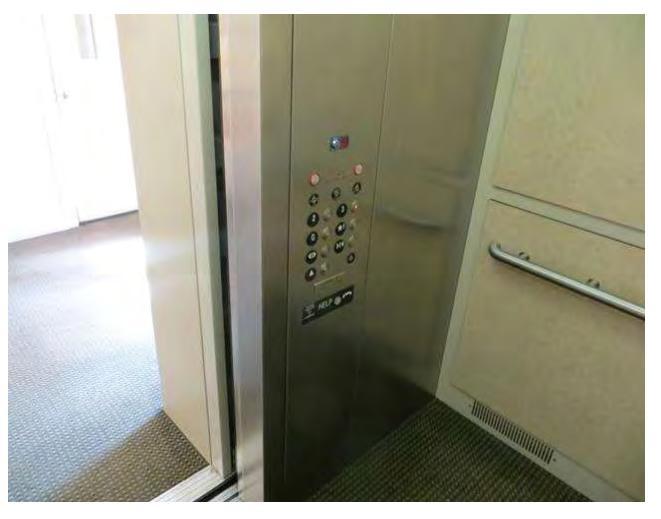
Component covers refurbishment of elevator cab. Elevator cab was in good condition during site visit.

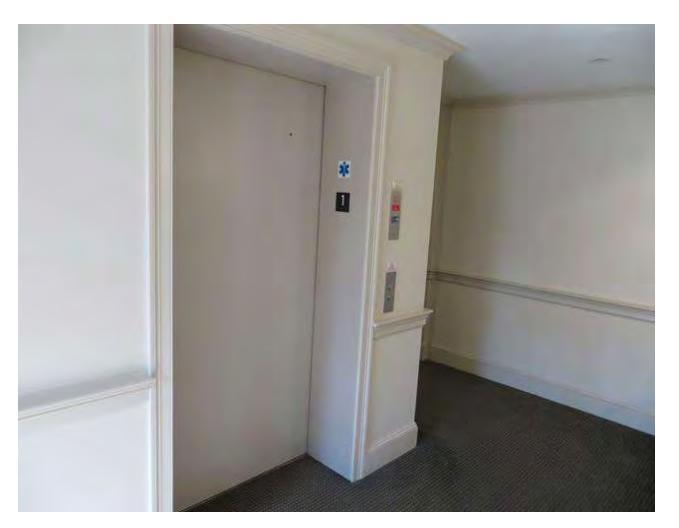
Component covers modernization of hydraulic elevator machinery. Elevator was in good condition during site visit and no issues were reported during site visit.

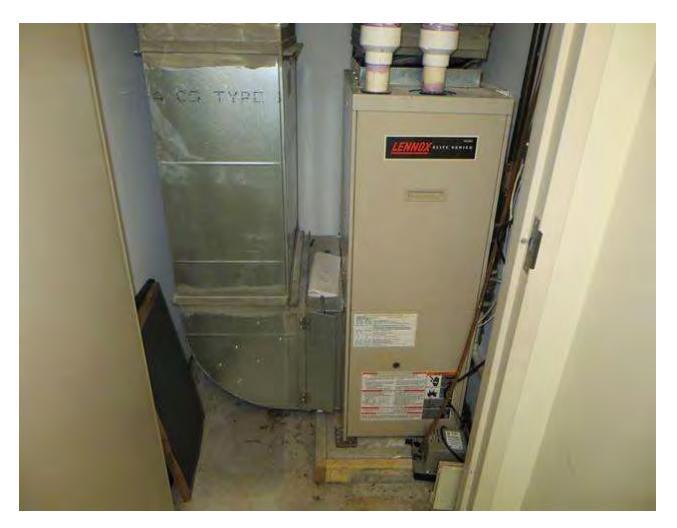
Component covers common vestibule area Lennox G2602-50-6 furnaces. Furnaces supply heat to vestibules and storage unit hallways in basement. Furnaces appeared to be in good condition with no issues reported. Condensate pump for furnace located in mechanical room B1 was cycling. Per model number the sealed combustion natural gas furnaces have an input of 50,000 BTU/hr and an efficiency of 92%.

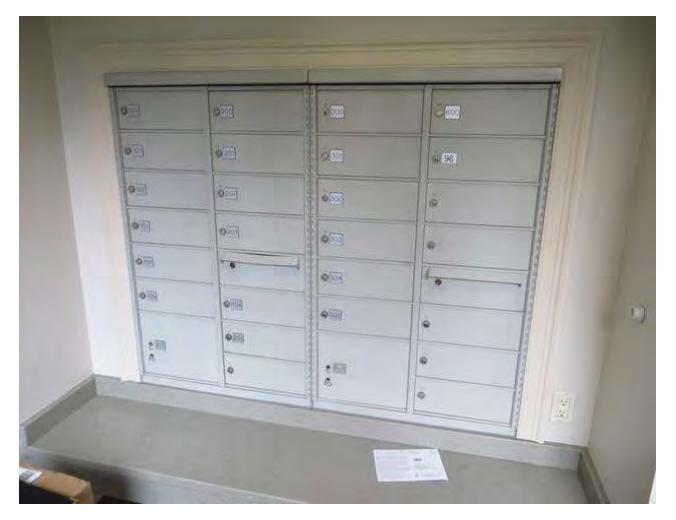
Component covers Salsbury Industries USPS-STD-4B+ 13 door mailboxes in main vestibule. Mailboxes were in good condition order during site visit.

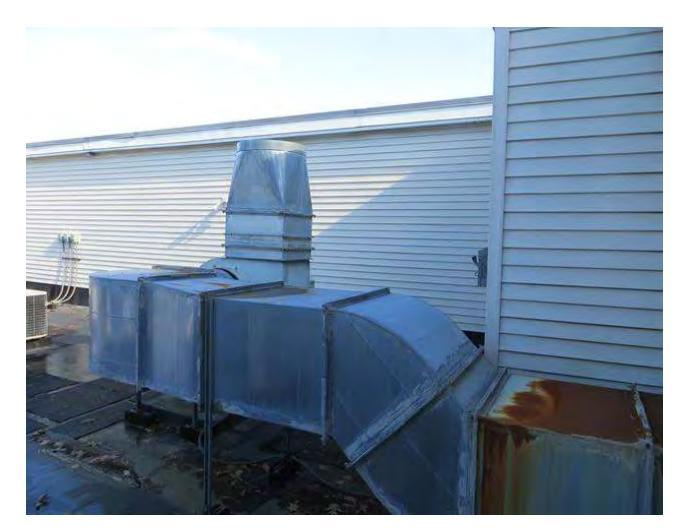
Component covers parking garage exhaust fan located on roof. Greenheck SWB-24-LMD-CW-TH fan appeared to be in average condition with no issues reported.

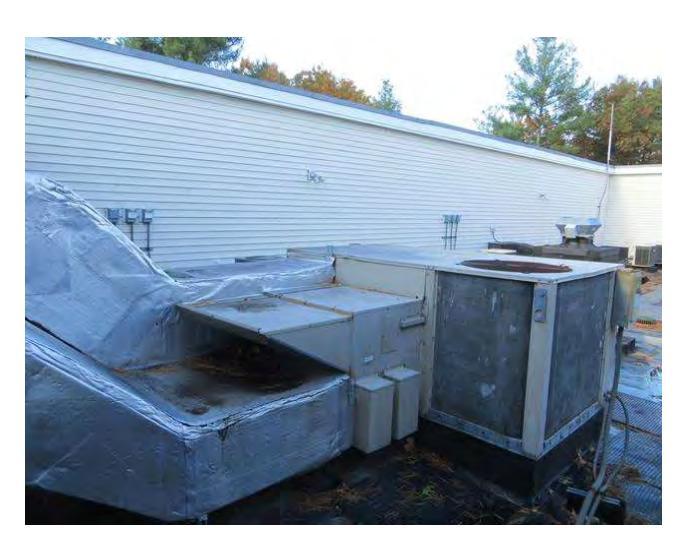
Component covers common area Lennox GCS16-90-200-2Y packaged roof top unit. Air handler appeared to be in average condition. Unit heats and cools building hallways and stairwells. Per model number the natural gas furnace has input of 200,000 BTU/hr. Cooling capacity is 90,000 BTU/hr (7.5 ton). The remaining life of this component has been decreased based on input from service contractor.

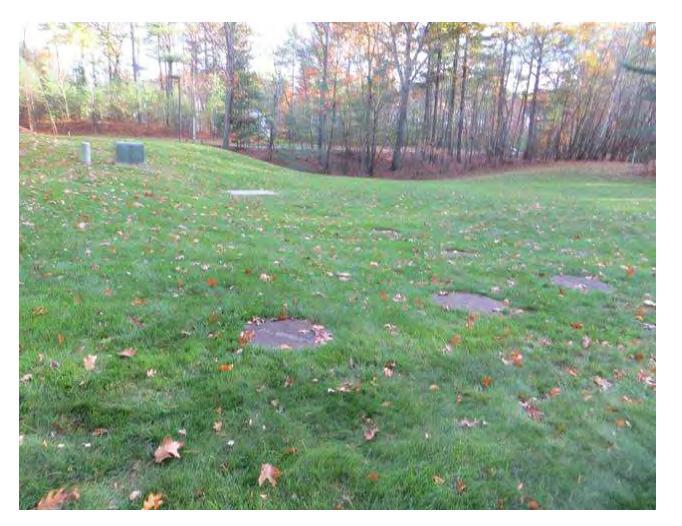
Component covers septic system tanks and leach field. System plans are available at Concord Health Department, but were not available during site visit. Allowance should be refined as more information becomes available. Useful life extended due to favorable soil conditions.

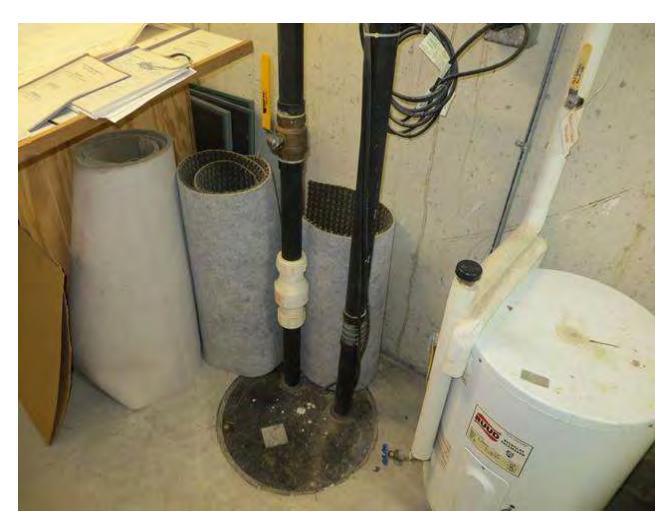
Component covers sump pump in mechanical room B1. Pump appeared to be in good condition with no issues reported. Useful life extended 3 years to reflect apparent low pump usage due to favorable soil conditions and dry appearance of basement.

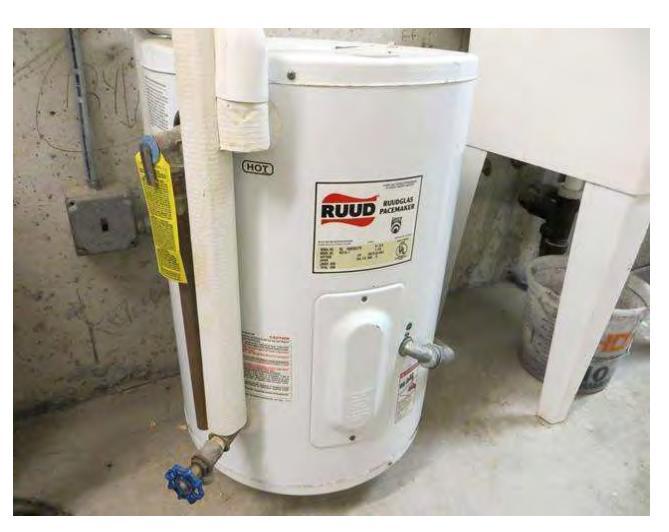
Component covers common area Ruud PEP15-1 point-of-use electric water heater in mechanical room B1. Water heater services adjacent utility sink. Heater appeared to be in good condition with no issues reported. Per model number the water heater has a capacity of 15 gallons.
