RESERVE ANALYSIS REPORT

Boston New Construction Condominium

Boston, Massachusetts

May 13, 2019

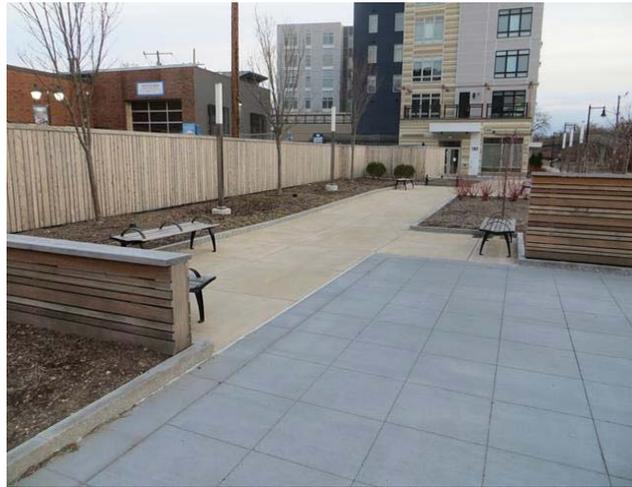
Component covers concrete walkway and patio areas around building and in plaza/park. Concrete has natural gray and dyed black colors and a brush finish. Dark concrete is saw cut to simulate tile pattern. Concrete was in good condition at site visit. Concrete street sidewalks are assumed to be municipal responsibility and not included in area total.

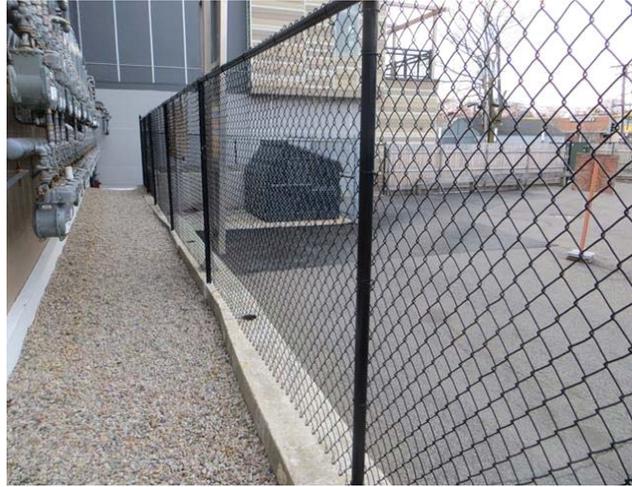
Component covers 6' black chain link fence behind building. Fence was in good condition at site visit.

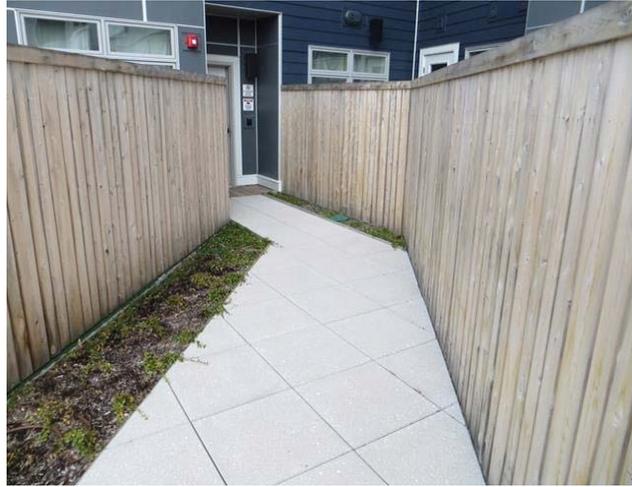
Component covers 6' tall cedar stockade fence around unit terraces and 5' fence along open perimeter of courtyard. Fences were in good condition at site visit. Per client, fences will be left natural to weather in environment. Treating wood with sealer will likely prolong life.

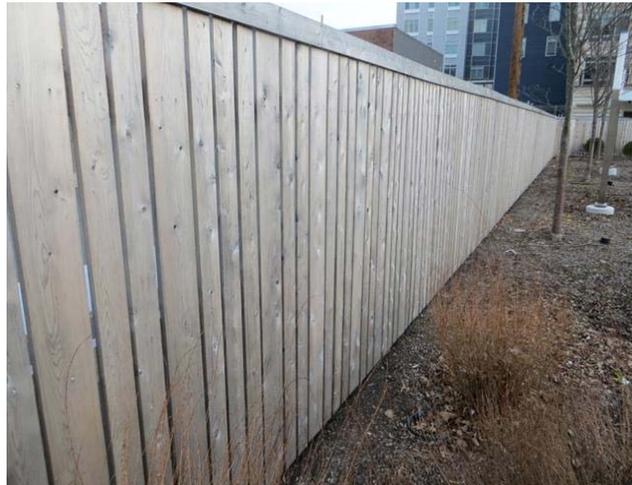
Component covers wood fences and decorative wood walls on site. Fences and walls were in good condition at site visit. Per client, fences will be left natural to weather in environment. Treating wood with sealer will likely prolong life.

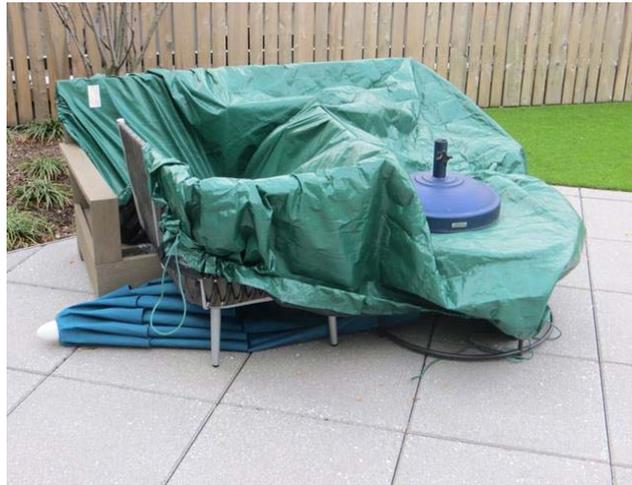
Component covers courtyard furnishings. Furnishings were stacked and partially covered with tarps at site visit. Quantities estimated.

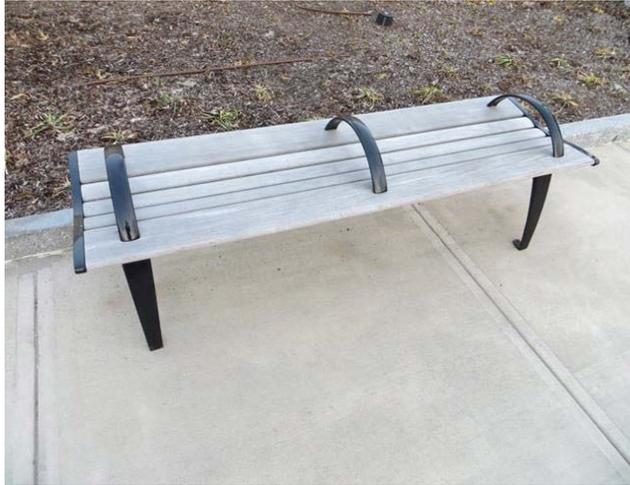
Component covers mahogany & steel benches and steel bike racks on site. Furnishings were in good condition at site visit.

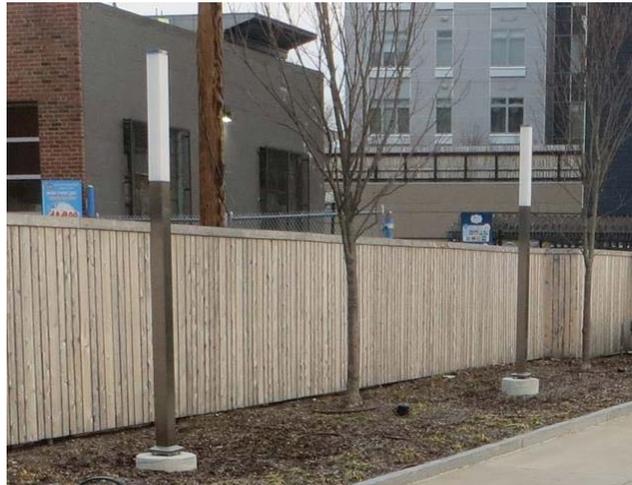
Component covers site lighting around building, courtyard, and in plaza area. Lighting was in good condition at site visit.

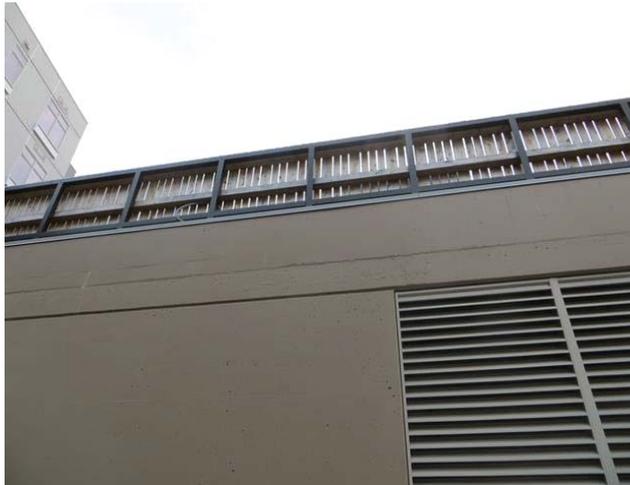
Component covers black aluminum railing along open perimeter of courtyard. Railing was in good condition at site visit.

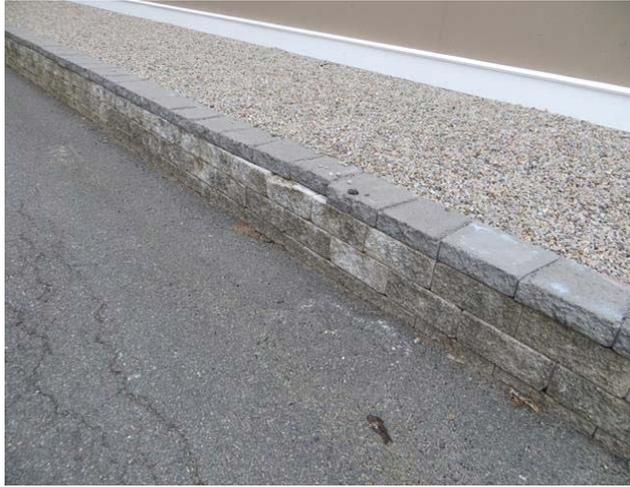
Component covers small landscape block retaining wall behind building. Wall was in good condition at site visit.

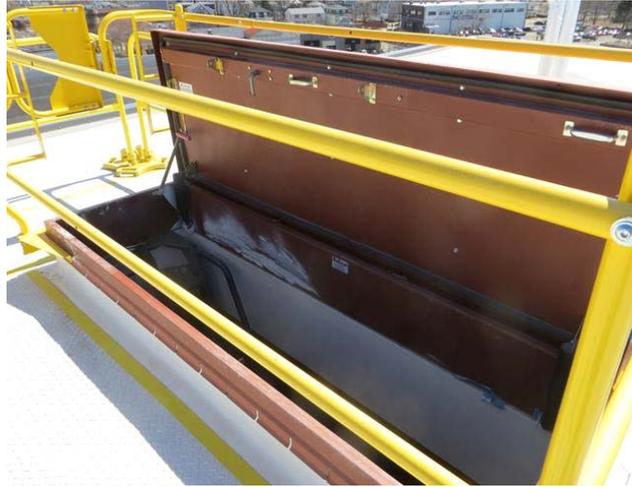
Component covers roof access hatches. Bilco L-20 hatches measure approximately 30" x 96" and include safety rail system. Hatch and rails were in good condition at site visit but hatchways need finish painting over factory red primer. Hatchways need to be painted with finish coat to achieve useful life.

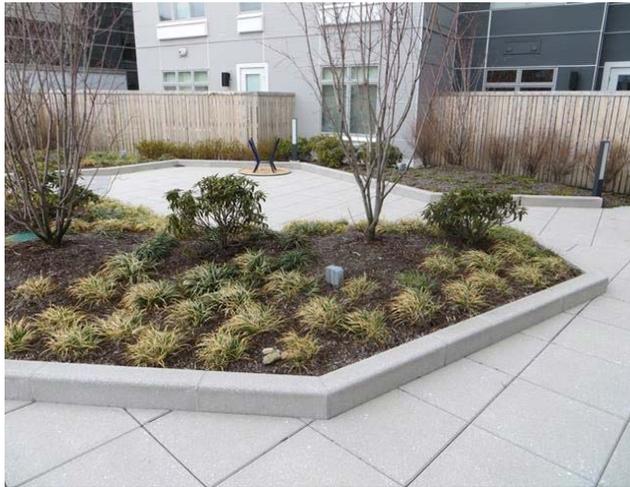
Component covers plaza deck roof of underground parking garage supporting courtyard. Pricing for this combination of roofing and landscaping is difficult to predict. It is recommended that contractors and/or roofing consultants be contacted to determine a reasonable budget for replacement. Unit price per similar association in Boston.

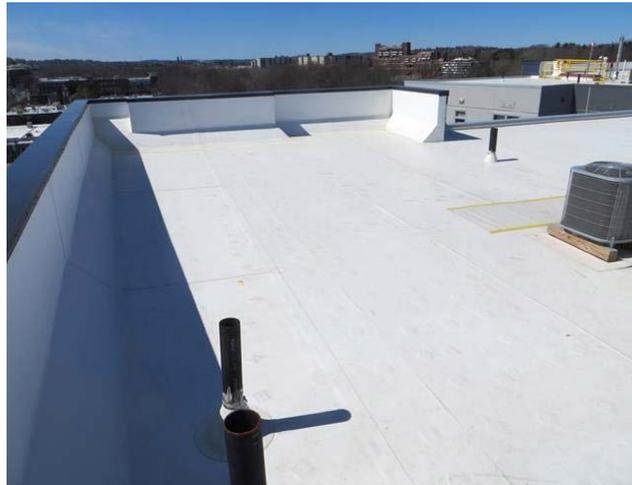
Component covers single-ply Johns Manville TPO roof membranes on main and secondary canopy roofs. TPO is an abbreviation for thermoplastic polyolefin. TPO is usually a blend of polypropylene and ethylene-propylene rubber. Johns Manville TPO roof membrane has 15 year warranty per documentation package provided.

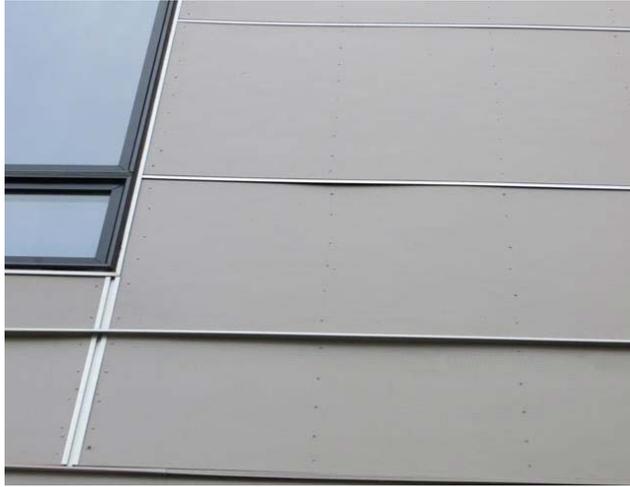
Component covers visual exterior inspection and minor repairs/sealing of building and garage every 3 years. Inspections can spot minor issues before they become major and create an organized plan for more major repairs. Detailed inspection will also yield information on painting schedule need for fiber cement siding on buildings.

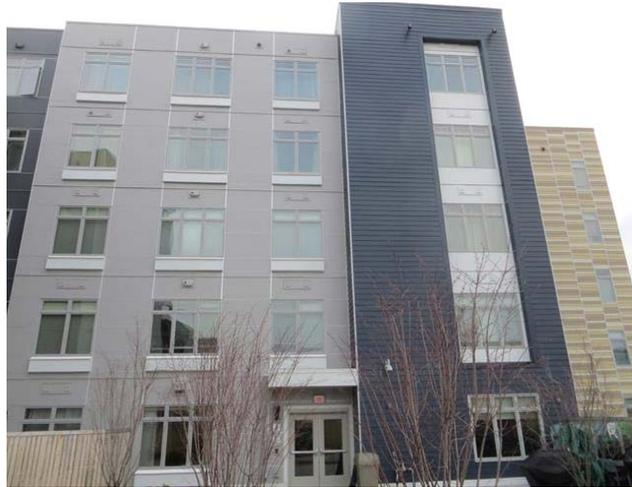
Component major cladding repairs. Typical cost for fiber cement siding may be about \$12-\$15 per sq. ft. However, siding on building is more complex than typical so increased cost of \$20 sq. ft used.

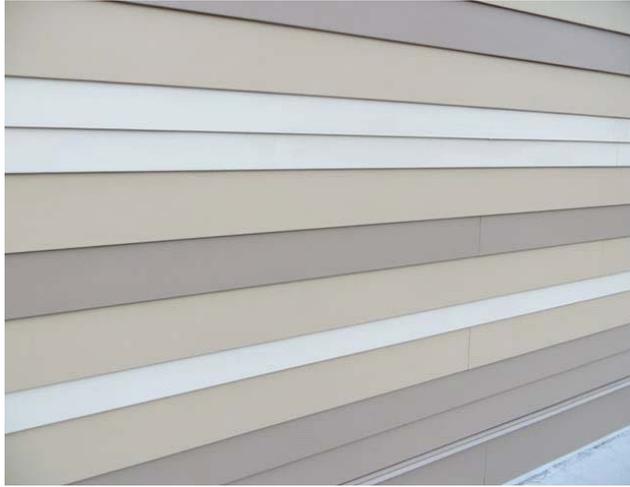
Component covers painting of fiber cement siding and trim areas of all buildings. Condition of exterior building cladding appeared good during site visits. No specific current issues were noted.

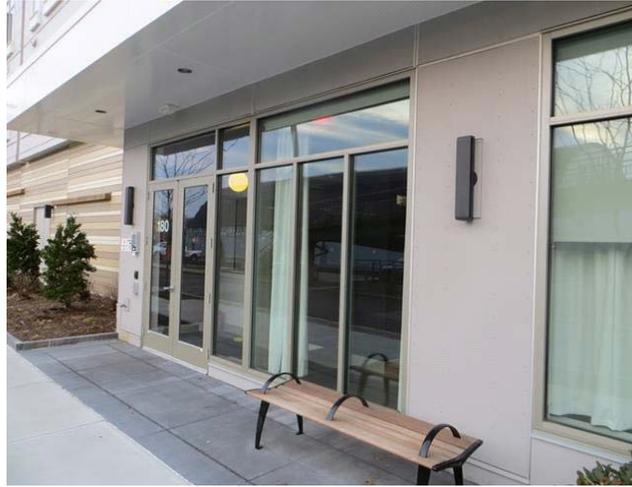
Component represents exterior common store front doors, casement windows in bike room, and fixed windows around building. Doors and windows were in good condition during site visits and no problems were reported by client. Doors will need periodic replacement of wear items (hinges, handles, etc.) to achieve useful life.

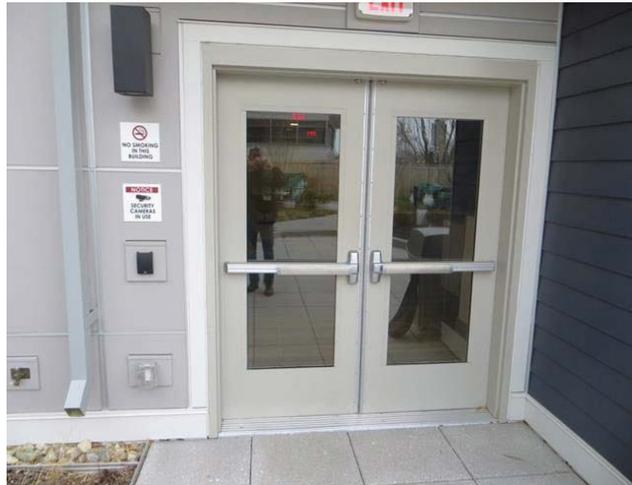
Component represents exterior common steel doors around building and courtyard. Doors were in good condition during site visits and no problems were reported by client. Doors for trash room are listed separately due to high use and impacts with dumpsters moving through.

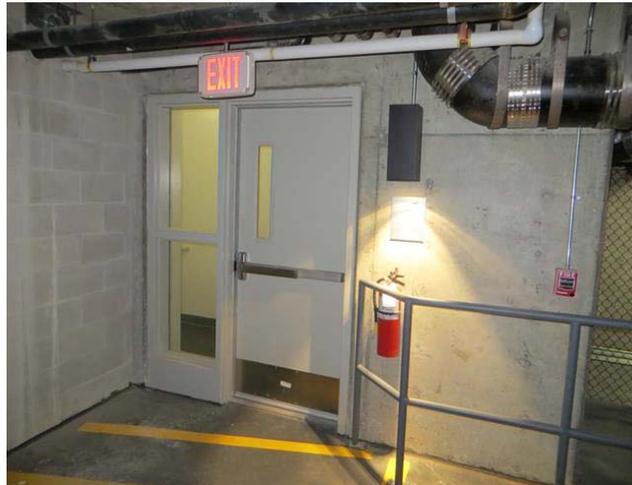
Component represents exterior common doors opening into interior of parking garage. Doors were in good condition during site visits and no problems were reported by client.

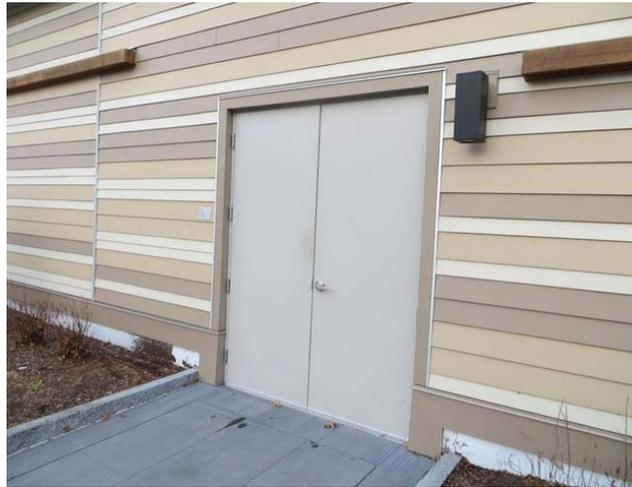
Component covers high use double steel 72" x 96" trash room doors. Doors were in fair to good condition during site visits and door handle was broken. Due to high use with dumpsters moving through, doors will likely have reduced service life.

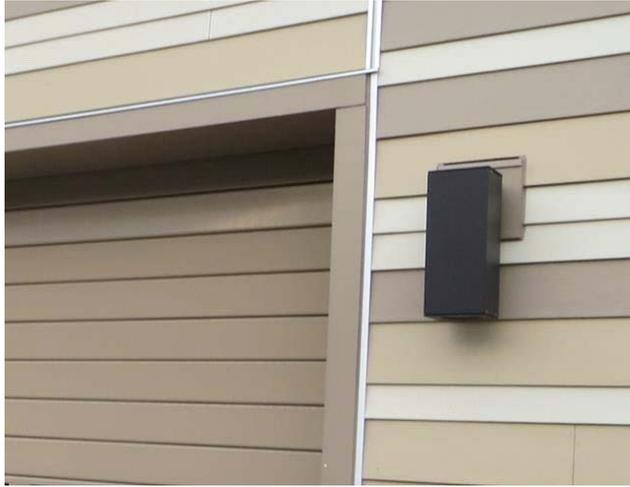
Component covers wall and ceiling mounted exterior lighting. Lighting was in good condition at site visit.

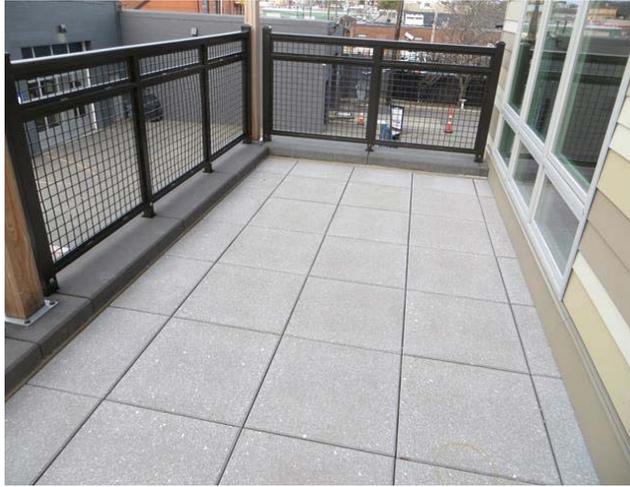
Component covers painted aluminum railing at fitness terrace. Railing was in good condition at site visit.

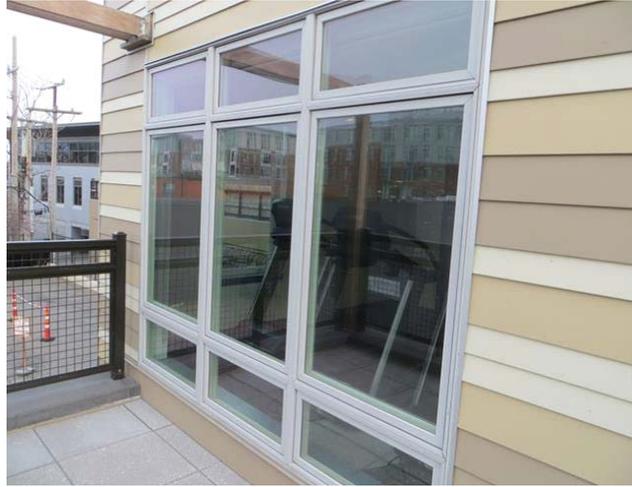
Component represents Pella Proline exterior common windows. Windows were in good condition during site visits and no large problems were reported by client. New construction window replacements assumed. Installation allowance assumes that multiple windows are replaced concurrently.

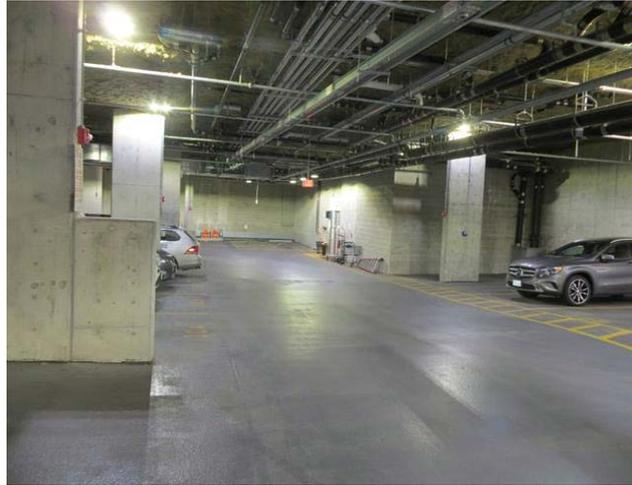
Component covers Neogard coatings on garage floors. Component does not include complete replacement of concrete which is unfunded. Occasional repairs should be addressed by operating budget on as-needed basis. Floors were in good condition at site visit.

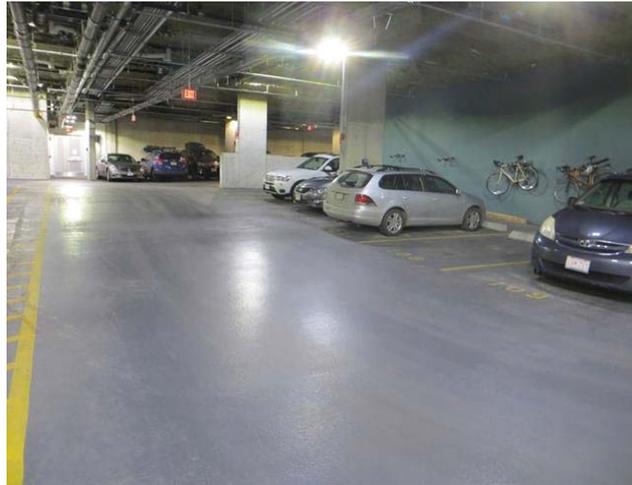
Component covers garage lighting. Lighting was in good condition at site visit.

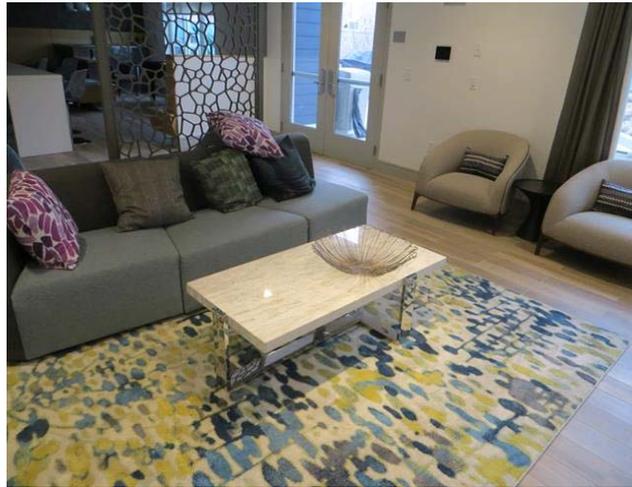
Component covers replacement of furnishings in café clubroom and home offices. Furnishings were in very good condition at site visit. Replacement furnishings may vary widely in price based on selections.

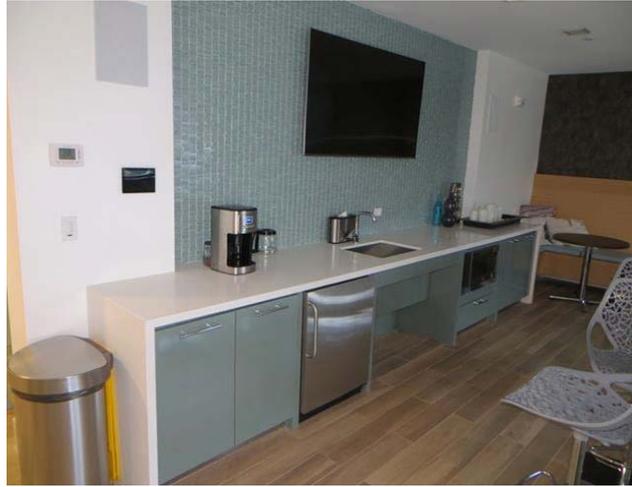
Component covers replacement of clubhouse IKEA painted steel kitchen cabinetry, engineered stone counter, and kitchen sink/faucet. Kitchen was in very good condition at site visit.

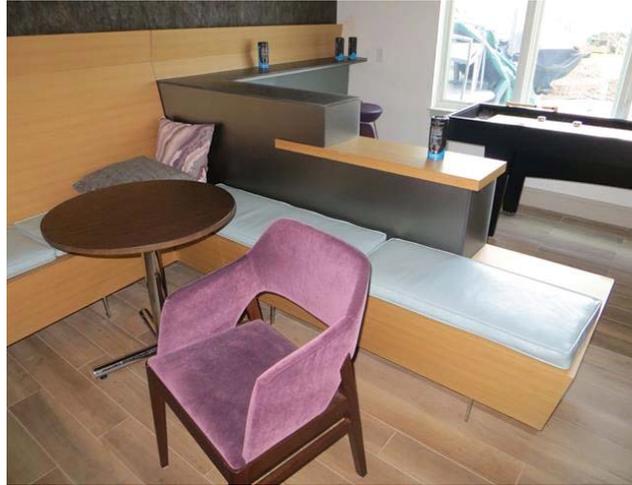
Component covers general renovation of café clubroom and home offices. Café clubroom and home offices were in good condition at site visit. Flooring, kitchen cabinetry, furnishings, TV/electronics, and lighting are covered by separate components. Renovation component covers other details including: ceiling details, built-in furniture, and artwork.

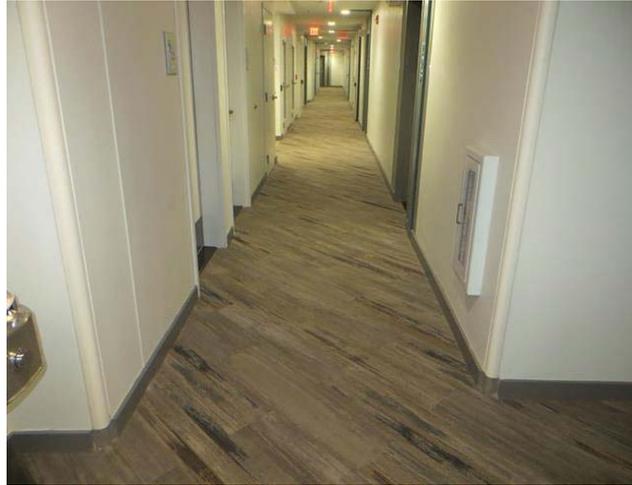
Component covers hallway carpet tile. Carpet in hallways is in good condition.

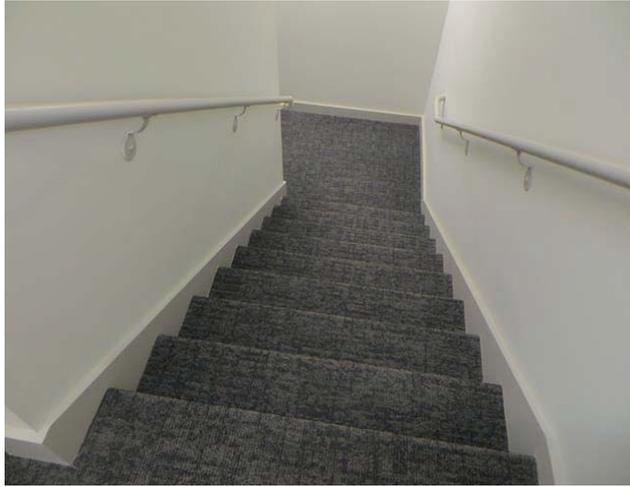
Component covers stairwell carpet and vinyl baseboard (in limited areas). Carpet in stairwells was in good condition at site visit.

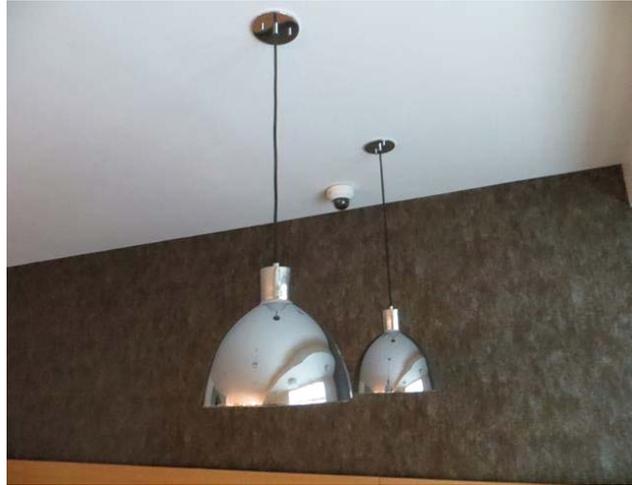
Component covers clubroom lighting. Lighting was in good condition at site visit.

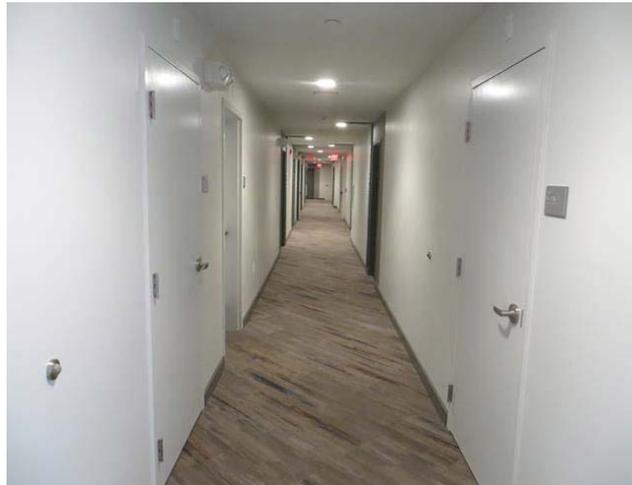
Component covers interior unit hallway lighting on floors 2-6. Lighting was in good condition at site visit.

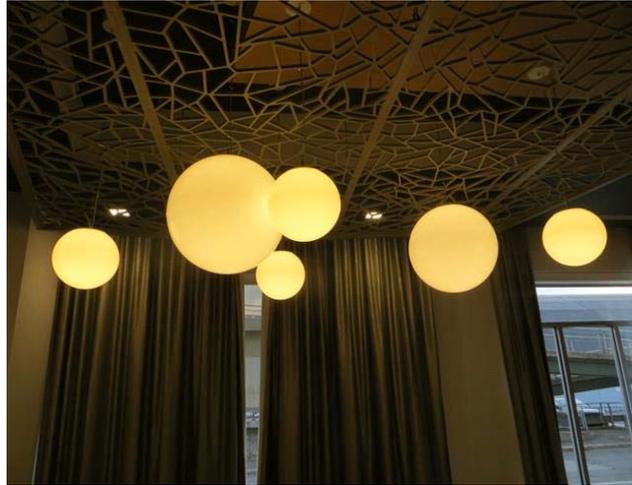
Component covers interior lobby area lighting. Lighting was in good condition at site visit.

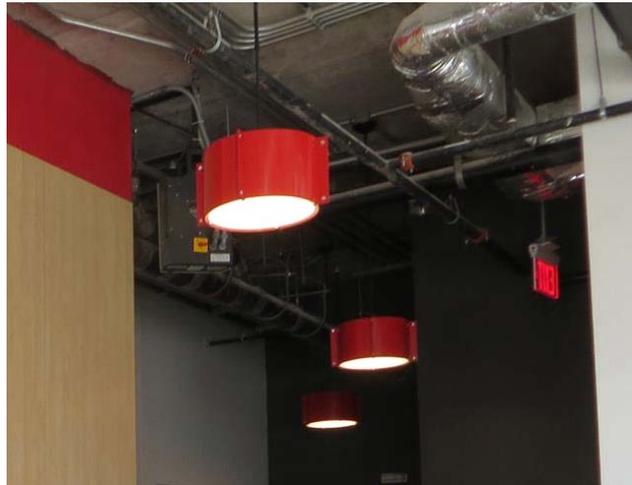
Component covers interior bike room, row room, unit storage, equipment rooms, and fitness room lighting. Lighting was in good condition at site visit.

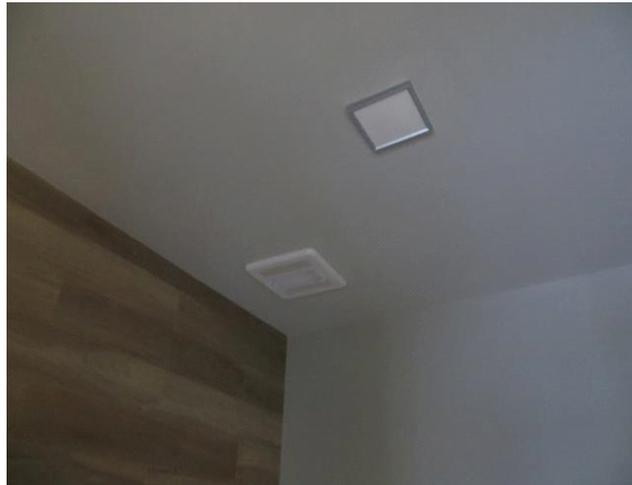
Component covers lighting in three restrooms. Ceiling fan/light also included. Lighting was in good condition at site visit.

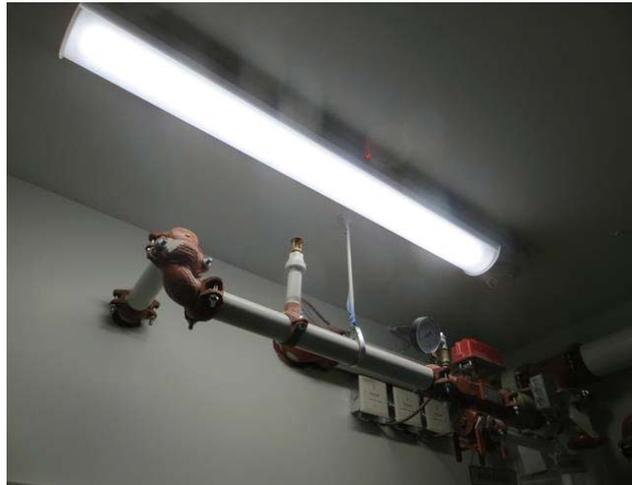
Component covers stairwell lighting in building. Lighting was in good condition at site visit.

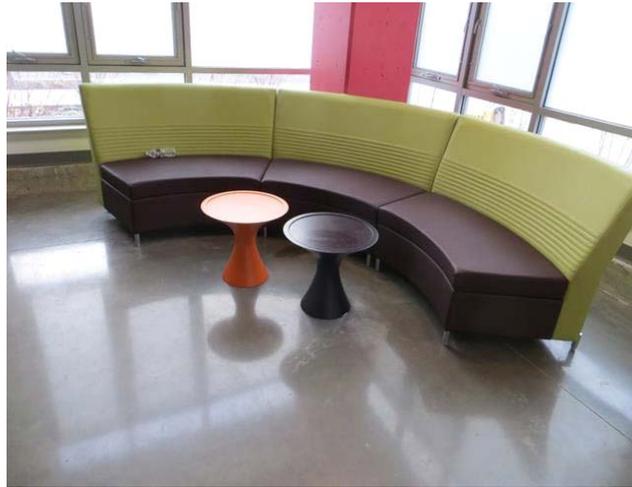
Component covers allowance for furnishings in main lobby and bike room. Furnishings were in good condition. Furnishings vary widely and cost is difficult to estimate.

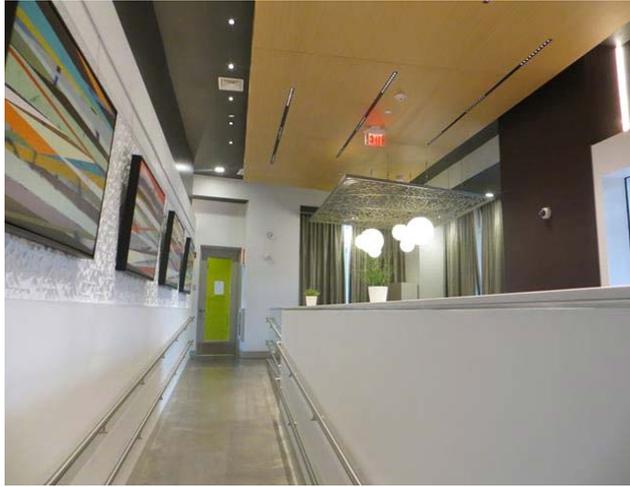
Component covers renovation of main lobby. Lobby was in good condition at site visit. Flooring, furnishings, and lighting are covered by separate components. Renovation component covers: ceiling details, counter top, and artwork.

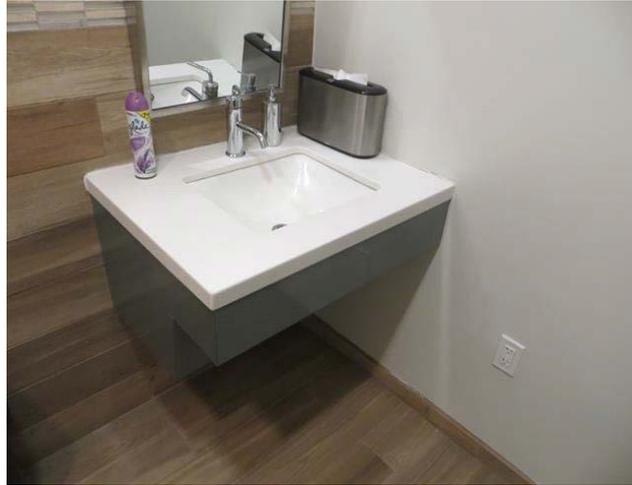
Component covers renovation of three restrooms. Restrooms were in good condition at site visit. Tile & lighting replacements listed as separate components.

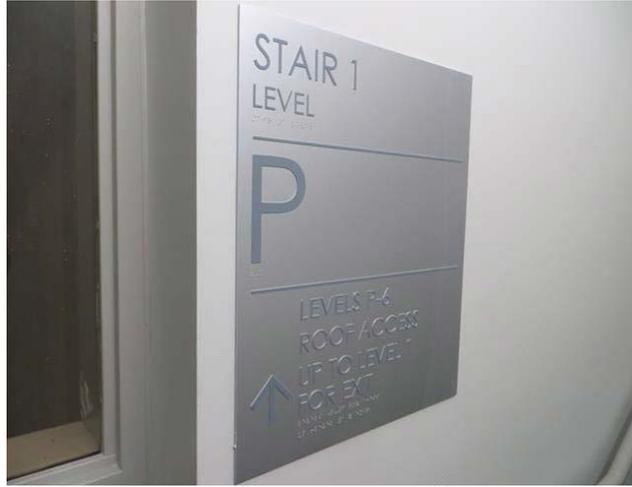
Component covers allowance for general signage throughout association.

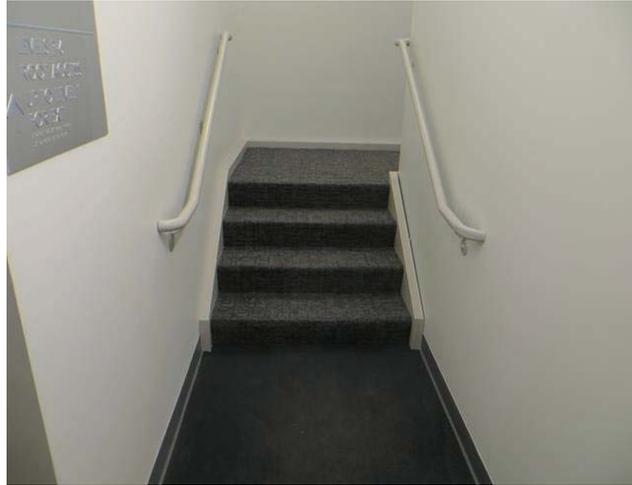
Component covers replacement of painted steel stair railings. There are about 280 ln. ft. of stair rails per stairwell. Total about 560 ln. ft.
 Component can be added if desired by client.

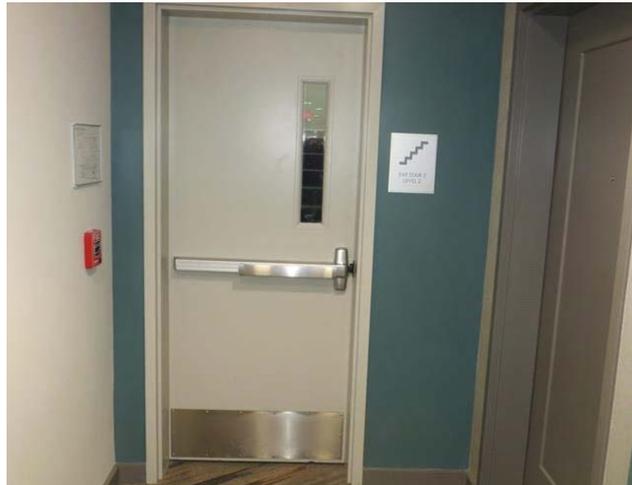
Component covers interior common steel doors in higher use locations within building. Doors were in good condition at site visit. Door life will vary with usage. It is unlikely that all interior doors will be replaced at one time. Allowance and interval for repairs and replacements should be adjusted over time to reflect aging of building. Current allowance is set at 10% every 5 years. With proper maintenance/repairs to hinges, handles, etc. doors may exceed expected useful life.

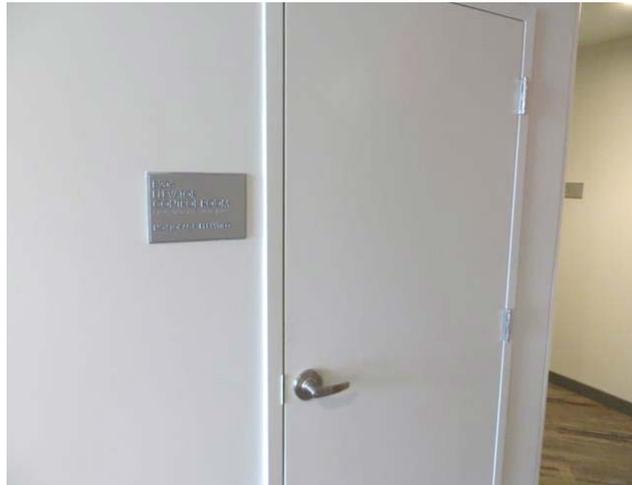
Component covers interior common steel doors in low use locations within building: tele/data closets, janitor closet, elevator machine room, equipment rooms, hall fire doors (held open by magnetic catches), row room exit to vestibule, etc. Doors are currently unfunded and will have a useful life well beyond 30 year timeframe of study. With proper maintenance, many doors should last indefinitely.

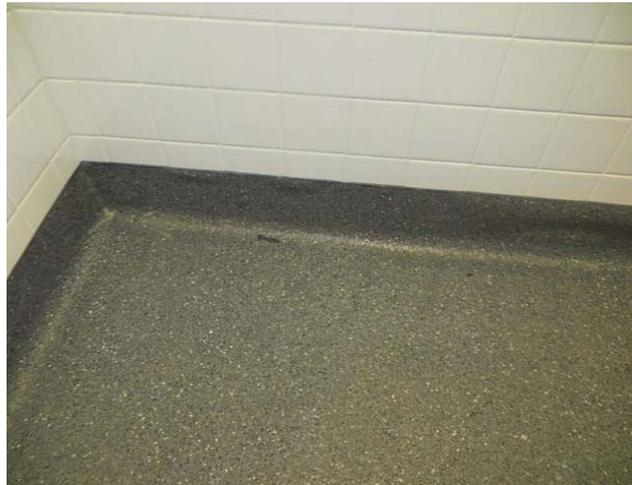
Component covers allowance for epoxy flooring (45 sq. ft) and wall tile (135 sq. ft.) in dog wash. Finishes were in good condition.

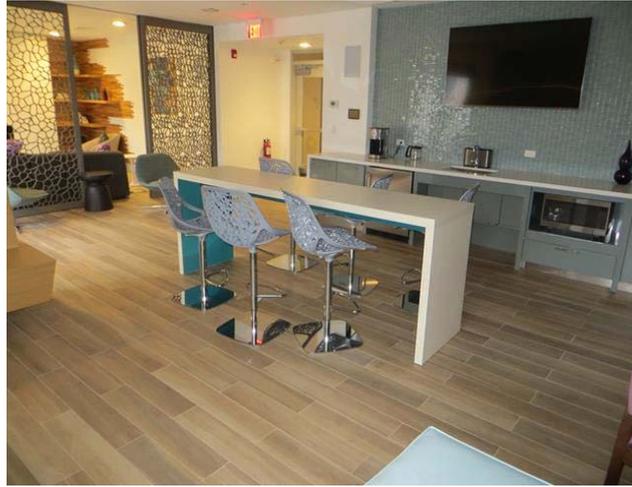
Component covers tile floor and glass tile backsplash in café clubroom. No loose or cracked tiles were observed. Removal of existing tile is difficult to estimate. Cost of materials chosen to replace the current tile can also vary widely. Quantities include 15% waste factor.

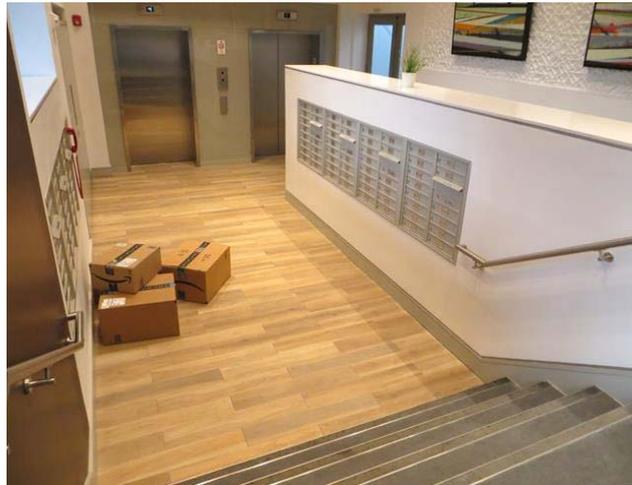
Component covers ceramic tile in main lobby. Tile was in good condition. No loose or cracked tiles were observed. Removal of existing tile is difficult to estimate. Cost of materials chosen to replace the current tile can also vary widely. Quantities include 15% waste factor.

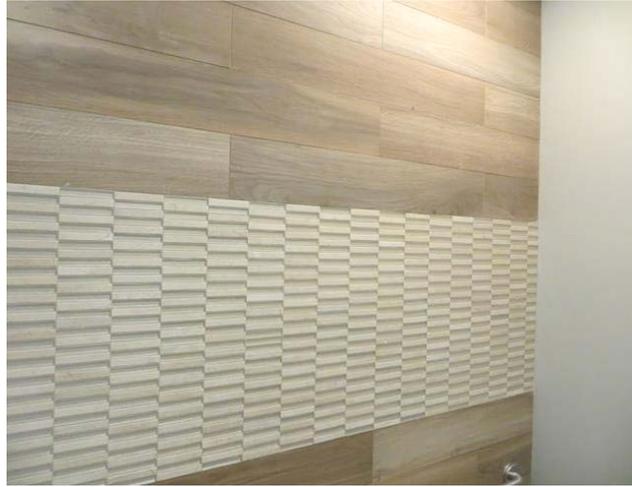
Component covers tile floors and walls in three restrooms. No loose or cracked tiles were observed. Removal of existing tile is difficult to estimate. Cost of materials chosen to replace the current tile can also vary widely. Quantities include 15% waste factor.

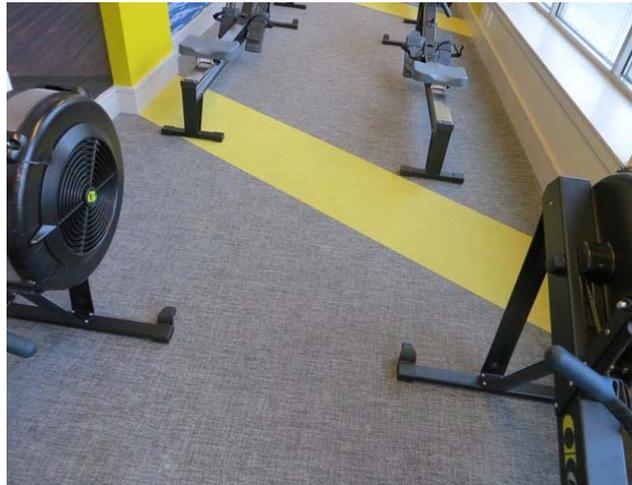
Component covers vinyl Chilewich sheet goods in fitness and row rooms. Chilewich was in good condition. Quantities include 15% waste factor.

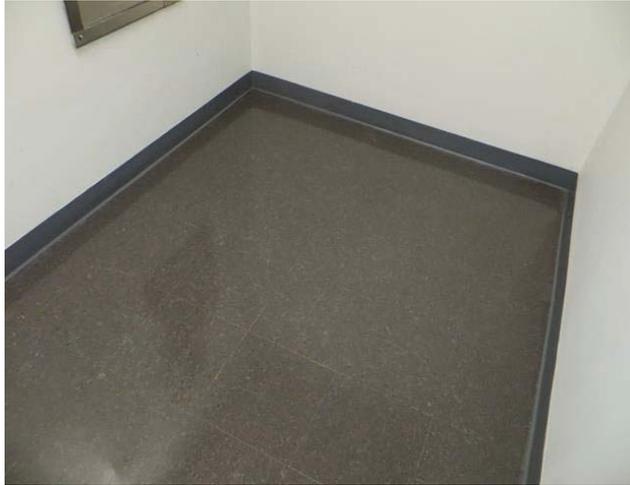
Component covers vinyl composition tile (VCT) in (5) trash rooms. VCT was in good condition and receives relatively low use.

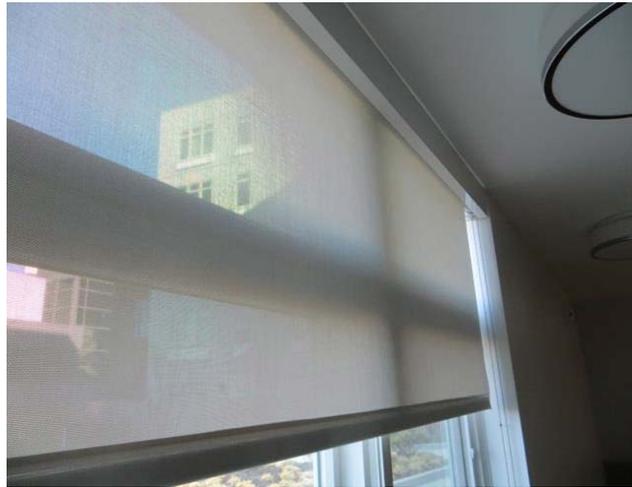
Component covers roller shade window treatments for exterior common windows. Shades were in good condition during site visits and no problems were reported by client.

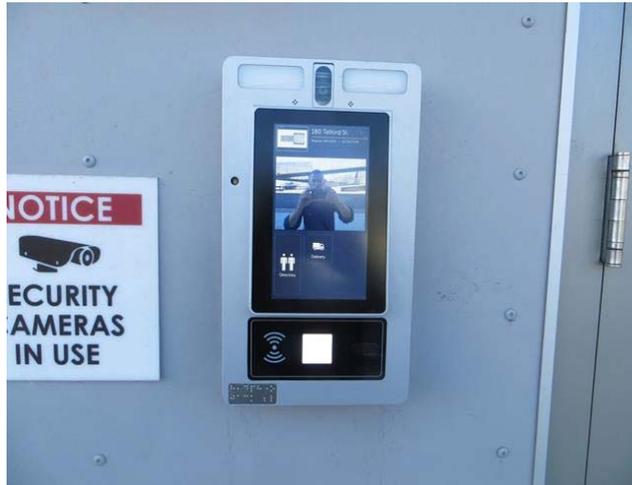
Component covers replacement of video intercom access system for building main lobby. No issues reported. Minor repairs should be funded from operating budget.

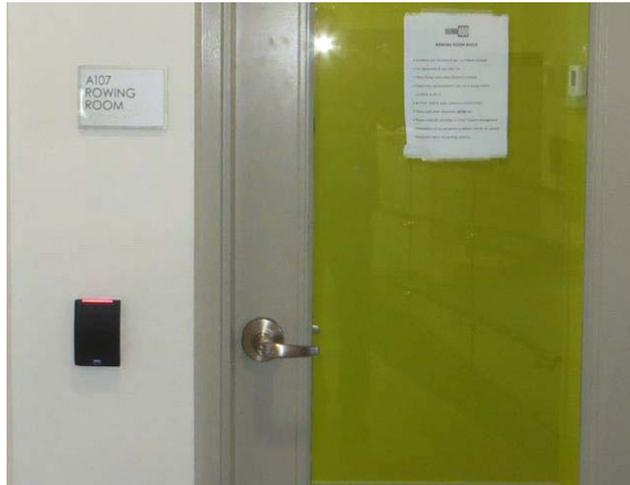
Component covers replacement of key fob access system for building. No issues reported. Minor repairs should be funded from operating budget. Number of doors utilizing fob access estimated at 50.

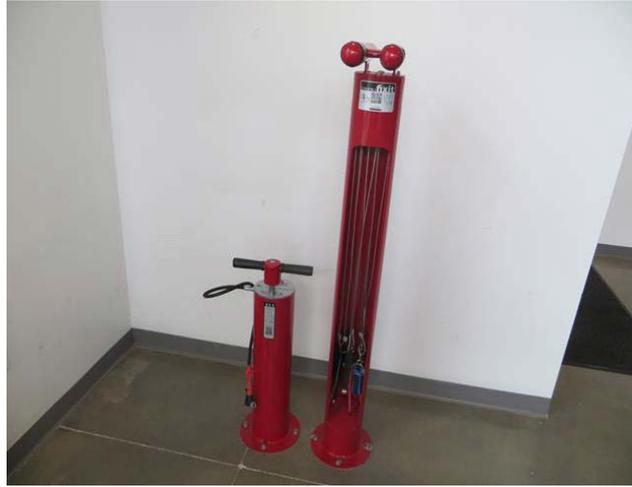
Component covers FixIt public bike repair station with air kit mounted in bike room. Station was in good condition at site visit.

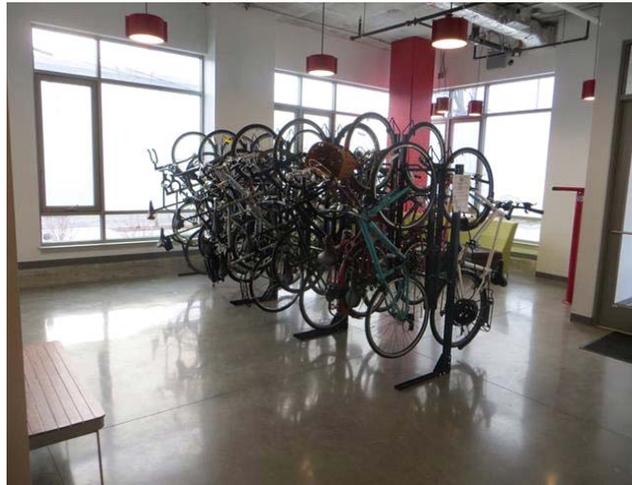
Component covers Saris vertical bike racks in bike room and Dero wall mounted bike racks in garage. Nine Saris vertical bike racks are also installed in garage. Racks were in good condition.

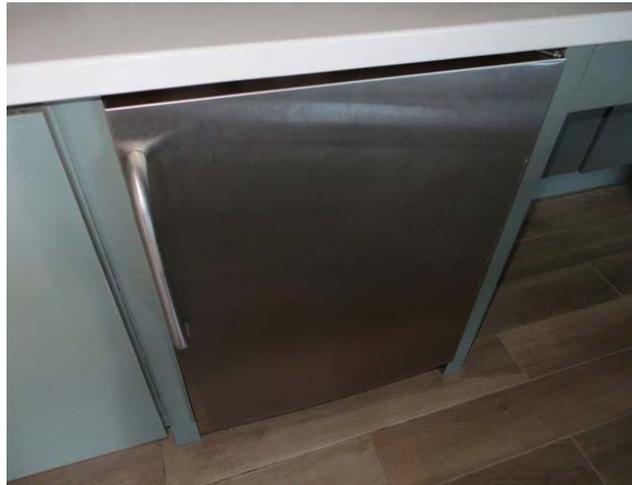
Component covers café kitchen major appliances. Appliances were in good condition at site visit.

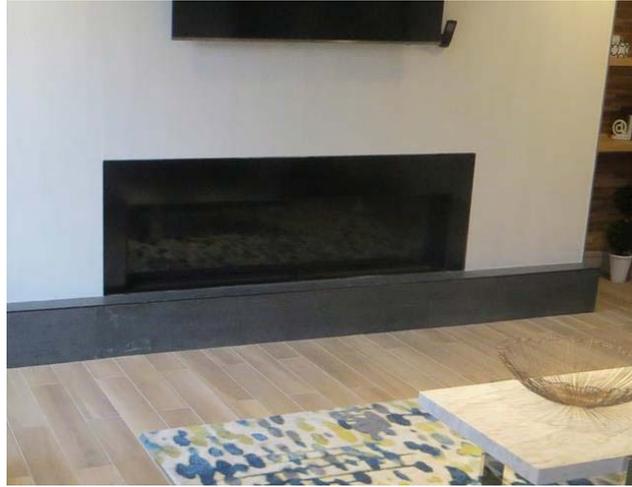
Component covers 72" wide Spark Modern Fires Fire Ribbon model 19N-E direct vent gas fireplace in café clubroom.

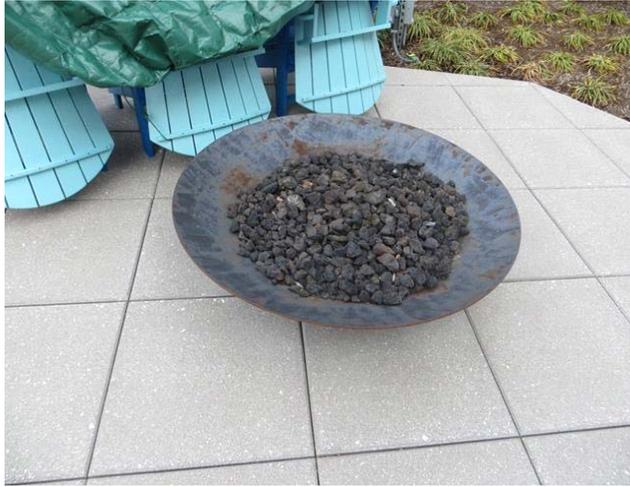
Component covers gas Fire Pit Art Asia 48" diameter steel fire pit in courtyard. Fire pit was in good condition at site visit. Cost for natural gas, all weather electronic ignition system.

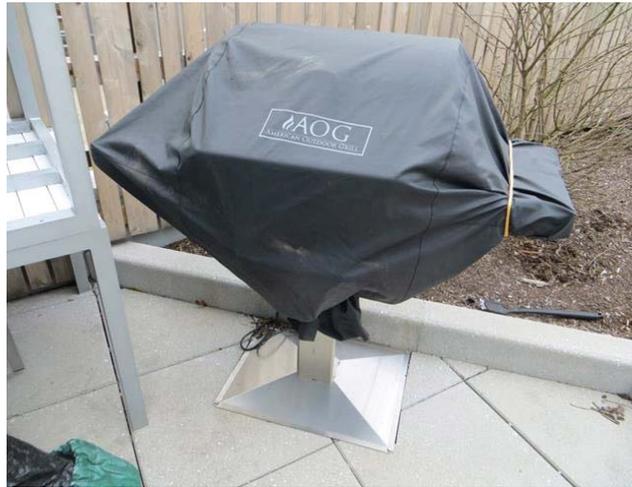
Component covers American Outdoor Grills in courtyard. Grills were covered and in good condition at site visit.

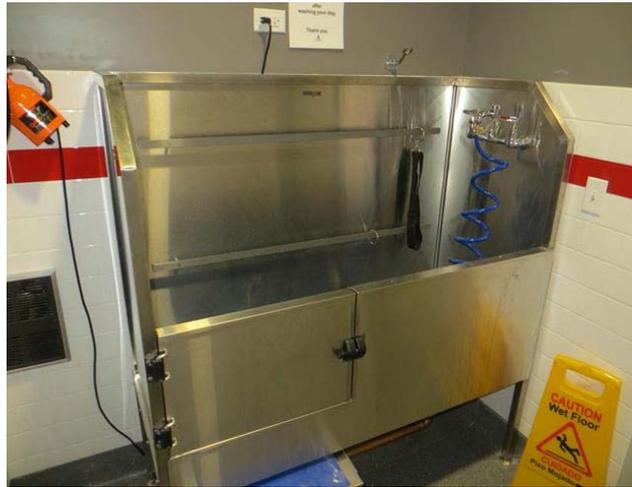
Component covers dog wash station in bike room area. Station was in good condition at site visit.

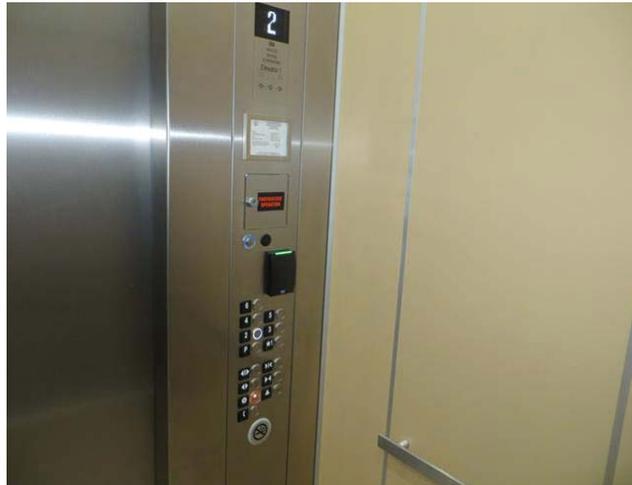
Component cover refurbishment of (2) elevator cabs. Cabs were in very good condition at site visit. Frequency of cab refurbishment is mainly an aesthetic decision.

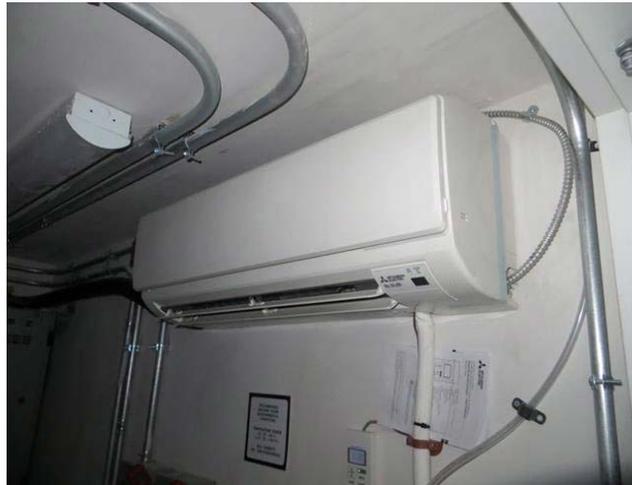
Component covers Mitsubishi ductless minisplit system that cools elevator machine room.

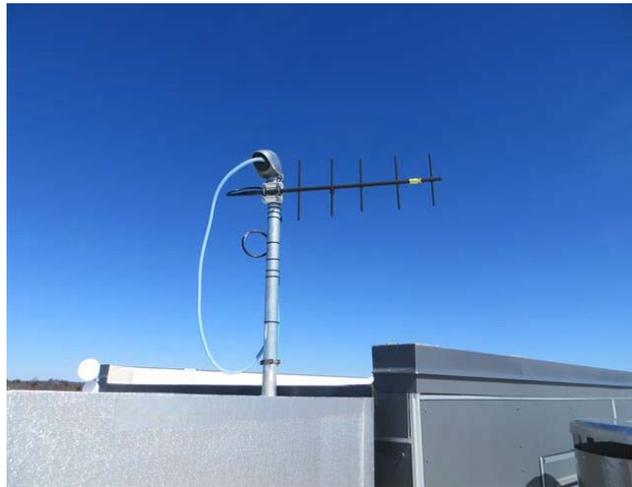
Component covers bidirectional antenna (BDA) system for emergency responder communication. No issues reported. Price per similar association.

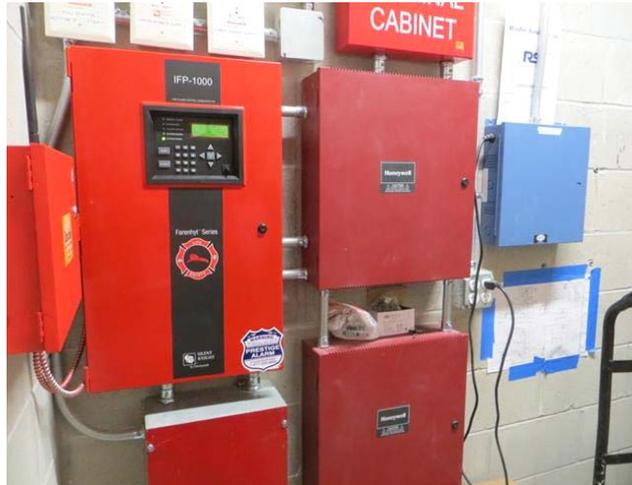
Component covers main parts of fire alarm system. The fire alarm system is composed of Honeywell Silent Knight fire alarm panels and peripheral equipment in the buildings. Component does not include re-wiring, pull stations, fire emergency lights, heat detectors, or horns. Replacement of peripheral devices currently on an as-needed basis. Funding for these devices can be added if desired.

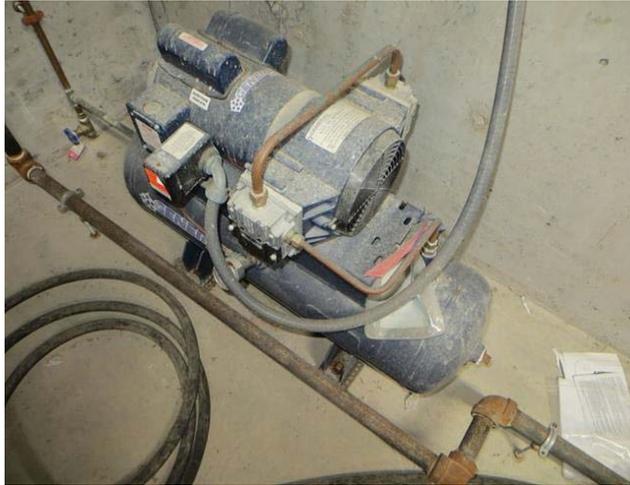
Component covers 1/2 hp air compressor for dry fire sprinkler system in parking garage. Pump maintains air pressure in sprinkler pipes to detect if a sprinkler head discharges. If sprinkler system has low leak/loss rate, compressor may only run once a week.

Service contractor: Gustavo Preston, Chelmsford, MA, 978-856-5587
 Per Ed Nickerson, compressor has a typical useful life of 5-10 years. Replacement cost approximately \$1,500.
