RESERVE ANALYSIS REPORT

Boston New Construction Condominium

Boston, Massachusetts

May 13, 2019

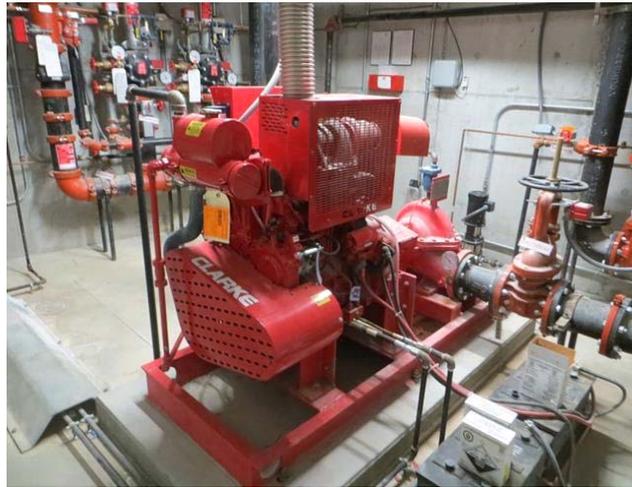
Component covers fire sprinkler diesel powering fire pump in building. Pump controller is Firetrol. Pump is listed as separate component.

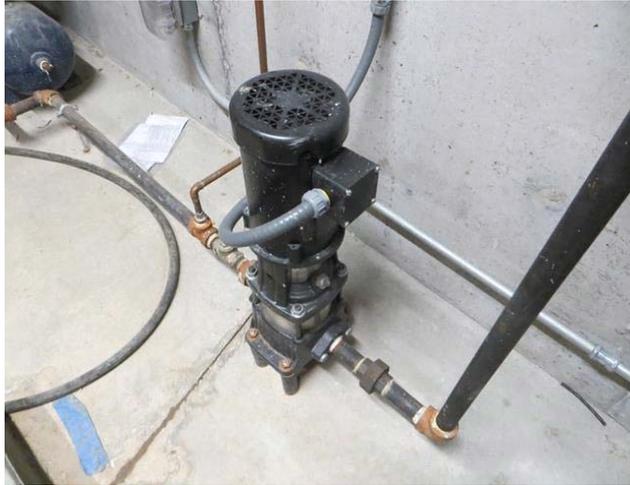
Component covers fire sprinkler jockey pump. Pump maintains wet sprinkler pipes at approximate target pressure to aid in sensing if a sprinkler head discharges. Jockey pump eliminates need for main fire pump to run to maintain system pressure. If sprinkler system has low leak/loss rate, pump may only run once a week.

Service contractor: Gustavo Preston, Chelmsford, MA, 978-856-5587
 Per Ed Nickerson, jockey pump has a typical useful life of 5 years. Replacement cost approximately \$1,800.

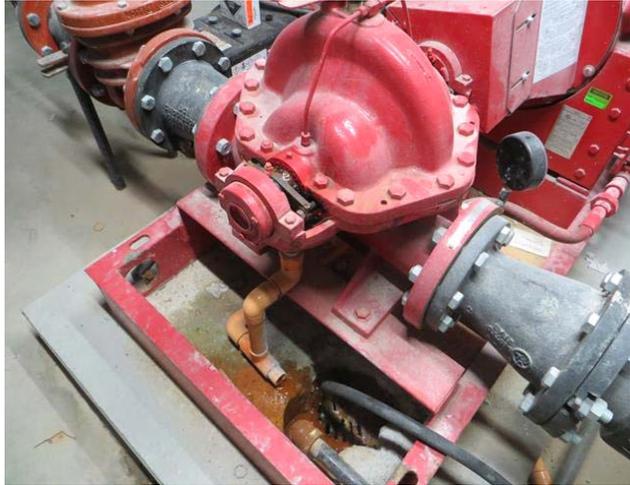
Component covers fire sprinkler diesel powered 500 gpm main pump in building. Pump controller is Firetrol. Diesel engine is listed as separate component.

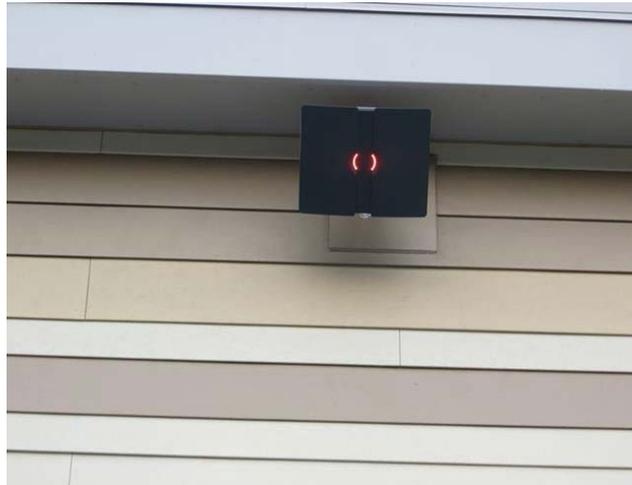
Component covers replacement of Nedap Transit Ultimate sensor for parking garage access system. No issues reported. Component does not currently cover window buttons or tags on individual vehicles. These could be add if desired.

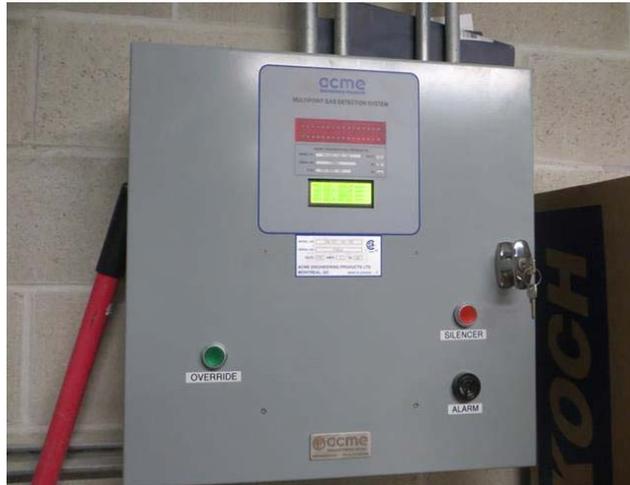
Component covers Acme Multi-Gas Detection and Control System in parking garage. Detectors control operation of supply dampers and exhaust fans to insure that carbon monoxide (CO) and nitrogen dioxide (NO2, combustion fumes) levels are safe. Detector sensors are listed as separate components. This component covers replacement of entire system. System was functioning normally at site visit.

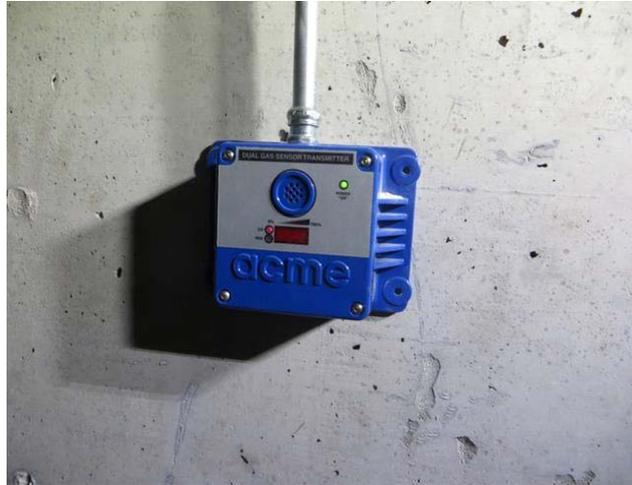
Component covers replacement carbon monoxide (CO) sensors for Acme Multi-Gas Detection and Control System in parking garage. Detectors control operation of supply dampers and exhaust fans to insure that carbon monoxide (CO) and nitrogen dioxide (NO₂, combustion fumes) levels are safe. There are 6 detectors in lower garage and 6 in ground floor garage.

Per operation & maintenance manual, carbon monoxide (CO) detector sensors must be replaced every 7 years and are due by October 2024. In discussion with manufacturer (see below), sensors can be tested to determine if replacement is needed. Testing should reduce costs over time.

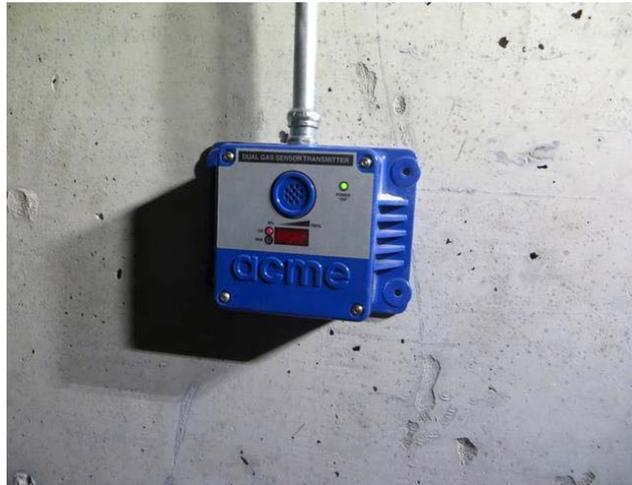
Component covers replacement nitrogen dioxide (NO₂) sensors for Acme Multi-Gas Detection and Control System in parking garage. Detectors control operation of supply dampers and exhaust fans to insure that carbon monoxide (CO) and nitrogen dioxide (NO₂, combustion fumes) levels are safe. There are 6 detectors in lower garage and 6 in ground floor garage.

Per operation & maintenance manual, nitrogen dioxide (NO₂) detector sensors must be replaced every 2 years and are due by October 2019. In discussion with manufacturer (see below), sensors can be tested to determine if replacement is needed. Testing should reduce costs over time.

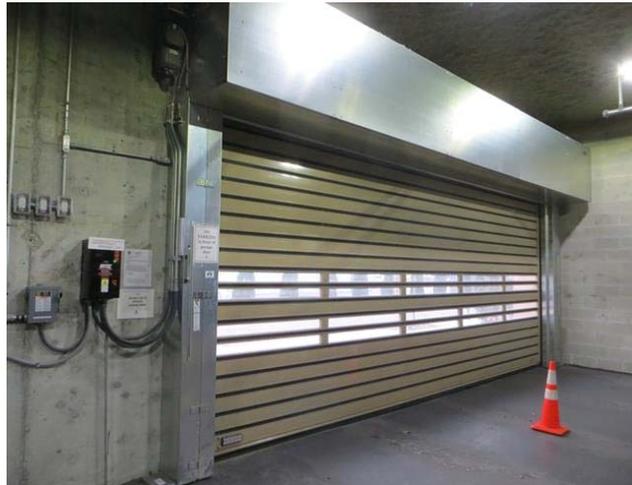
Component covers Rytec overhead garage door (approximately 22' x 9') at entrance to parking garage. Current number of cycles is about 54,500. Door is in good condition at site visit and operating normally.

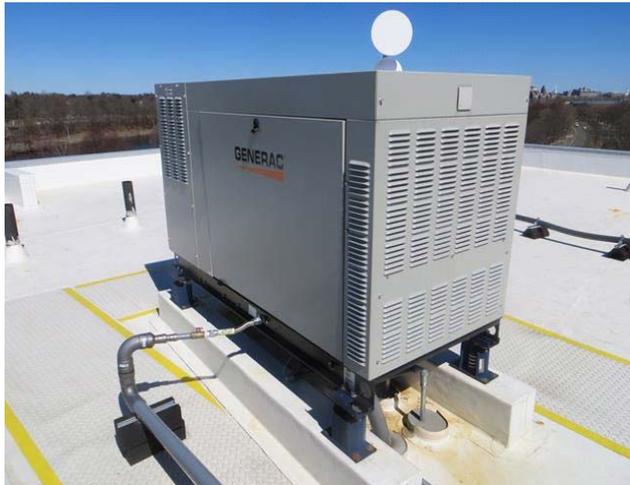
Component covers Genrac generator and peripheral equipment. Natural gas powered generator is rated at 25 kW. Generator was in good condition at site visit.

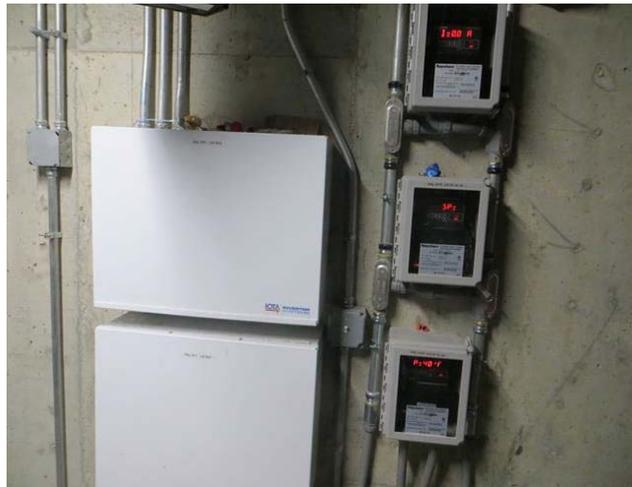
Component covers heat trace system to prevent plumbing pipes from freezing in parking garage. Systems were not operational at site visit. Systems are relatively simple and not typically problematic. This component is for allowance for inspection and repairs on 10 year interval. This allows some funding for occasional, unpredictable repairs. Allowance should be updated periodically based on operational experience.

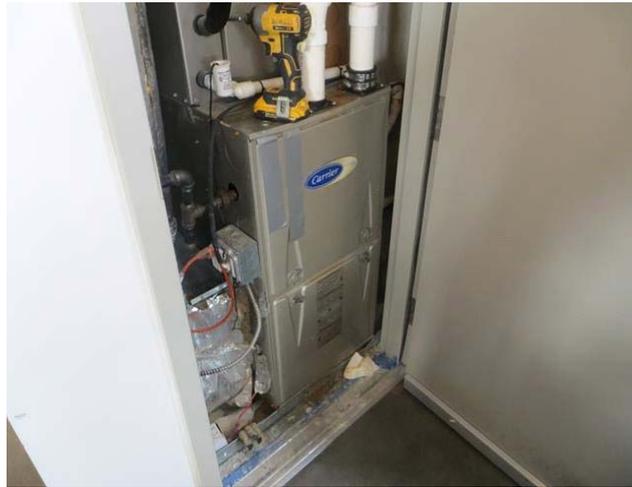
Component covers Carrier split air conditioning systems servicing main entry lobby, row room, café, and fitness room. Systems are located in closets adjacent to spaces served with condensers on the roof.

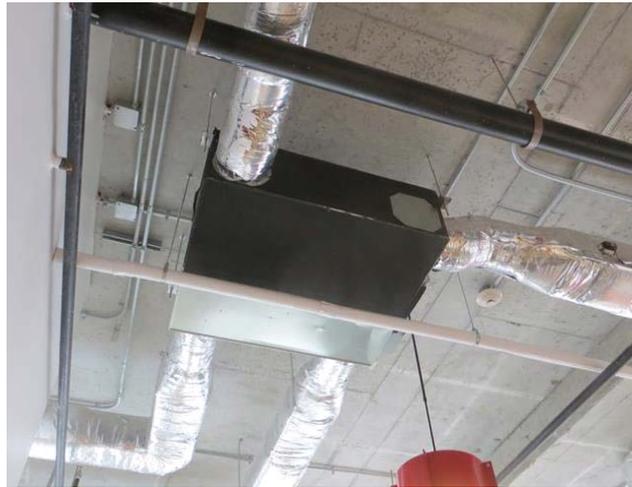
Component covers energy recovery ventilator (ERV) in bike room.

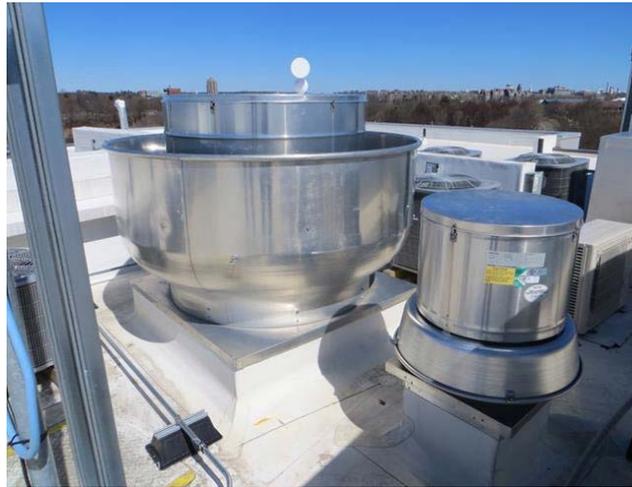
Component covers large roof top fan exhausting air from garage when toxic gas levels are high.

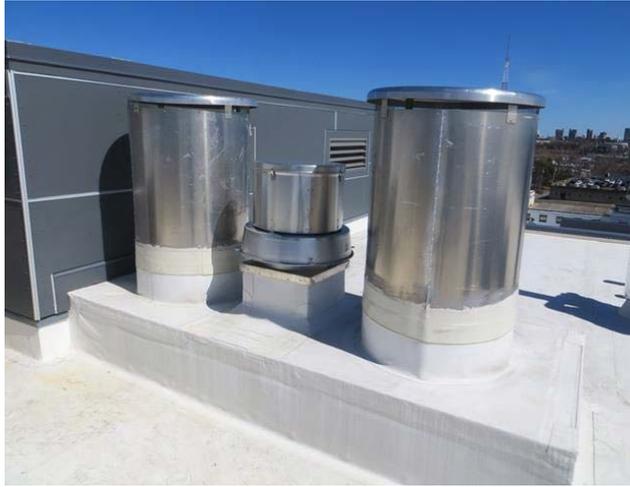
Component covers smaller roof top mushroom fans exhausting air from various areas of buildings.

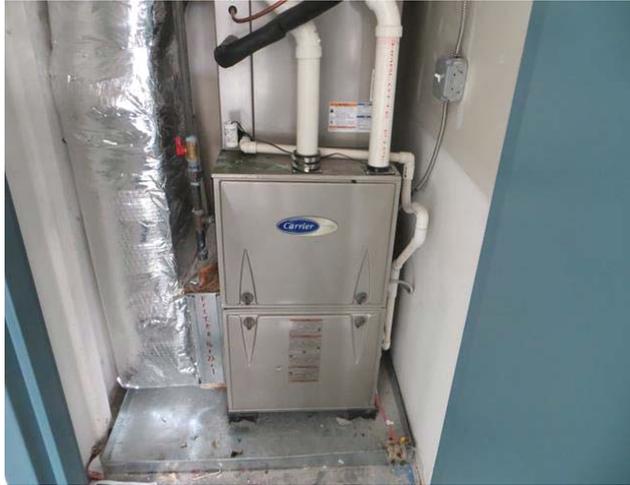
Component covers Carrier furnaces servicing main entry lobby, row room, café, and fitness room. Sealed combustion systems are located in closets adjacent to spaces served.

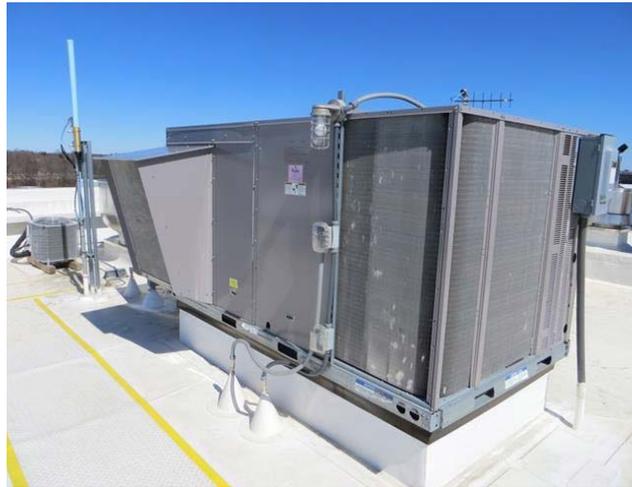
Component covers Carrier roof top unit (RTU) providing heating and cooling in common hallway areas.

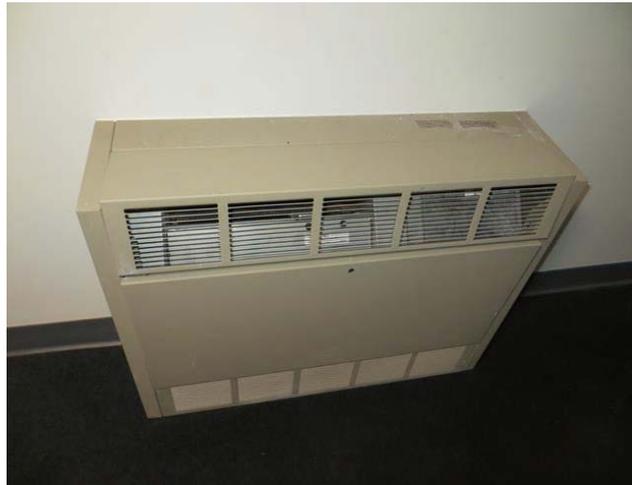
Component covers electrical unit heaters for interior conditioned spaces and unconditioned mechanical spaces in building. Inventory from drawings. Allowance covers repairs and replacements as needed. Allowance amount and interval should be adjusted as association gains more experience with replacements.

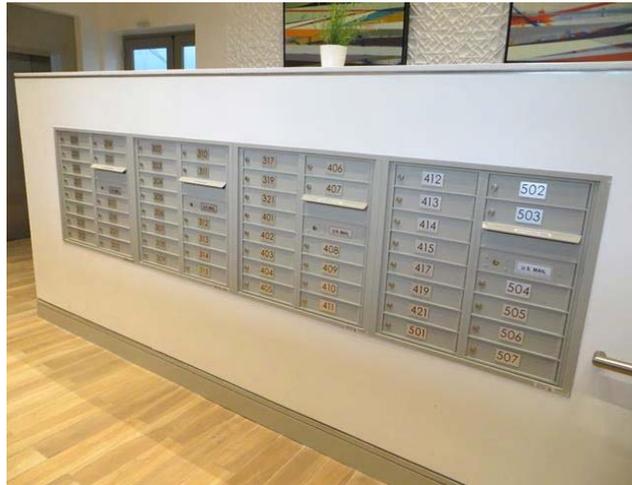
Component covers Florence Corp. USPS-STD-4B+ recessed mailboxes in building lobby. Mailboxes were in good condition at site visit.

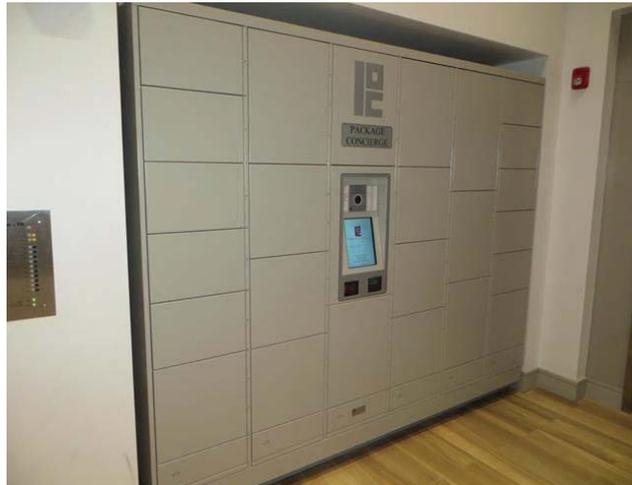
Component covers Package Concierge in entry lobby. Locker system was in good condition at site visit.

Useful life initially set at 15 years. Life should be updated as association gets experience with usage and wear.

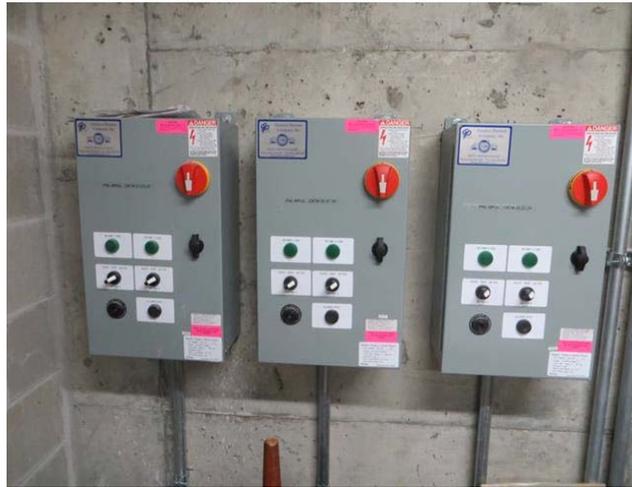
Component covers ejector duplex pumps for building floor drains. No issues reported by management.

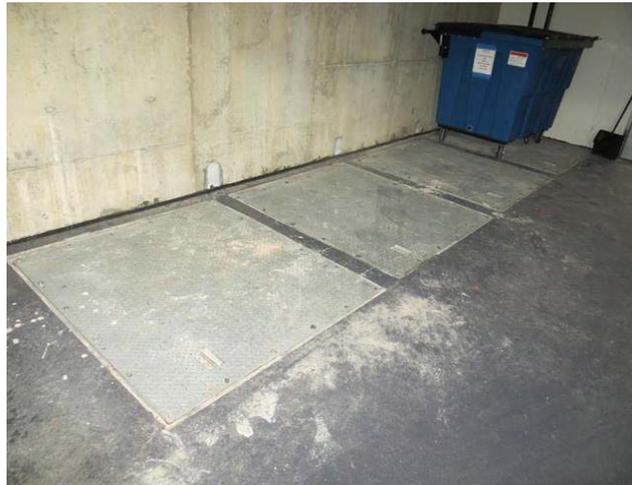
Equipment - Pumps, Foundation Drain

Component covers ejector pumps for building foundation drains. No issues reported by management.

Duplex pump system is located in lower level garage along north wall. Component covers pumps and controls. Collection tank has long life unless damaged.

Service contractor: Gustavo Preston, Chelmsford, MA, 978-856-5587
 Per Ed Nickerson, material only cost to replace individual pump is about \$3500.

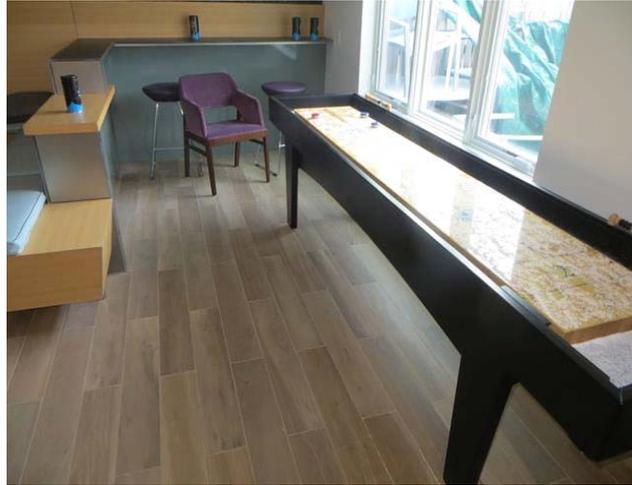
Component covers 9' Olhausen Pavilion Shuffleboard. Shuffleboard was in good condition at site visit. Useful life of recreation equipment is heavily influenced by amount of use.

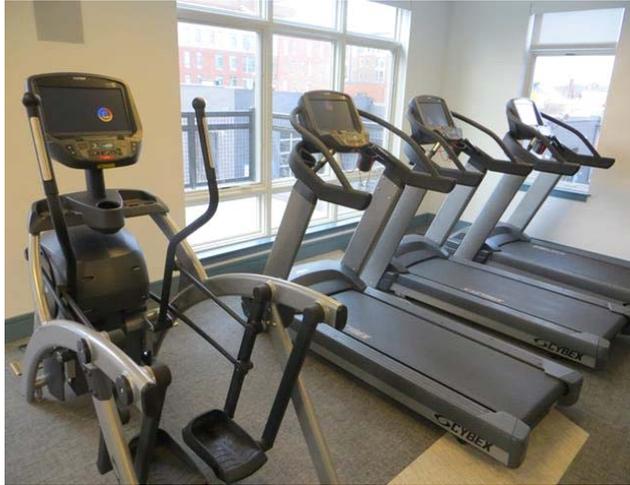
Component covers aerobic fitness machines. Machines were in good condition at site visit. Useful life of gym equipment is heavily influenced by amount of use. Equipment should be evaluated & serviced at least annually.

3 Cybex treadmills	@	\$6,000.00	=	\$18,000.00
1 Cybex arc trainer	@	\$6,000.00	=	\$6,000.00
1 Octane Fitness XT 3700 Elliptical	@	\$6,000.00	=	\$6,000.00
1 Cybex recumbent bike	@	\$3,500.00	=	\$3,500.00
1 Cybex spin bike	@	\$2,000.00	=	\$2,000.00
		TOTAL	=	\$35,500.00

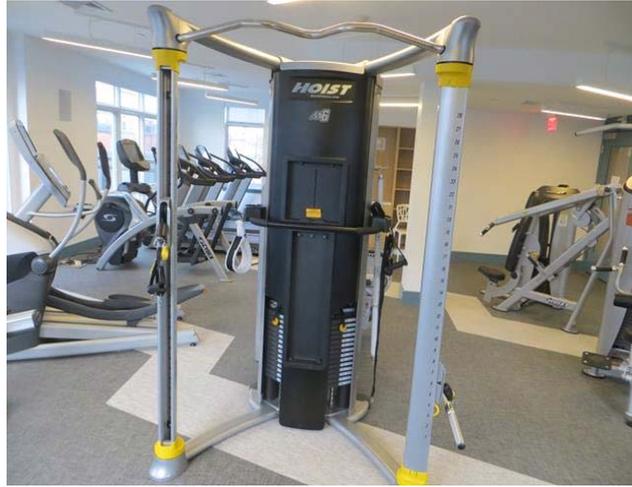
Component covers weight training machines & adjustable benches. Machines were in good condition at site visit. Useful life of gym equipment is heavily influenced by amount of use. Equipment should be evaluated & serviced at least annually.

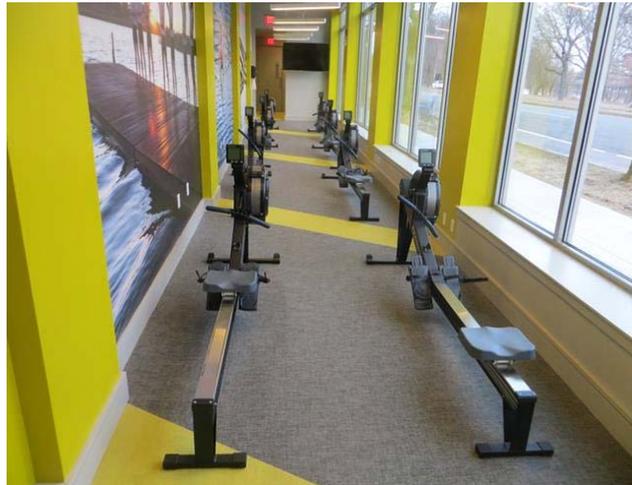
Component covers Concept 2 Model D rowing machines. Machines appeared to be in good condition at site visit. Useful life will depend heavily on usage. 10 years assumed initially.

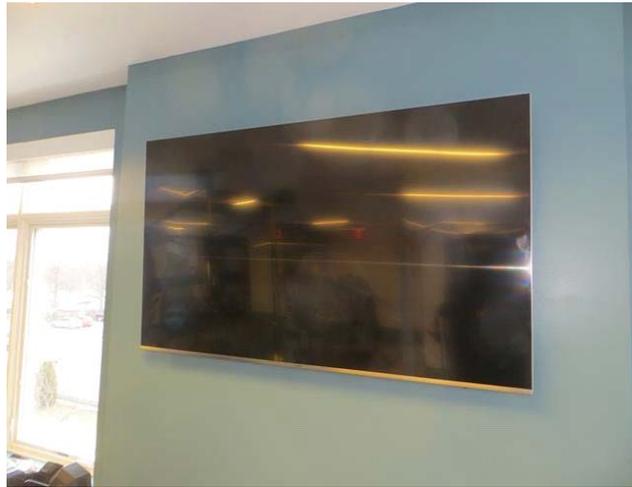
Component covers 65" televisions, speaker system, control touch screens, and peripheral equipment in fitness, row room, and (2) in café clubroom. No issues reported. With electronic technology changing rapidly, a general \$5000 allowance per television system replacement is included.

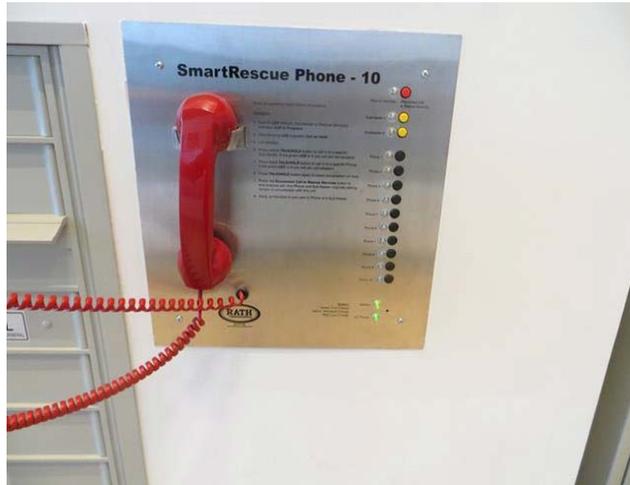
Component covers Rath Communications SmartRescue Phone 10 in main lobby and floor call boxes in elevator lobbies. Replacement cost assumes existing wires can be reused.

Operational experience: No issues reported.

Per Zack at technical support, useful life is about 20 years and replacement is not complicated from a wiring point of view.

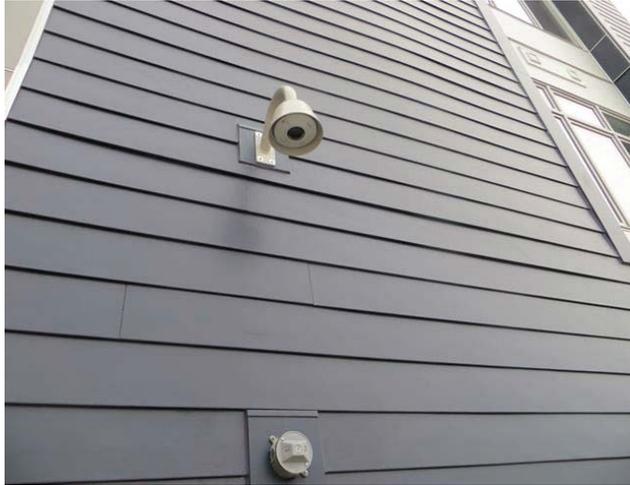
Component covers combined surveillance system for site. Additional cameras are being added for exterior of building. Placed-in-service date of 2019 for exterior cameras used.

Mr. Willoughby stated that system uses Cat5 cables for network that connects cameras. There will be approximately 30 cameras installed after approved project for exterior cameras is finished. Replacement is about \$1200 per camera installed for higher quality IP cameras. Useful life of cameras is about 5-7 years for outdoor and 10+ for indoor with new IP cameras that use CAT5 wiring with fewer connections. With high quality cameras installed, he feels 7 year time frame is appropriate. Most systems are replaced to improve picture quality and other performance measures rather than failure of the system.

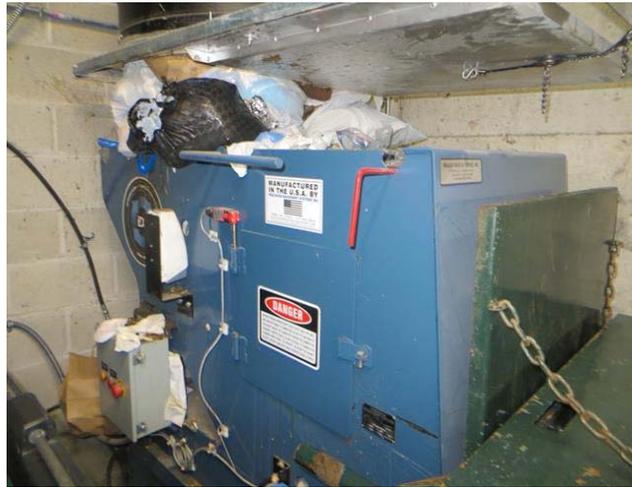
Component covers Precision Machinery Systems 520A trash compactor.

Service contractor: Willco Sales & Service, Inc., Hingham, MA 781-556-5460
Willco Sales stated that estimated useful life of the existing compactor is 30 years.

Per proposal provided by Sales Manager Tricia Tague, replacement cost is \$14,707 with old machine removal of \$1998. New 2 cu. yd. containers are \$2300 each.

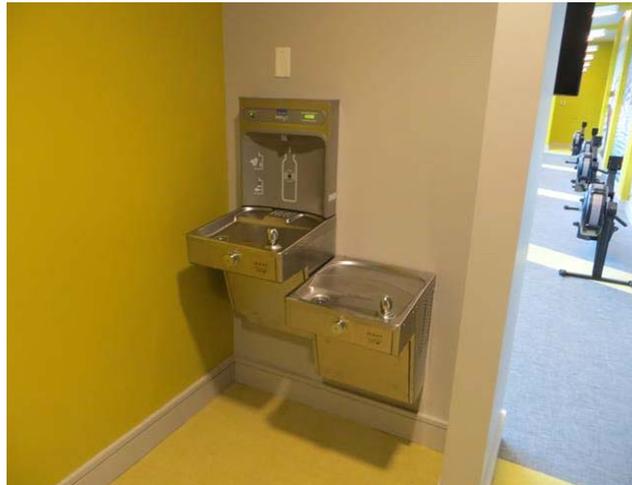
Component covers water fountains and bottle fillers in fitness and row room areas.

Operational experience: No major issues reported.

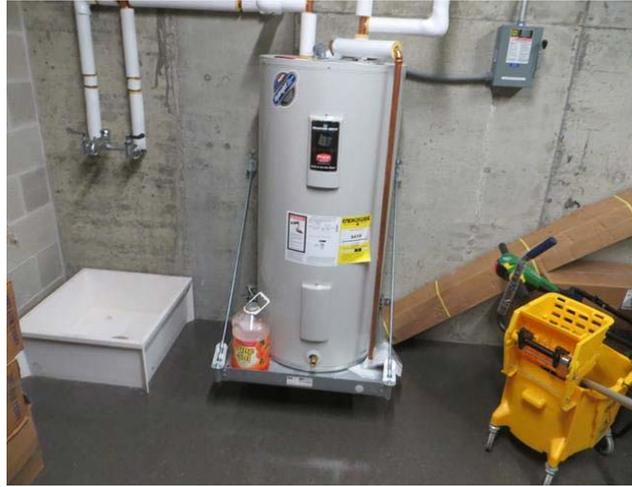
Component covers electric water heaters for café clubroom, restrooms, and dog wash. Water heaters are located in utility closet B001 on bottom level of garage by stairwell 1 and in ceiling of bike room.

Bradford White RE340S6 40 gallons
 Bradford White RE230L6 28 gallons (installation more costly due to ceiling location)
