Reserve Analysis Report

Sample High Rise Condominium Association

Denver, Colorado

Thursday, February 09, 2017

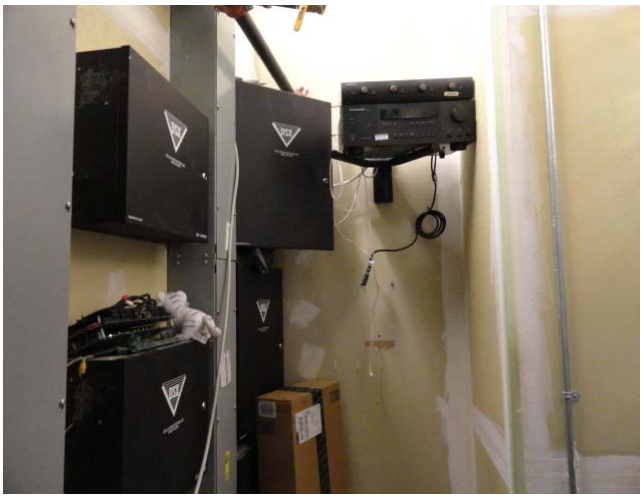
Typical surveillance system includes camera, monitor and time-elapsed VCR.

This equipment is located in the janitor's closet on the lobby level.

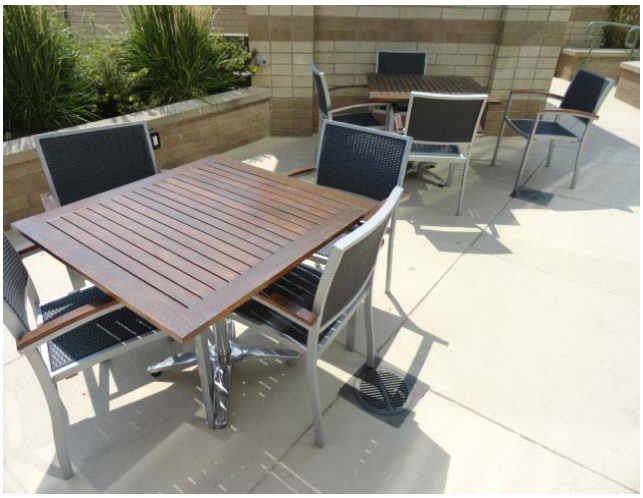
This is trhe pool area furniture located in the pool deck.

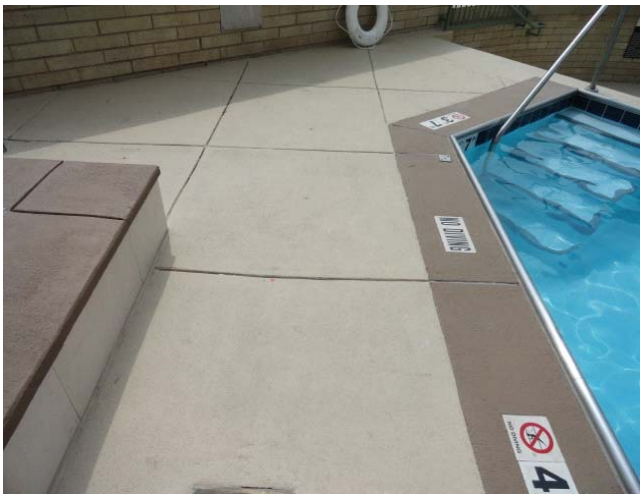
This is for the resurfacing of the pool deck.

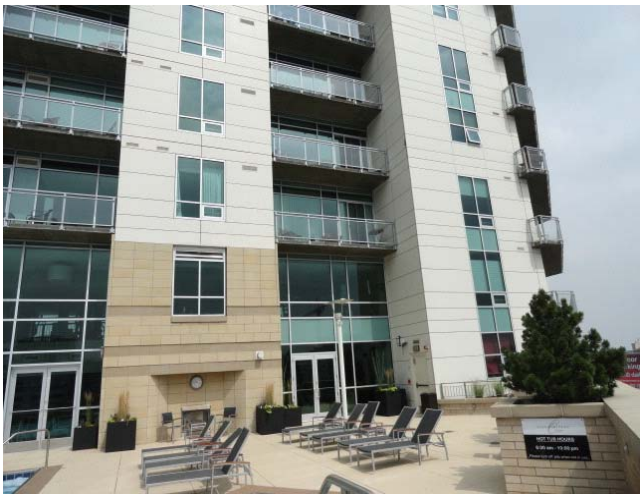
This is for the refurbishment of the powder coating on the metal deck railings.

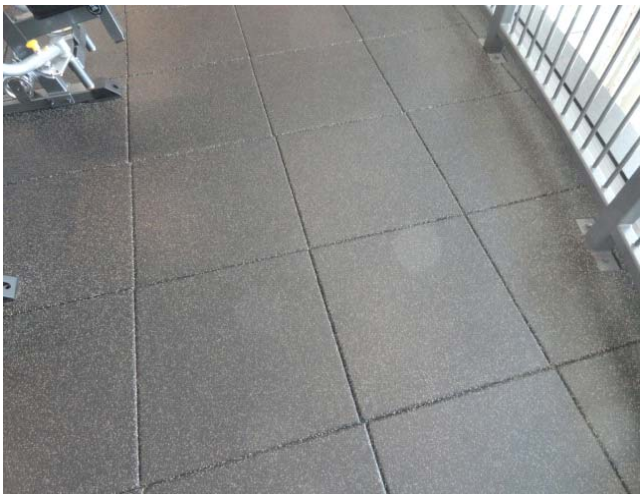
This is the rubber floor cover in the fitness room.

The measurement indicated represents the actual area to be replaced. The percentage of replacement has been increased above 100% to allow for a waste factor which should be considered when replacing this component.

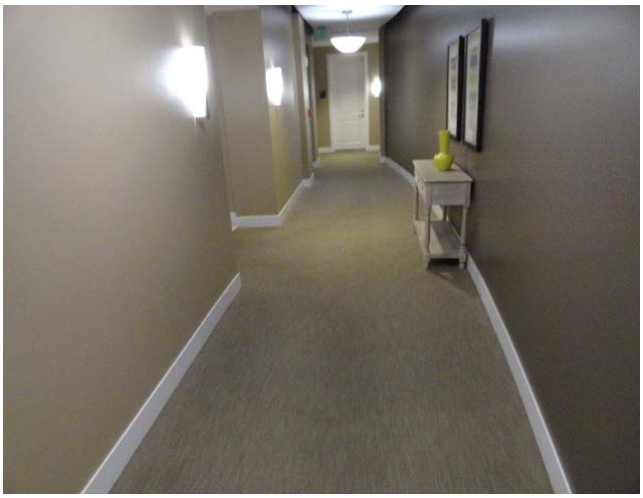
These are the lighting fixtures located throughout the interior common areas of the building.

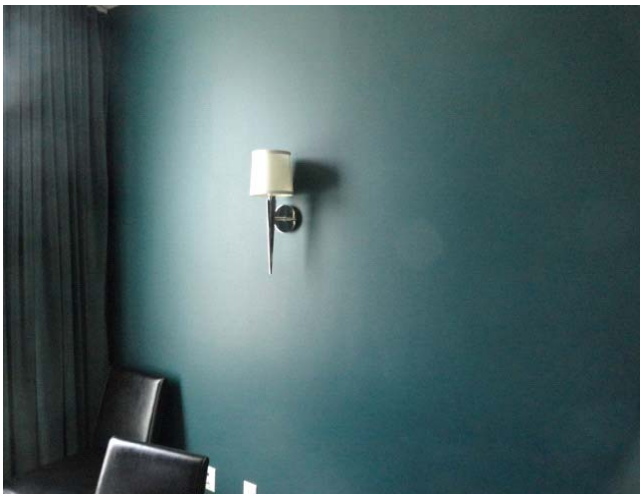
This is the painting of the management office within the building.

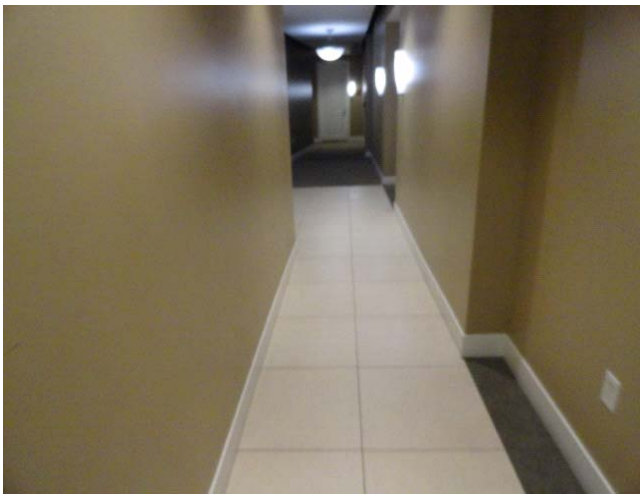
This is the painting of the resident floors within the building.

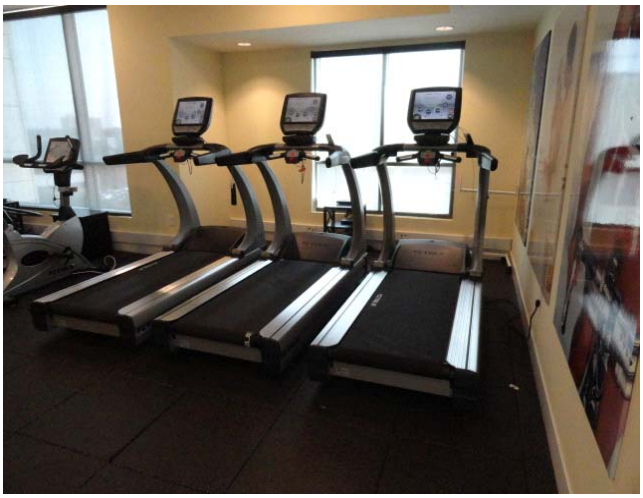
This is the equipment located in the gym.

It is anticipated that not all of the electronic gym equipment will need to be replaced at one time. Therefore, we have budgeted to replace $20,000.00 of the electronic gym equipment every 3 years. This component should be monitored over time and the replacement percentage and useful life should be adjusted accordingly.

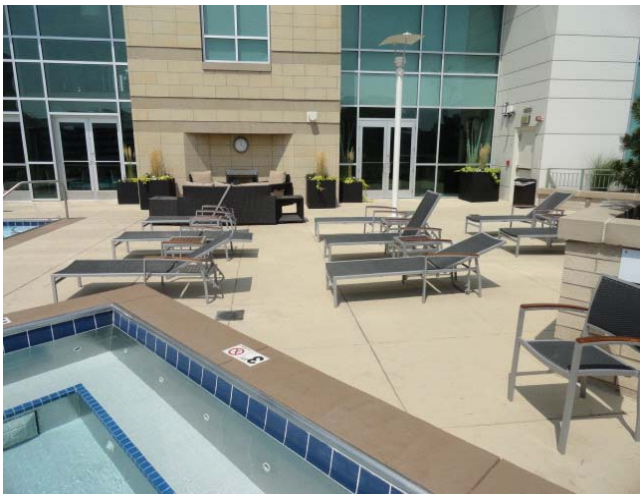
This is for the refurbishment of the trees, plants, shrubs and any other landscaping needs that may become necessary over time.

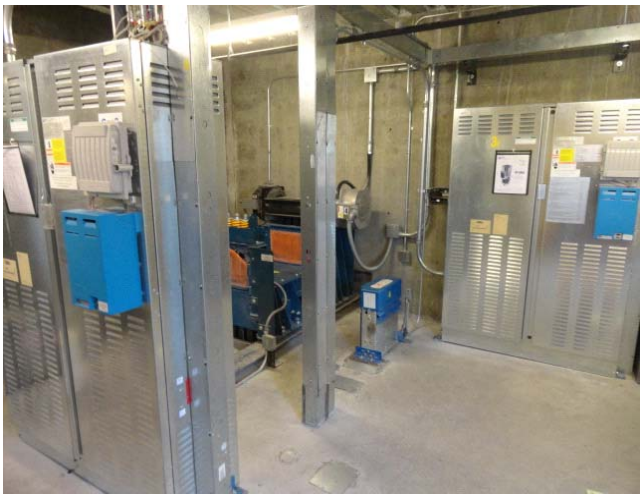
These are Otis traction style elevators located in the roof top equipment room.

This is for the major modernization of the elevators within the building.
