RESERVE ANALYSIS REPORT

Sample Community Association

Sample, Massachusetts Version 1 December 12, 2017

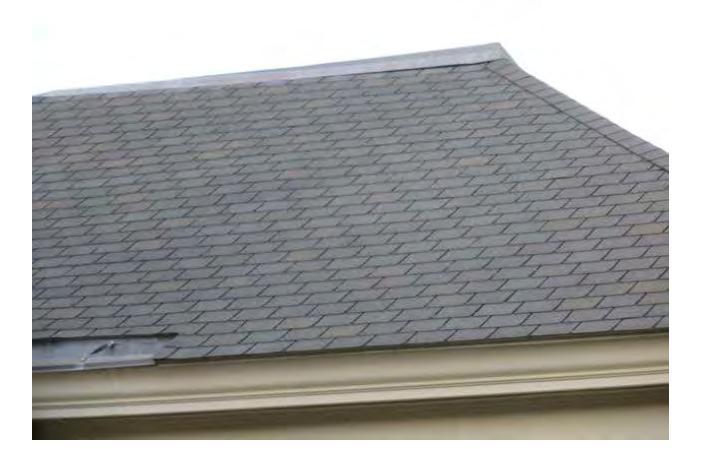
Roof of main building is comprised of flat EPDM membrane and sloped asphalt shingle areas.

Component covers repair allowance for lead-coated copper flashings and built-in gutters when roof covering is replaced. Copper appeared to be in very good condition during site visit and will have a long useful life. It is unlikely that all copper would need to be replaced when re-roofing. No issues were reported by management. Copper work is difficult to inventory due to inaccessibility. Allowance budget should be modified as association gains experience.

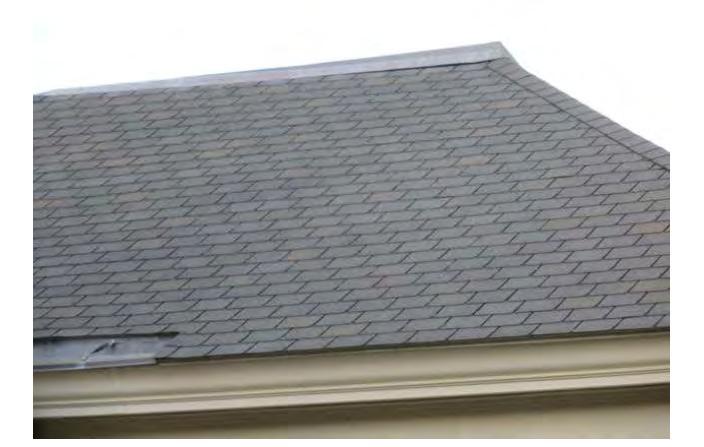
Roof of main building is comprised of flat EPDM membrane and sloped asphalt shingle areas.

Component covers replacement of asphalt shingle roof. Roof appeared to be in good condition for its age during site visit. No issues were reported by management. One missing tab on GAF Slateline shingles was noted on south slope of west facing gable of main building.

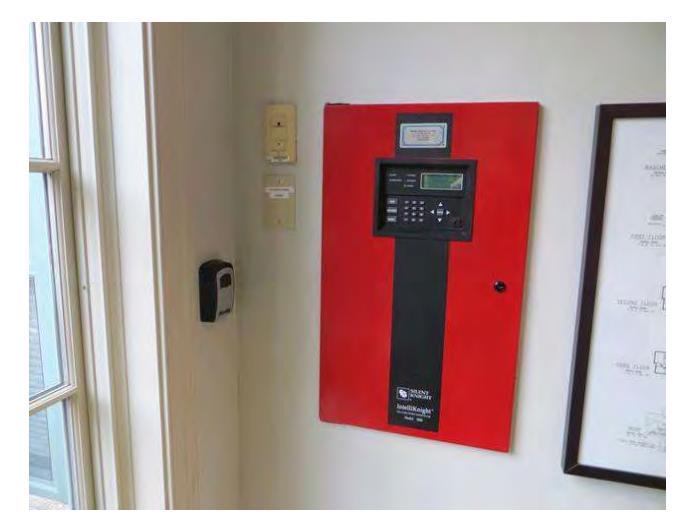
Component covers replacement of fire alarm main panel for main building. Main panel is located in main entry vestibule.

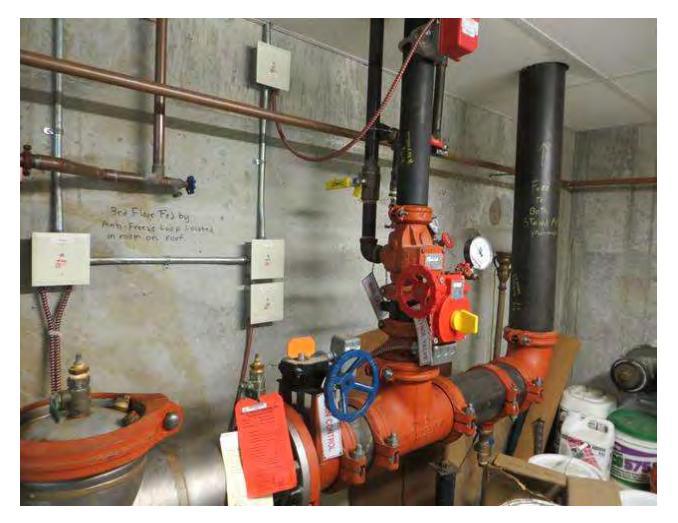
Component covers fire sprinkler system for main building. System should be tested per code and parts replaced on asneeded basis from operating budget. Component listed for inventory purposes.

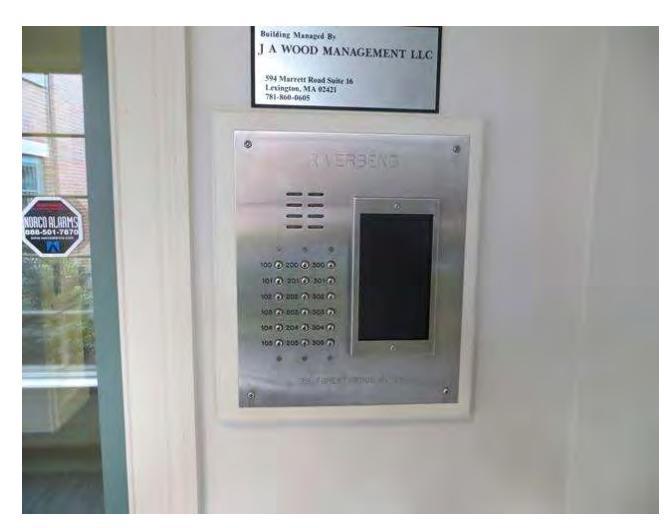
Component covers replacement allowance for front entry access intercom system. System was in good operating order during site visit.

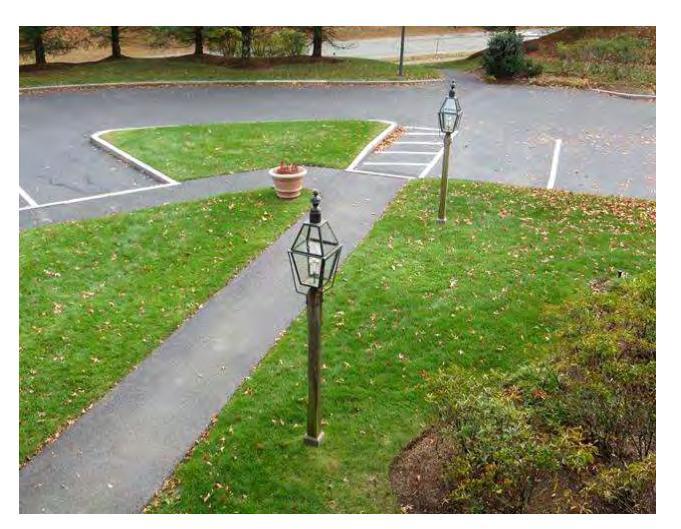
Component covers major parts of irrigation system. System is supplied with city water.

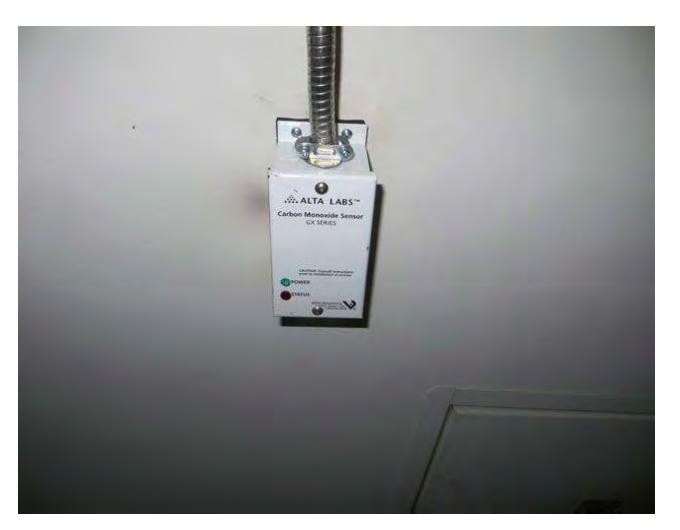
Component covers (3) carbon monoxide detectors in main building parking garage.

Equipment: Alta Labs GX Series carbon monoxide transmitter and fan controller.

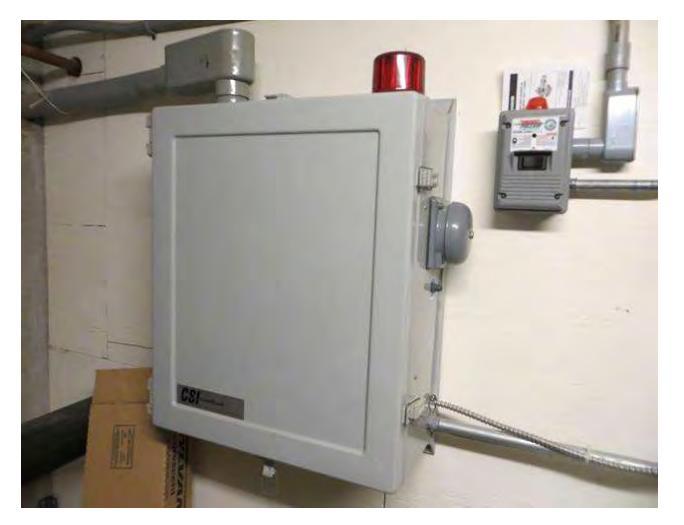
Component covers pump equipment for septic system. Control for pump is located in Mechanical Room B1. Additional high water alarm is located in trash/garage building.

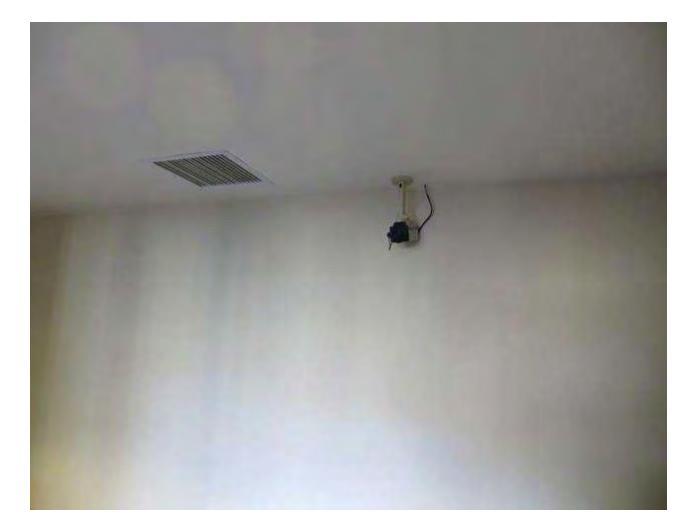
Component covers surveillance system replacement allowance for main building. Equipment is assumed to be from original construction.

Failure of individual components should be repaired on as-needed basis from operating budget. A large range of costs are associated with surveillance systems depending on capability. Allowance covers general replacement and will need to be refined for accuracy if details are available.
