RESERVE ANALYSIS REPORT

The Sample Condominium

Boston, Massachusetts

April 8, 2020

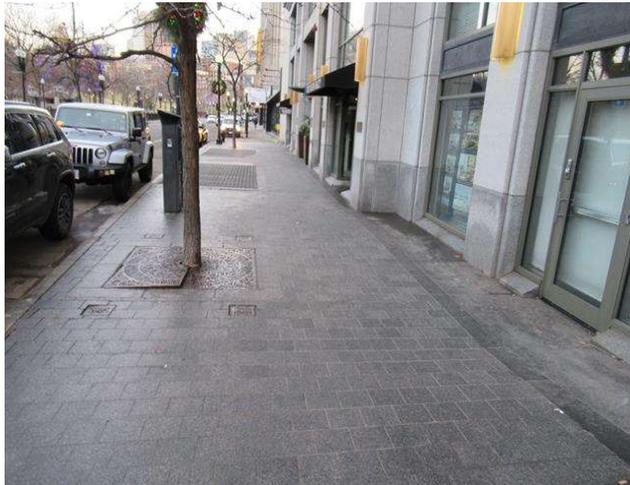
Component covers allowance for paver and concrete walkway repairs at front and rear of building. Walkways were in good condition at site visit. Allowance should be adjusted in future reserve study updates as walkways age.

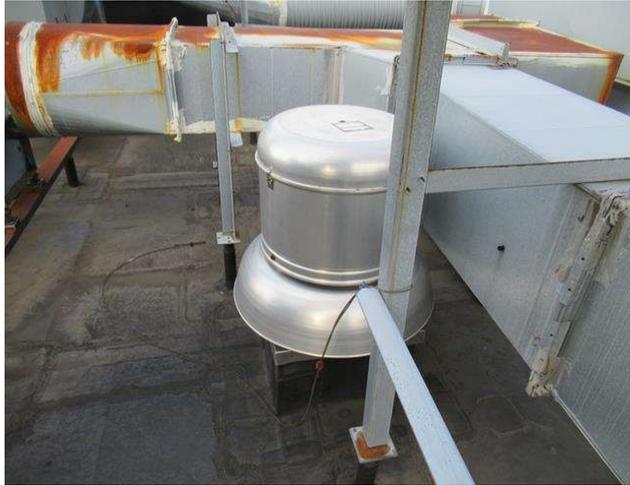
Component covers allowance for one-time life extension measures for original EPDM (ethylene propylene diene terpolymer) membrane roofs. Original roofs were in good to fair condition. Numerous prior patches noted on some roof areas. No current issues with roofs, per management. An average cost of \$7.50 per sq. ft. is used for life extension measures. Cost should be updated after Knollmeyer recommendations are received. Additional roof extension measure components can be added in future reserve study updates as other roofs get closer to the end of their useful lives.

The remaining life of full replacement components has been extended due to the anticipation that roof extension measures will be performed.

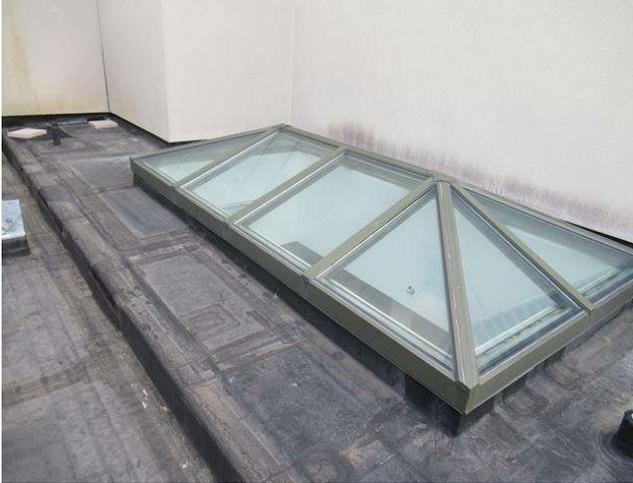
Component covers allowance for periodic replacement of (2) penthouse and (3) opera corridor skylight glass panels. Skylights appeared to be in fair condition at site visit. Some glass panels have been replaced in past on opera corridor due to impacts. Netting has been installed to minimize damage. No issues with skylight frames reported. As infrastructure ages, allowance should be adjusted in future reserve study updates.

Contractor: Melrose Glass, Bob McConaghy, 781-632-2802
 Glass varies in size. If access to opera corridor roof can be through a unit, cost for average glass replacement will be \$4500-\$5000.

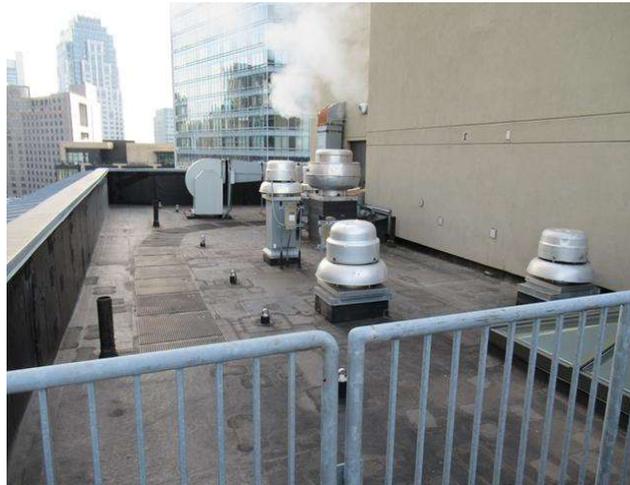
Component covers replacement of EPDM (ethylene propylene diene terpolymer) membrane roof adjacent to boiler room at northeast corner. Roof is original to construction.

Roof was in fair condition. Numerous prior patches noted. No current issues with roof, per management. The remaining life of this component has been extended due to lack of current issues and anticipated life extension measures listed as separate component.

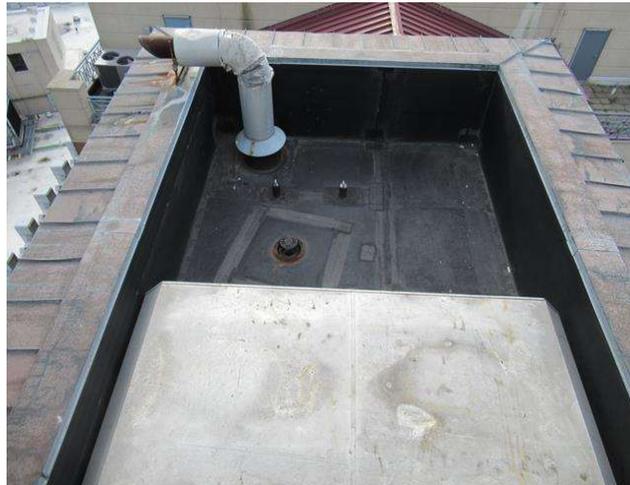
Component covers replacement of EPDM (ethylene propylene diene terpolymer) membrane roof over generator room. Roof is original to construction.

Roof was in good condition. No major issues noted. No current issues with roof, per management. The remaining life of this component has been extended due to lack of current issues and anticipated life extension measures listed as separate component.

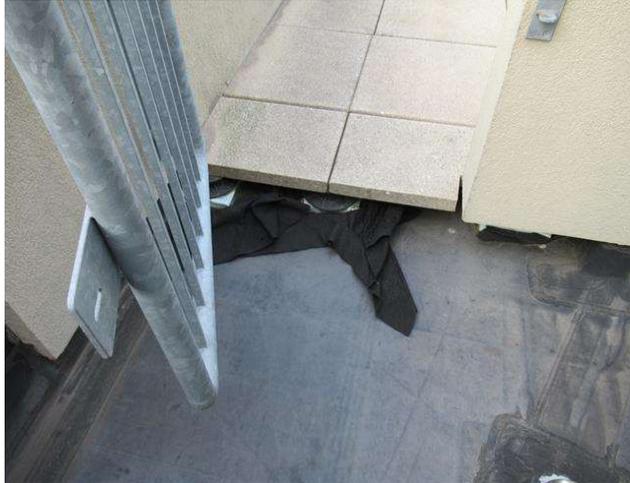
Component covers replacement of EPDM (ethylene propylene diene terpolymer) membrane roof under common roof terrace and extending up to 6" curb parallel to front elevation (1490 sq. ft.). Placed-in-service date per client.

Roof was in good condition. No major issues noted. No current issues with roof, per management.

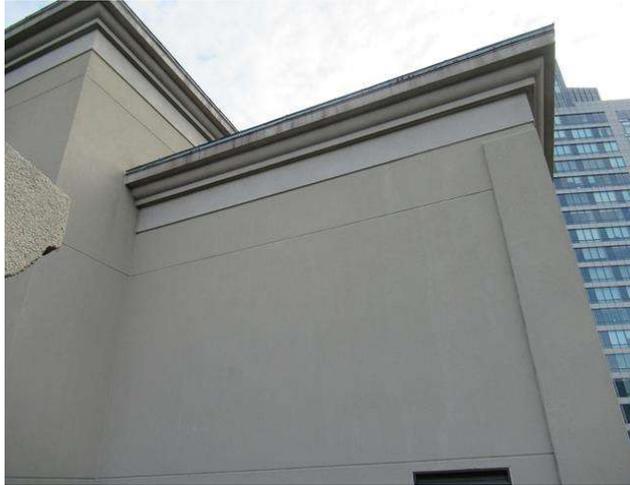
Component covers estimated re-coating allowance for Exterior Insulation and Finish Systems (EIFS) siding. System is also referred to as synthetic stucco. EIFS has been subject of many moisture-related failures when applied to wood framed buildings. Steel framing at [redacted] is also subject to moisture damage. Installation methods have transitioned from face-sealed approaches to current moisture draining methods. System appears to be face-sealed. The wall structural configuration and EIFS system manufacturer is unknown. It is recommended that walls be periodically tested for moisture that would indicate internal damage could be occurring.

EIFS textured acrylic finish appeared to be in generally good condition, but walls could not be closely examined in all areas. Finish can be cleaned and does not typically need to be painted, per Dryvit (one of several large EIFS manufacturers) documentation examined. No leaking issues reported. Flaking and prior minor repairs were observed in localized areas. Cost for re-coating of outer textured acrylic finish layer assumes that there are no internal wall issues. EIFS should be closely monitored. Timing of repair/re-coat should be adjusted based on observations.

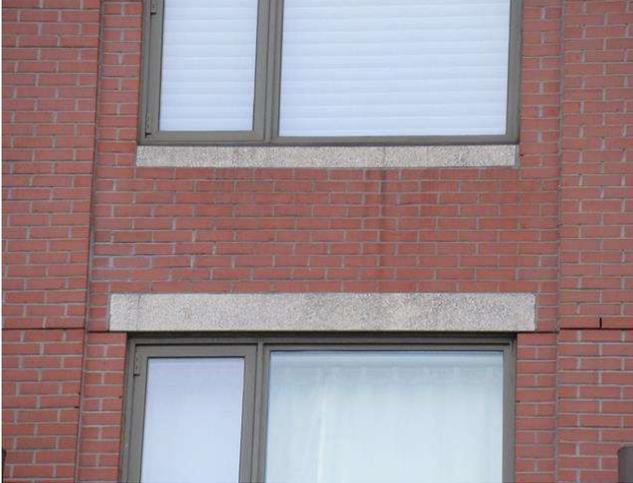
This component covers the initial recommended major masonry repairs after approximately 25 years. A percentage of brick and sealants are expected to be repaired at that time. Component includes any repairs required for cast stone cornices.

Repointing entire building would be approximately \$30 per sq. ft. including staging. Total cost to repoint building at \$30/sq. ft. is about \$492,000. It is anticipated that percentage of brick will need to be addressed at 25 years. As infrastructure ages, percentage allowance should be adjusted in future reserve study updates.

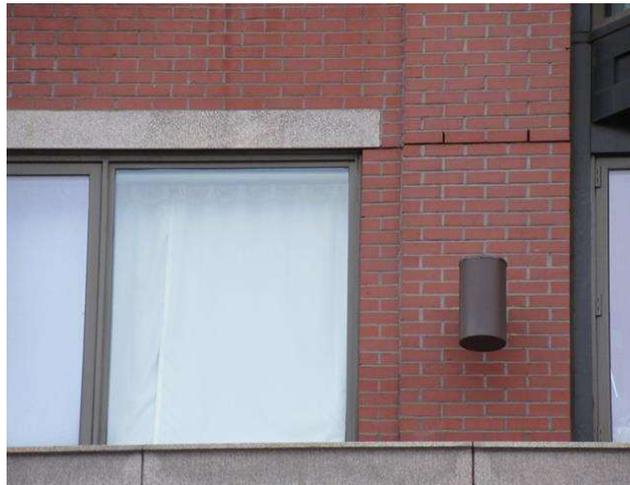
This component covers sealants and minor masonry repairs. Repairs typically include repointing damaged areas and sealing penetrations. Replacing sealants to maintain water resistance is included. Cleaning and sealing brick surface may also be required. Major repairs are covered by separate component.

As infrastructure ages, allowance should be adjusted in future reserve study updates.

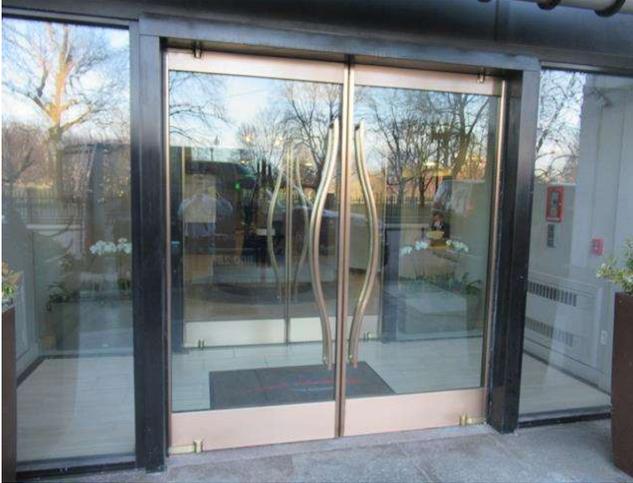
Component represents exterior and vestibule double counter-balanced bronze main entry doors. Doors were in good condition during site visit and no problems were reported by client. Cost per prior study.

Doors will need periodic adjustments and replacement of wear items (hinges, handles, etc.) to achieve useful life.

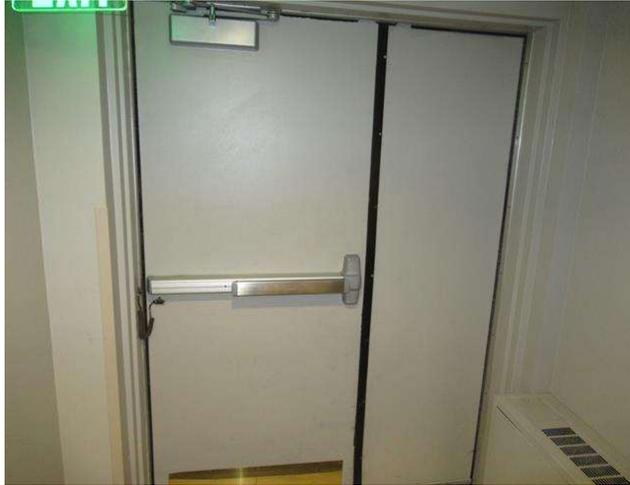
Component represents exterior flush steel doors for building egress on Mason Street and roof access. Doors were in good condition during site visits and no problems were reported by client. Quantities per prior reserve study. Component covers periodic allowance for replacement of doors. As infrastructure ages, allowance should be adjusted in future reserve study updates.

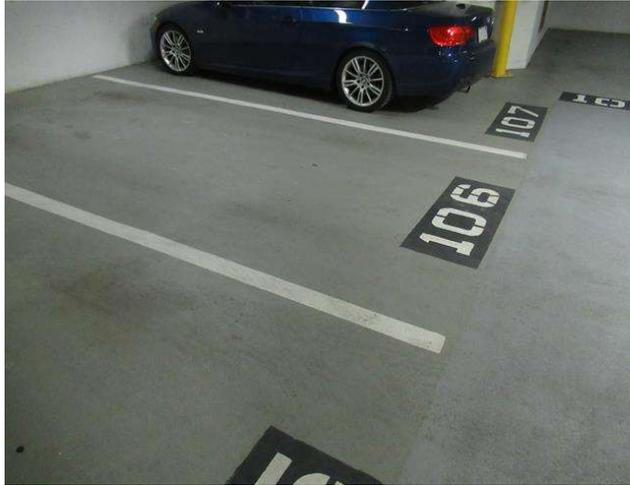
Component covers floor coating on parking stall areas on all levels of garage. These areas receive much wear than traffic lane. Elastomeric membrane is original. Quantity per prior reserve study.

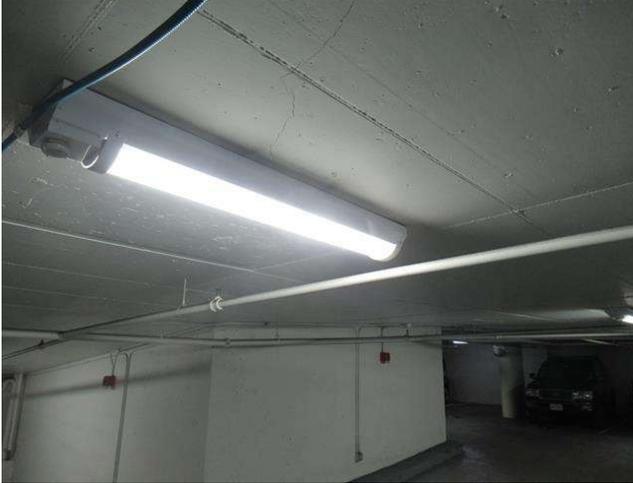
Component covers garage lighting. Lighting was in good condition at site visit. Quantity and cost of ceiling mounted induction fixtures per prior reserve study. Induction lights have a useful life of up to 100,000 hours. This is over 11 years at 24 hours per day. Additional allowance added for exit lights and miscellaneous lights.

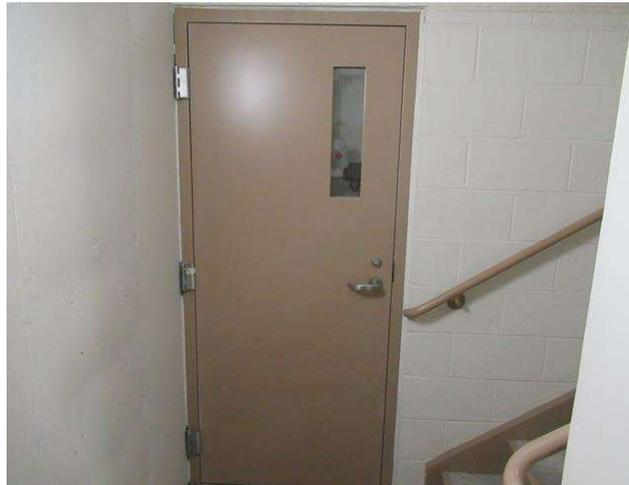
Component covers interior common steel doors in stairwells, hallways, closets, and mechanical rooms. Doors were in good condition at site visit. Door life will vary with usage. It is unlikely that all interior doors will be replaced at one time. There are approximately 100 doors in the building.

Allowance and interval for repairs and replacements should be adjusted over time to reflect aging of building. Current allowance is set at 5% every 5 years starting in 2030. With proper maintenance/repairs to hinges, handles, etc. doors may exceed expected useful life.

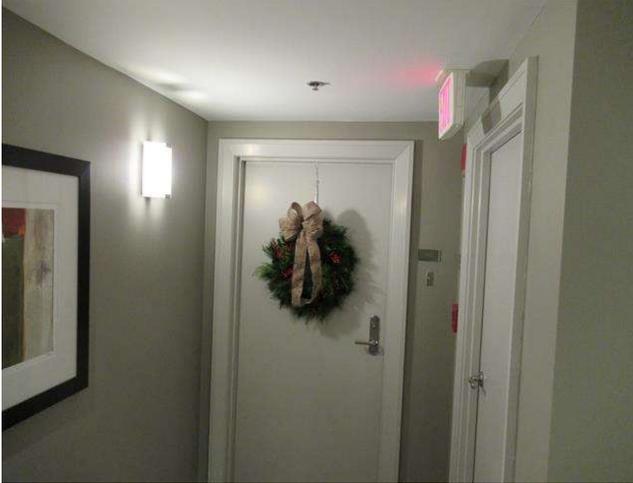
Component covers unit steel doors to common hallways. Doors were in good condition at site visit. Door life will vary with usage. It is unlikely that all doors will be replaced at one time. Allowance to replace percentage of doors beginning in 2030.

Allowance and interval for repairs and replacements should be adjusted over time to reflect aging of building. With proper maintenance/repairs to hinges, handles, etc. doors may exceed expected useful life.

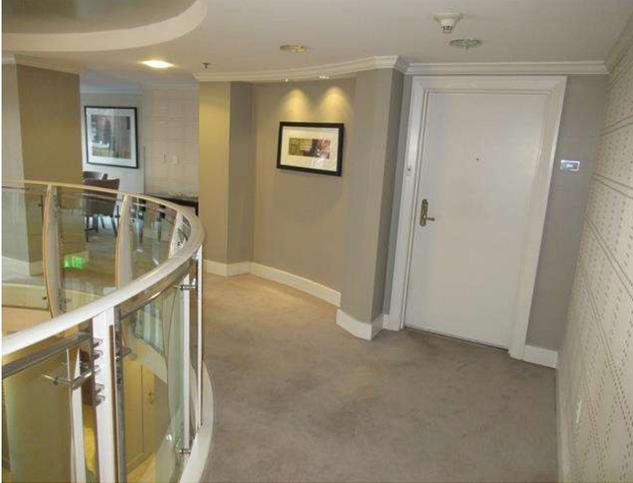
Component covers carpet flooring in 2nd floor common lounge area. Luxury-grade wool carpeting was installed in 2016. Carpet is difficult to clean because water cannot be used. Only spot cleaning is practical. Quantity per prior reserve study.

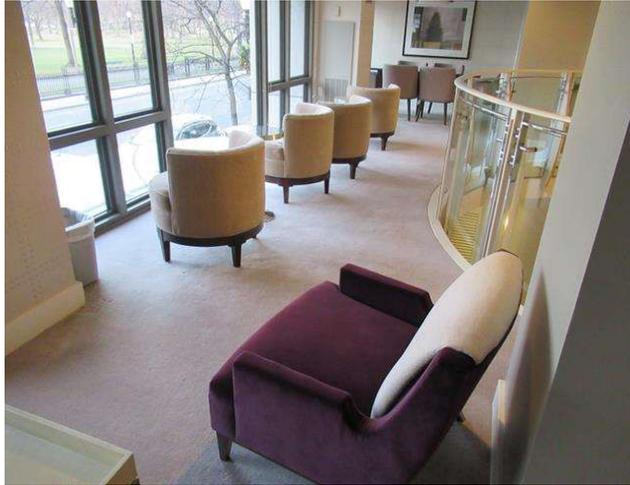
Component covers allowance for replacement of furnishings in second floor lounge area and lobby. Furnishings were in very good condition at site visit. Replacement furnishings may vary widely in price based on selections. No data available for 2016 renovation.

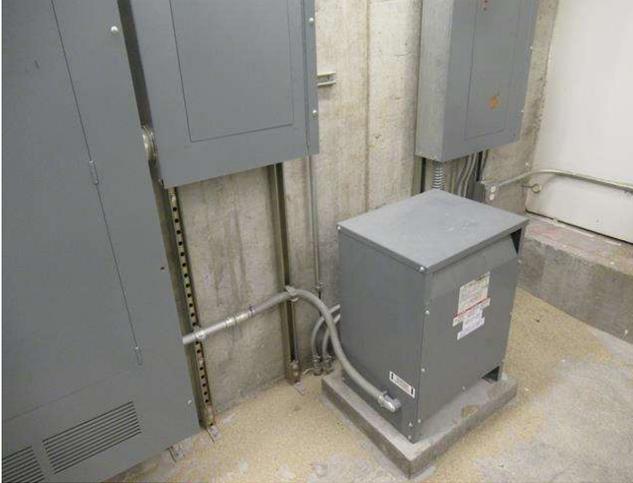
Component covers periodic allowance for electrical system repairs and replacements. As infrastructure ages, allowance should be adjusted in future reserve study updates.

Electrical components are typically unfunded due to lack of predictable useful life. However, given the large quantity of electrical equipment at the association, a periodic component is included.

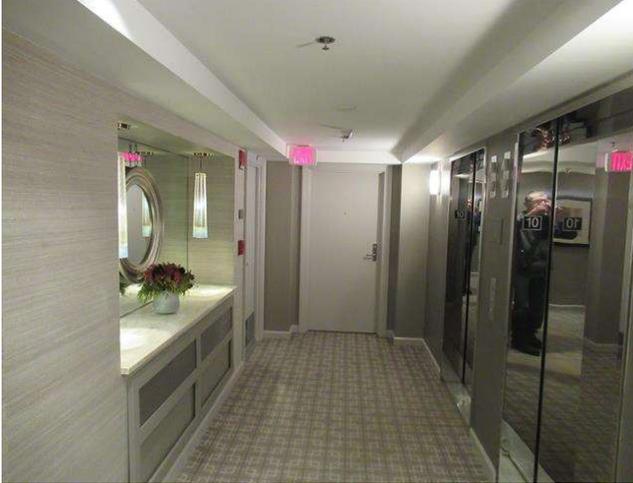
Component covers replacement of (2) elevator car door operators. Doors have been problematic.

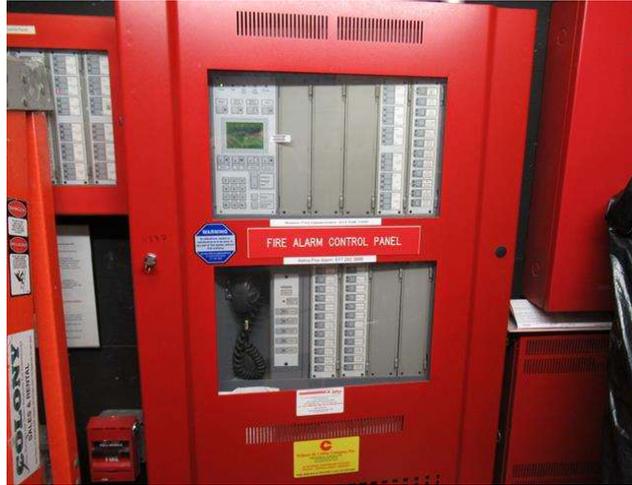
Component covers main parts of fire alarm system. The fire alarm system is composed of Edwards EST3 fully addressable fire alarm panel and peripheral equipment in the buildings. Component does not include re-wiring, pull stations, fire emergency lights, heat detectors, or horns. Replacement of peripheral devices currently on an as-needed basis. Funding for these devices can be added if desired.

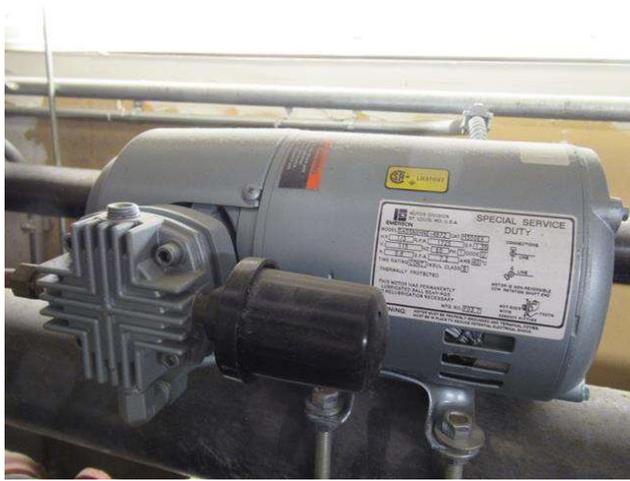
Component covers 1/2 hp air compressor for dry fire sprinkler system in parking garage. Pump maintains air pressure in sprinkler pipes to detect if a sprinkler head discharges. If sprinkler system has low leak/loss rate, compressor may only run once a week. Compressor is original, per client, with no issues reported.

The remaining life of this component has been extended to reflect satisfactory operation at our most recent site visit.

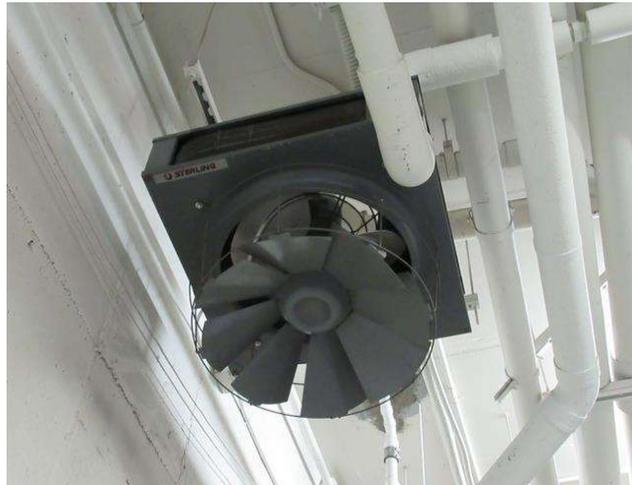
Component covers unit heaters located on ceiling over exit ramp near garage door. Units utilize heated water from boilers. Access is difficult due to steep ramp and ceiling height. No issues reported.

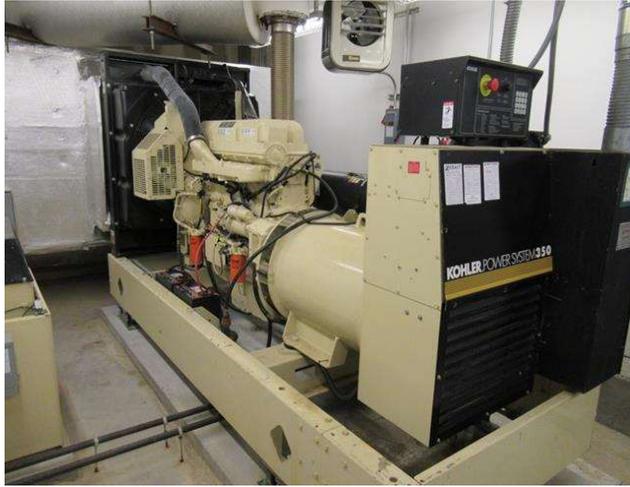
Component covers Kohler generator and peripheral equipment. Diesel-powered generator is rated at 350 kW. Generator was in good condition at site visit. Useful life assumes rebuild component listed separately is implemented.

Service contractor: Kraft Power, Woburn, MA, 781-938-9100, Michael Kelleher
Operational experience: no major issues reported.

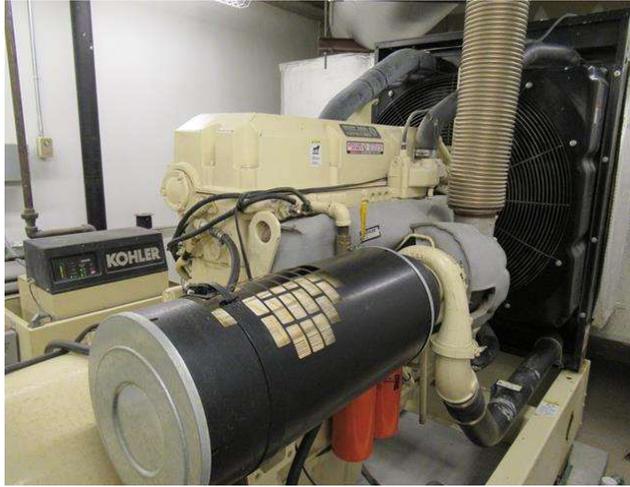
Component covers Kohler generator and peripheral equipment. Diesel-powered generator is rated at 350 kW. Generator was in good condition at site visit. Complete replacement is listed as a separate component. Remaining life extended due to lack of issues.

Service contractor: Kraft Power, Woburn, MA, 781-938-9100, Michael Kelleher
Operational experience: no major issues reported.

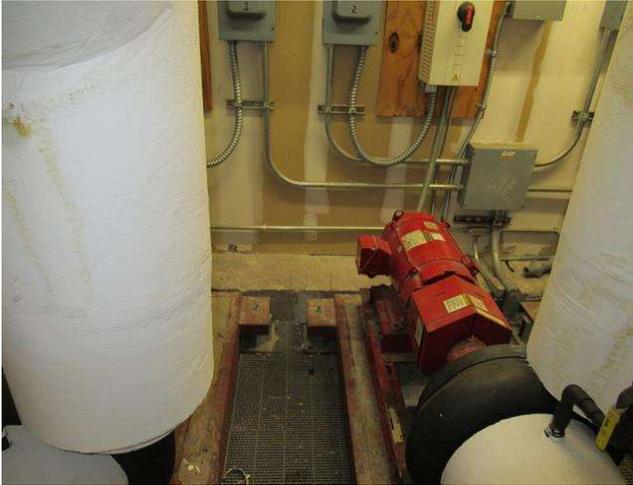
Component covers (2) 20 HP circulation pumps for cooling water loop supplying cold water to air handlers located throughout the building. No issues reported by management. Both pumps and one motor appear original to construction. One motor was replaced in 2013, per prior reserve study. Variable frequency drives installed in 2015 will help extend pump & motor useful life. However, pumps are near end of useful life and replacement should be anticipated in next several years. Remaining life extended to reflect current satisfactory operation near end of typical service life and motor replacement in 2013.

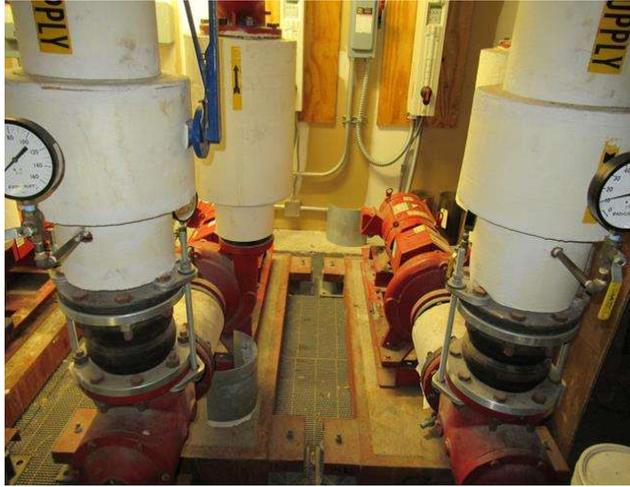
Component covers (2) 15 HP circulation pumps for hot water loop supplying heated water to air handlers located throughout the building. No issues reported by management. Motors and pumps appear original to construction. Notation on one pump indicates a new seal was installed in 2014. Variable frequency drives installed in 2015 will help extend pump & motor useful life. However, pumps are near end of useful life and replacement should be anticipated in next several years. Remaining life extended to reflect current satisfactory operation near end of typical service life.

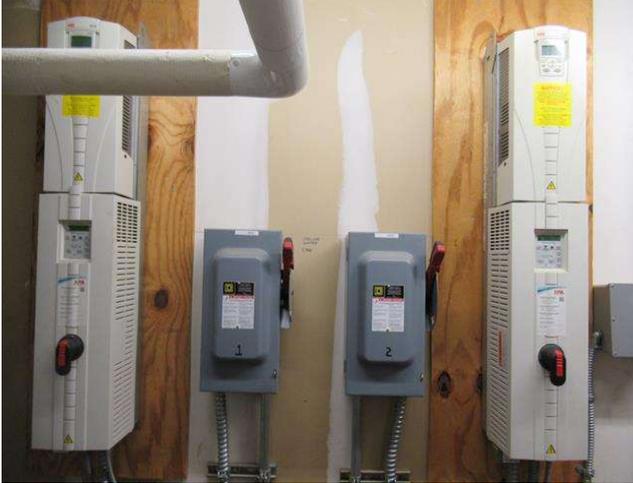
Component covers (2) variable frequency drives (VFD) for cooling water loop supplying cold water to air handlers located throughout the building. No issues reported by management. Drives were installed in 2015, per prior reserve study.

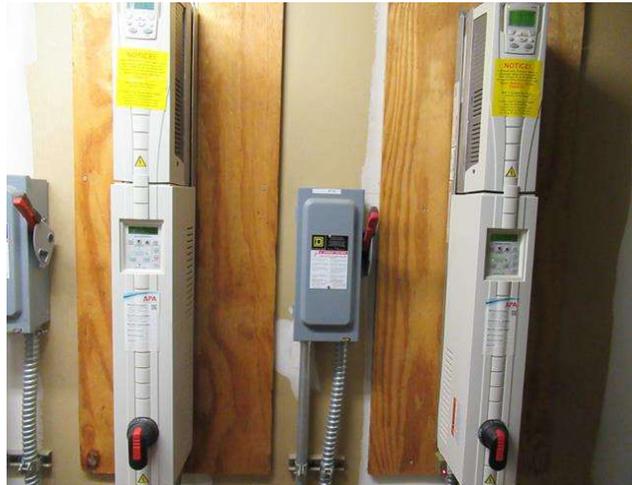
Component covers (2) variable frequency drives (VFD) for heating water loop supplying hot water to air handlers located throughout the building. No issues reported by management. Drives were installed in 2015, per prior reserve study.

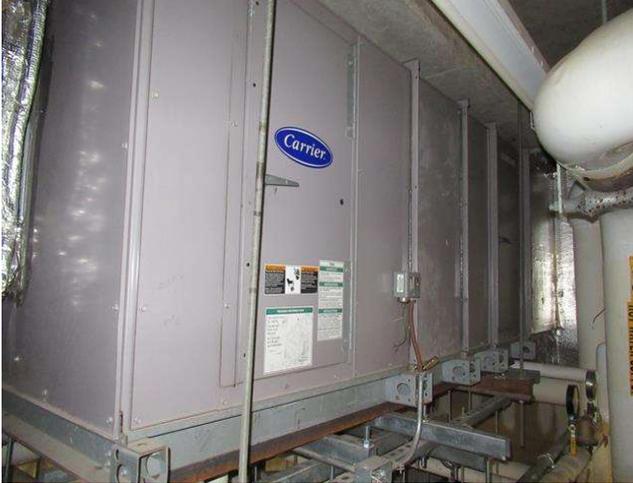
Component covers Carrier ventilation unit that provides fresh air in common hallway vestibule areas. No issues reported. Large enclosure contains several fans that can be replaced. Allowance covers periodic fan replacement. Allowance should be revised based on association experience in future reserve study updates.

Replacement of entire enclosure is not funded.

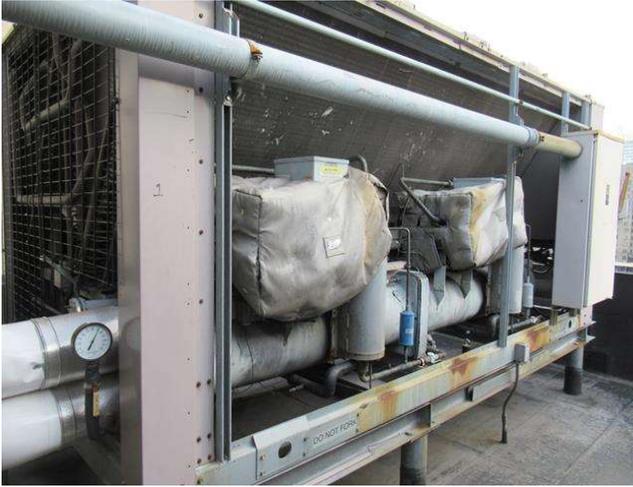
Equipment - HVAC, Chiller Repairs

Component covers repair of dual rooftop 250-ton Carrier packaged air-cooled liquid chillers which provide cold water for building cooling. Replacements of compressors and coils anticipated. Complete chiller replacements listed as separate component.

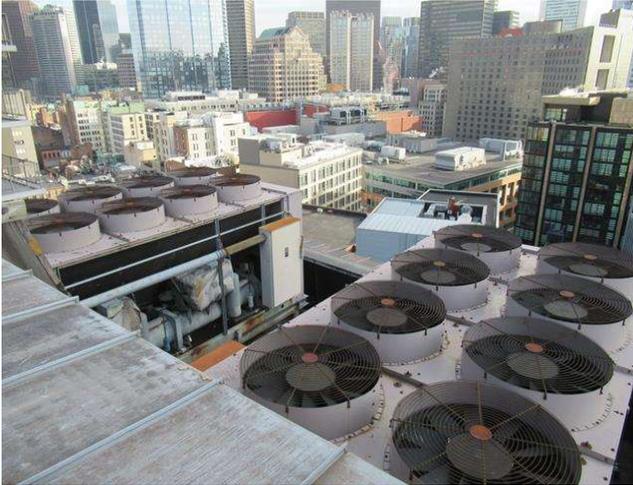
Equipment - HVAC, Chiller Replacements

Component covers dual rooftop 250-ton Carrier packaged air-cooled liquid chillers which provide cold water for building cooling. Useful life extended to reflect anticipated repairs. Compressor and coil repairs to extend life listed as separate component.

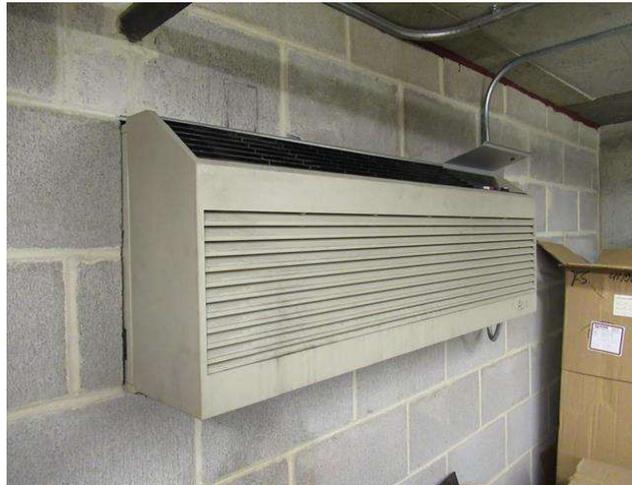
Component covers PTAC (packaged terminal air conditioners) supply cooling and heat to garage G2 & G3 mechanical rooms. PTAC units are original, per client.

The remaining life of this component has been extended due to its satisfactory operation at our most recent site visit.

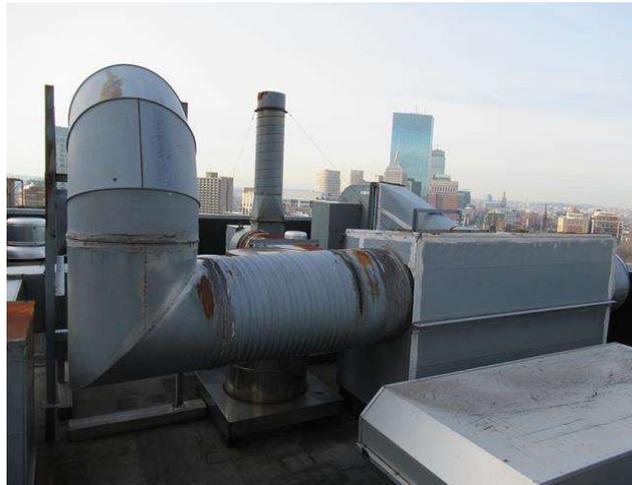
Component covers stairwell pressurization fans for fire department smoke control. Quantity from prior reserve study. Useful life reflects light use with intermittent operation.

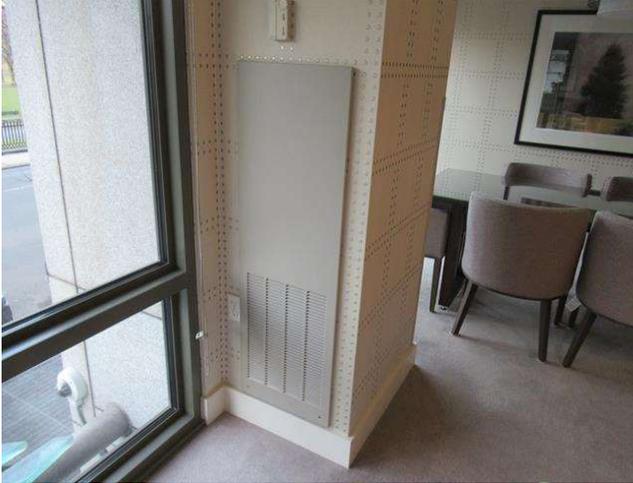
Component covers fan coil unit air handlers for common interior spaces. Allowance covers repairs and replacements as needed. Allowance amount and interval should be adjusted as association gains more experience with replacements. No issues reported except location of thermostat between supply and return on the same wall results in poor temperature control within units.

Association is responsible for about 35 air handlers, per client. Air handlers within units are unit owner responsibility.

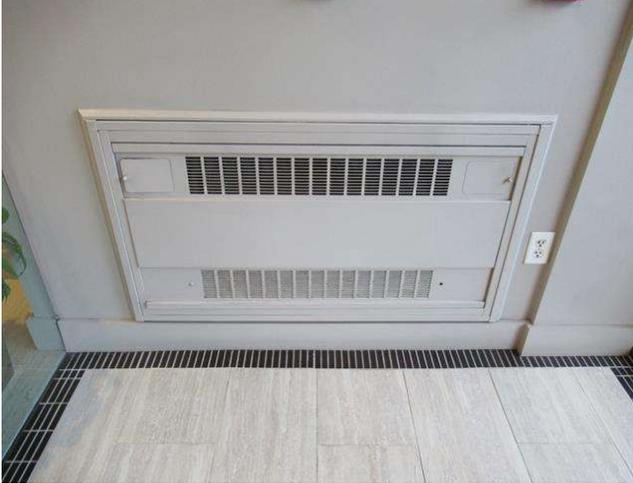
Component covers unit heaters located in main entry vestibule and at rear stairwell exit door. Units utilize heated water from boilers. No issues reported.

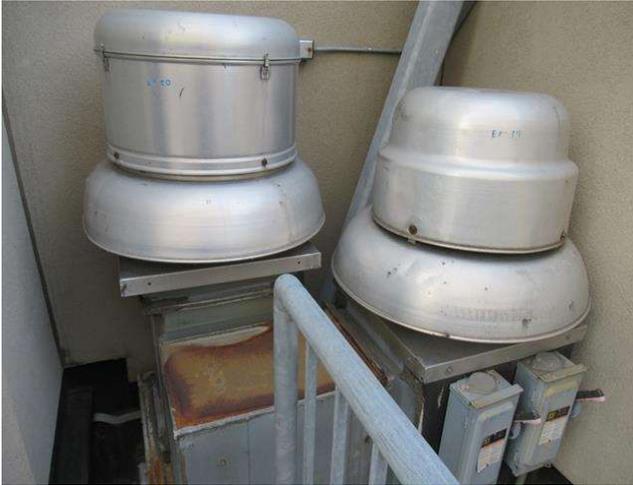
Component covers roof top hooded and mushroom fans exhausting air from various areas of buildings. Quantity per prior reserve study. Allowance to periodically replace fans.

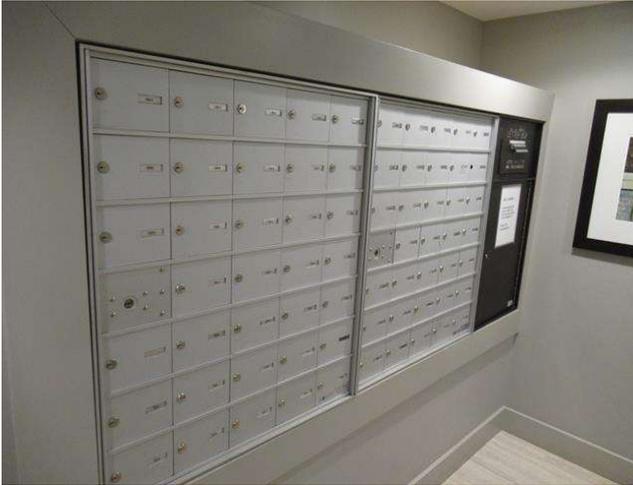
Component covers 35-door USPS-STD-4B+ horizontal recessed mailboxes in building lobby. Mailboxes were in good condition at site visit. The remaining life of this component has been extended due to its condition at our most recent site visit.

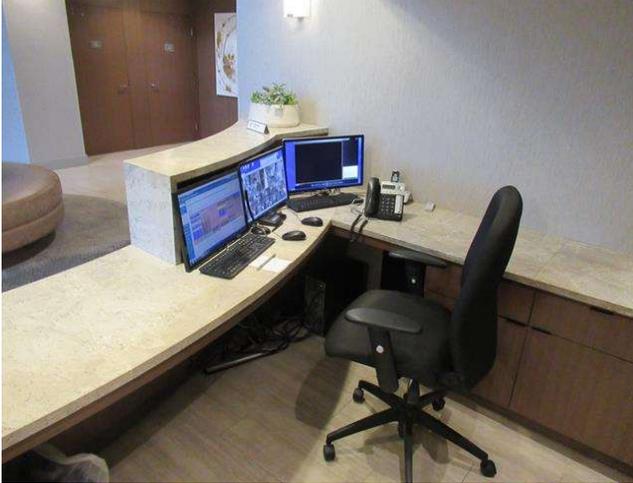
Component covers replacement allowance for office equipment used by concierge and building manager. No issues reported. Allowance should be revised based on association experience in future reserve study updates.

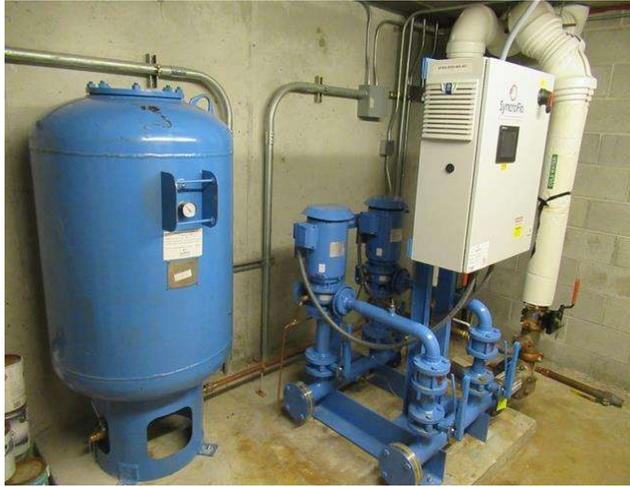
Component covers SyncroFlo domestic water duplex booster pumps. Pumps are powered by 5 hp motors. 125 gpm per pump typical. Cost, per prior reserve study, includes vertical removable-bladder hydropneumatic pressure tank.

Control panels may also have individual components that need periodic replacement (electrical contactors are an example).

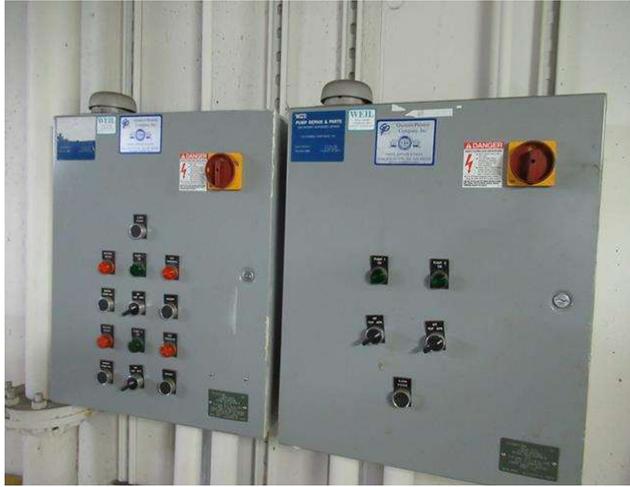
Equipment - Pumps, Foundation Drain

Component covers ejector pumps for building foundation drains/groundwater. No issues reported by management. Placed-in-service date per prior reserve study.

Duplex pump system is located in lower G4 level garage along west wall. Component covers pumps and controls. Collection tank has long life unless damaged.

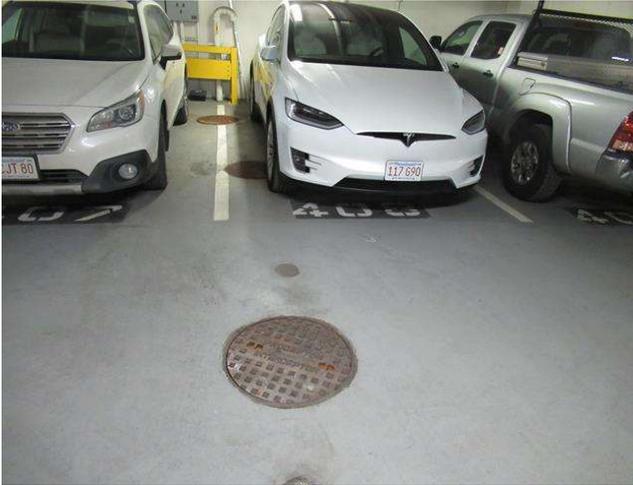
Component covers ejector duplex pumps for garage floor drains. Oil, sand, and salt water pass through separator before entering floor drain tank. No issues reported by management. Placed-in-service date per prior reserve study.

Duplex pump system is located in lower G4 level garage along west wall. Component covers pumps and controls. Collection tank has long life unless damaged.

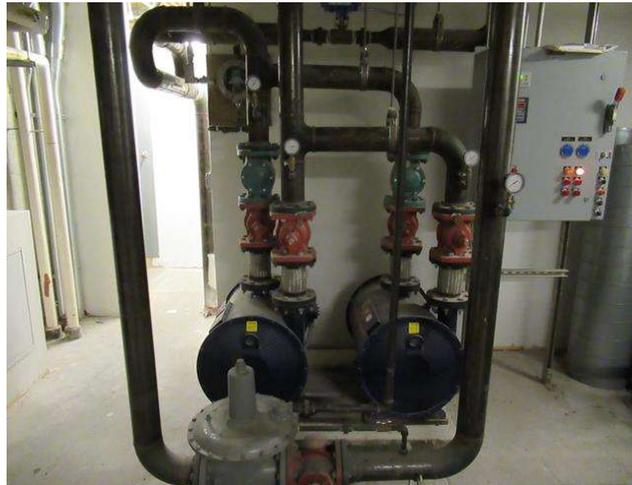
Component covers natural gas pressure booster pumps. Dual Spencer hermetically-sealed multistage natural gas boosters with control panel. No issues reported by management.

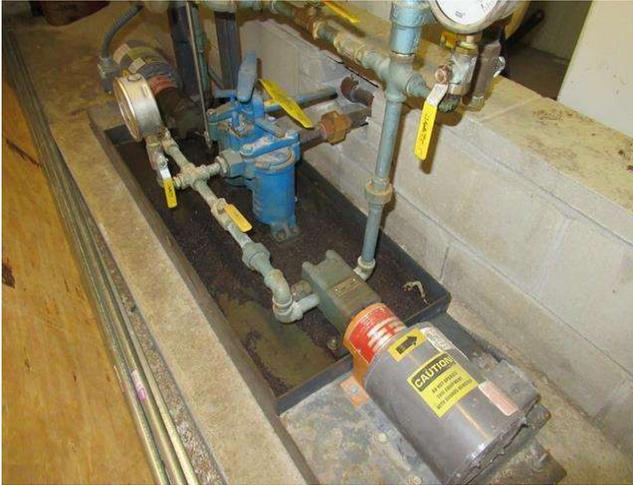
Automatic fuel oil transfer pump set with dual 1/2-hp explosion-proof pumps and control panel. No reported operating issues. Future replacement/upgrade allowance. Remaining life extended due to infrequent use. Cost per prior reserve study.

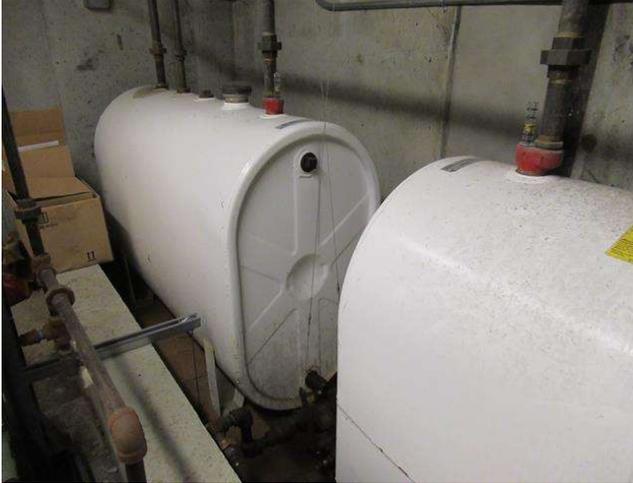
Component covers (2) 275 gallon diesel fuel storage tanks located in garage storage room. Steel tanks hold fuel for backup generator. No major issues reported. Tanks are without cathodic protection, but fuel usage is low so introduction of water in tank with fuel deliveries should be low also. Cathodic protection should be considered.

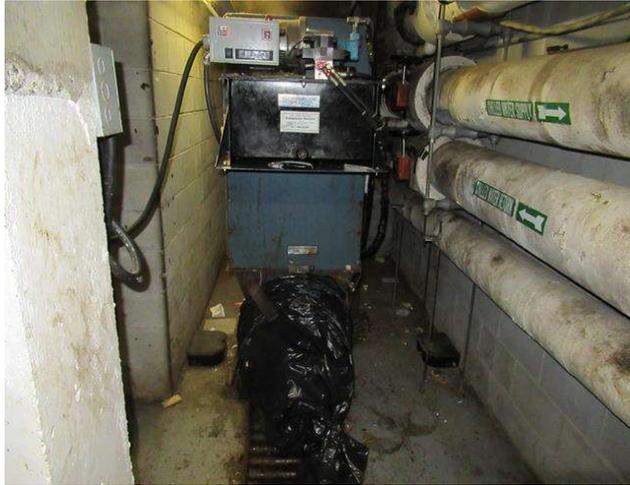
Component covers chute-fed, sausage-type hydraulic compactor. No reported operating issues. Future replacement based on 25-year useful life, per client, based on prior reserve study comment.
