RESERVE ANALYSIS REPORT

Sample Report Condominium Association

Any City, Any State Version 1 Saturday, August 05, 2017

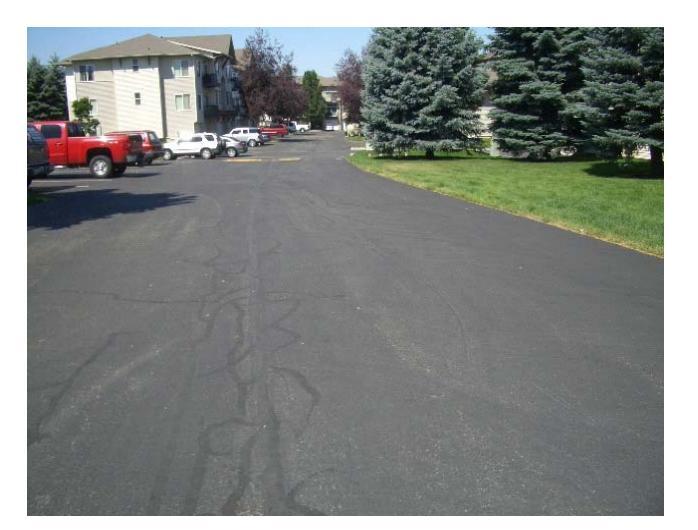
9	- manhole cover adjustments	@	\$340.00	=	\$3,060.00
160,820	- sq. ft. of asphalt overlay	@	\$1.55	=	\$249,271.00
17	- valve cover adjustments	@	\$125.00	=	\$2,125.00
			TOTAL	=	\$254,456.00

Most asphalt areas can be expected to last approximately 20-25 years before it will become necessary for an overlay to be applied. This can double the life of the surface upon application. It will be necessary to adjust manhole and valve covers at the time the overlay is applied. Deflection testing should be conducted by an independent consultant near the end of the estimated useful life to determine the condition of the asphalt and estimated remaining life before the overlay is required.

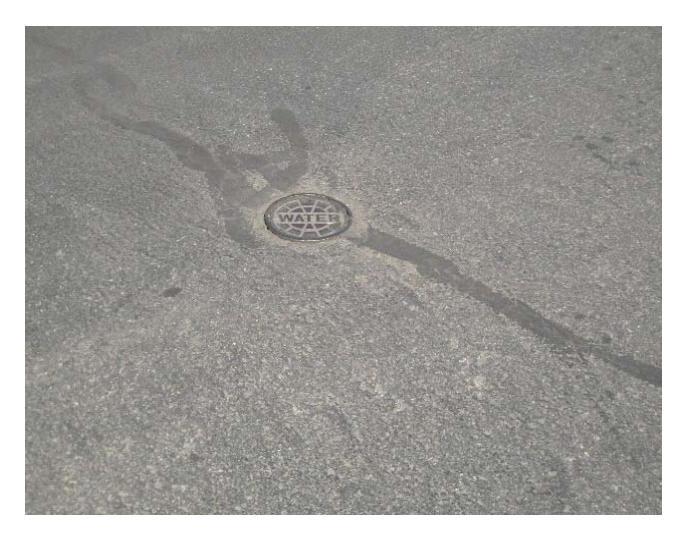
It is estimated that a percentage of the asphalt areas will require repair or replacement. The actual condition of the asphalt should be monitored through time and these estimates adjusted accordingly.
Component Detail Component Calculation Method; Sorted by Category

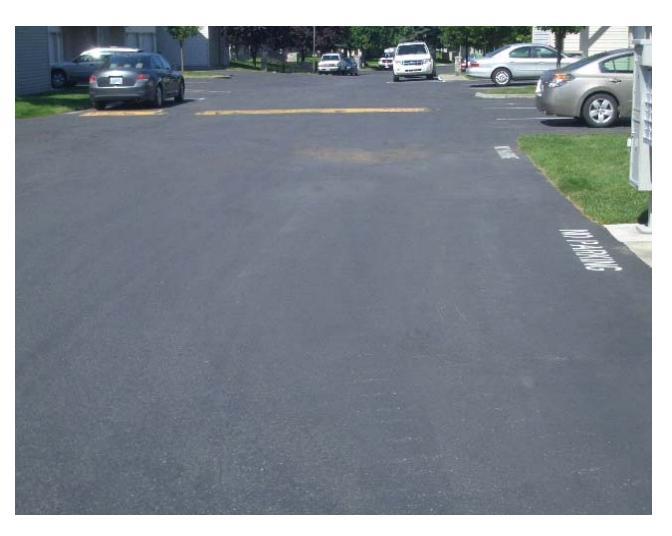
The association had the asphalt seal coated and crack fill in 2016 at a cost of \$26,205.00.

Asphalt surfaces should be seal coated within 5 years of their initial installation. Thereafter, a 3 to 5 year cycle should be observed and adjusted according to the client's particular needs.

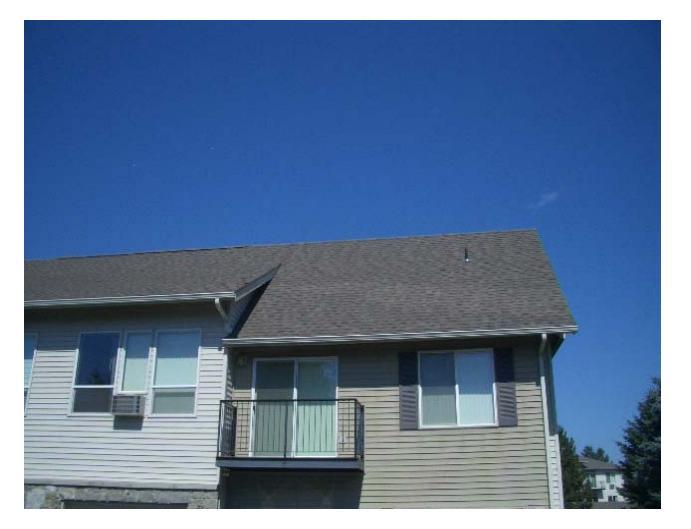
These are the composition roofs:

housing buildings	147,890	sq. ft
carports	22,420	sq. ft
pool house	2,325	sq. ft
	172,635	sq. ft

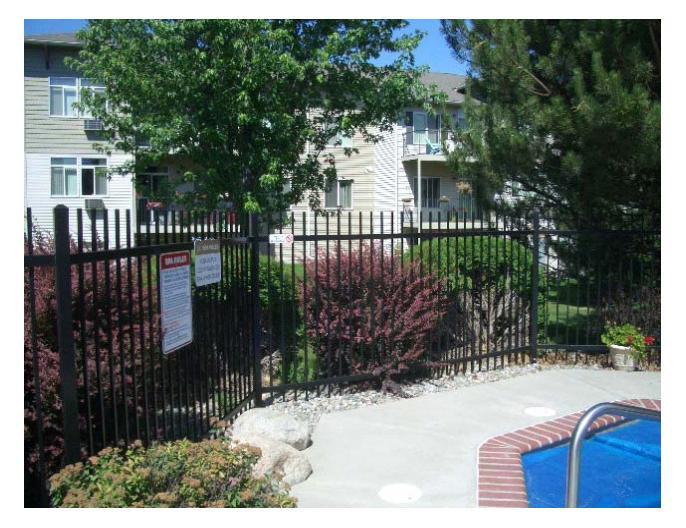
This is for painting of the metal fencing surfaces located throughout the community:

- 5ft pool fencing	1,225	sq. ft.
	1,225	sq. ft.

The association had the residential buildings, fitness center, pool house and fencing around pool stained and painted in 2014 at a cost of \$155,942.00.

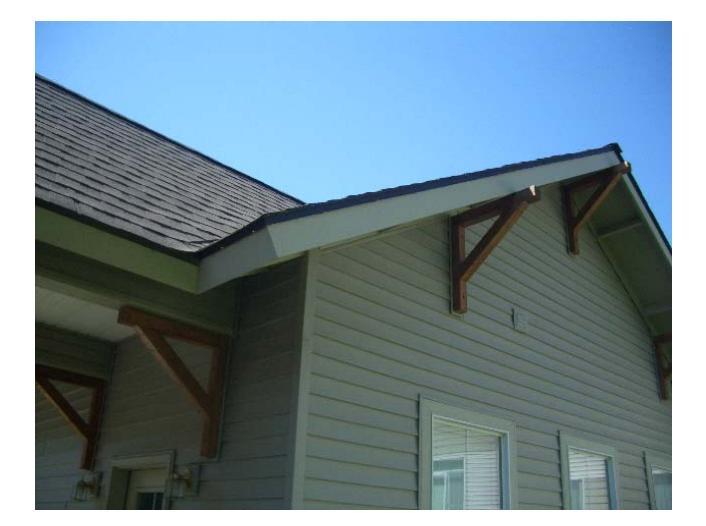
This is for painting of the exterior trim & railings:

housing buildings	55,875	sq. ft.
pool house	960	sq. ft.
carports	4,580	sq. ft.
	61,415	sq. ft.

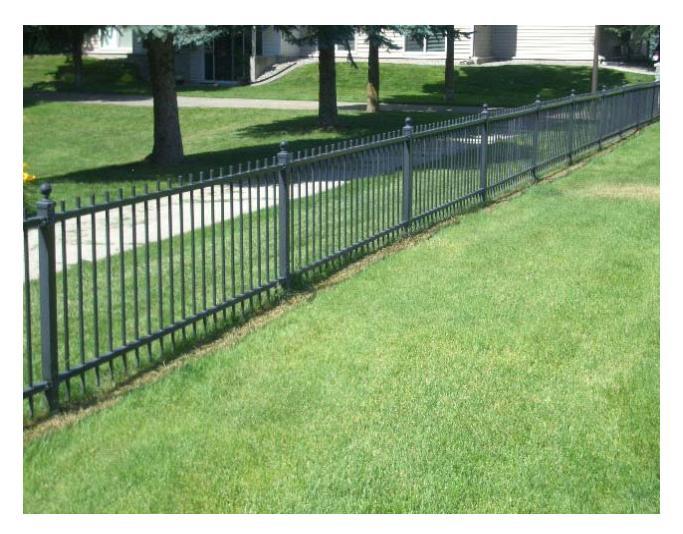
This is for painting of the metal fencing surfaces located throughout the community:

- 3ft property line fencing	4,950	sq. ft.

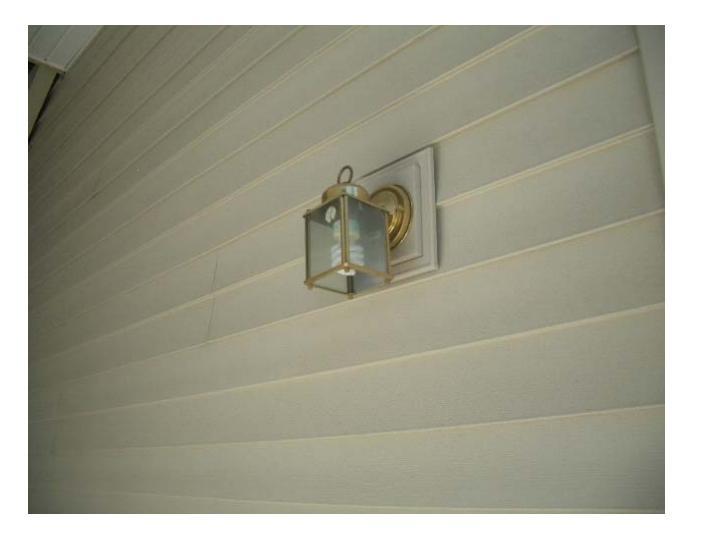
These are the exterior lights located at the fitness/pool house:

10	 porch & patio lights* 	@	\$80.00	=	\$800.00
1	 sensored flood lights* 	@	\$120.00	=	\$120.00
			TOTAL	=	\$920.00

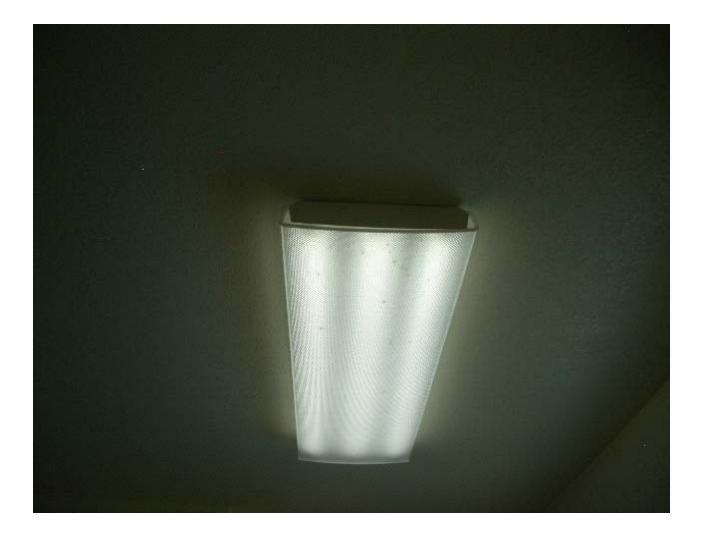
These are the interior lights located at the fitness/pool house:

6	- florecent lights	@	\$100.00	=	\$600.00
			TOTAL	=	\$600.00

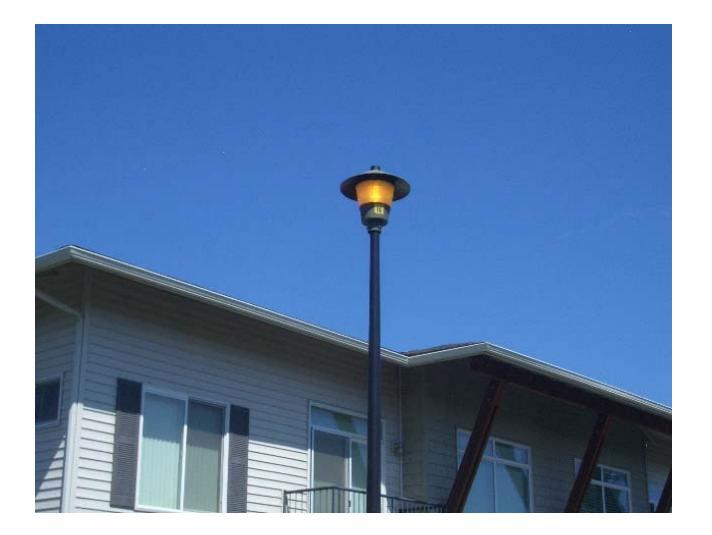
These are the street lights located throughout the community:

13	 metal post street lights* 	@	\$1,500.00	=	\$19,500.00
5	 metal post pool lights* 	@	\$1,500.00	=	\$7,500.00
			TOTAL	=	\$27,000.00

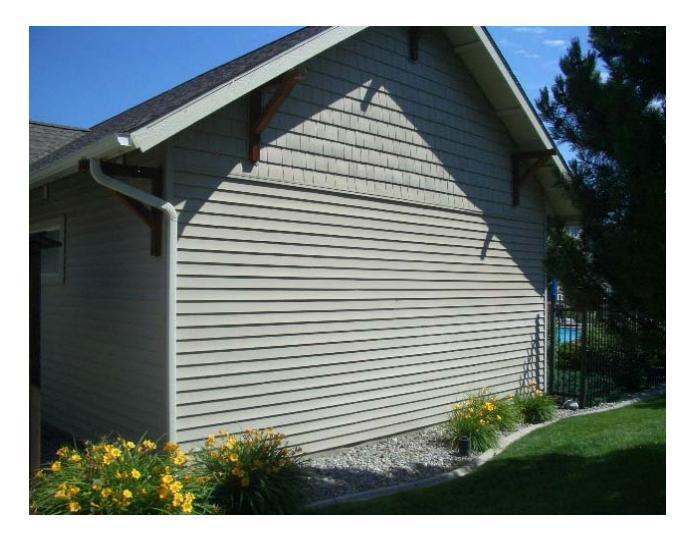
This is for the vinyl siding located throughout the community:

housing buildings	136,160	sq. ft.
fitness center / pool house	2,950	sq. ft.
carports	9,520	sq. ft.
	148,630	sq. ft.

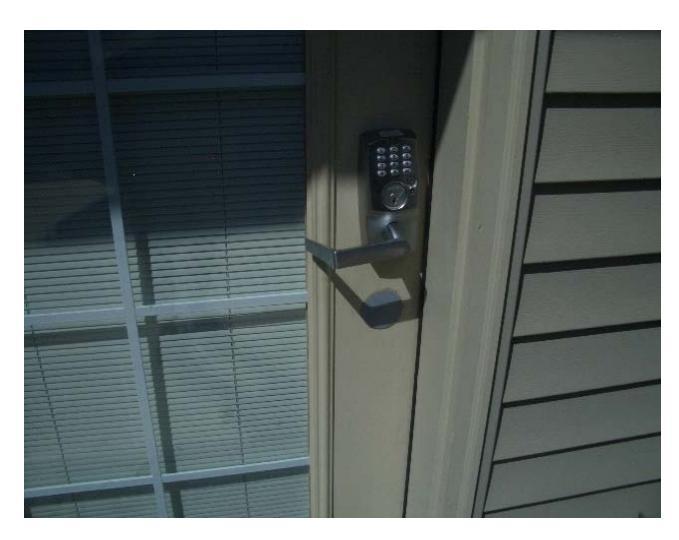
These are the Schlage entry keypads located at the fitness center and pool house.

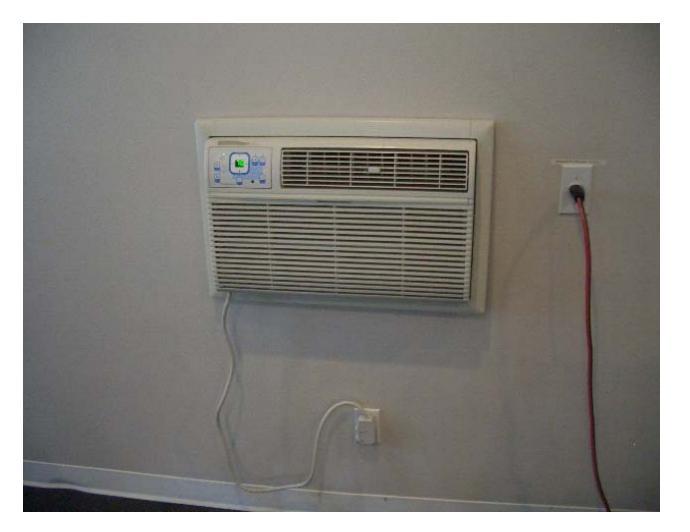
This is the wall mounted Frigidaire Air Conditioner located in the fitness center.

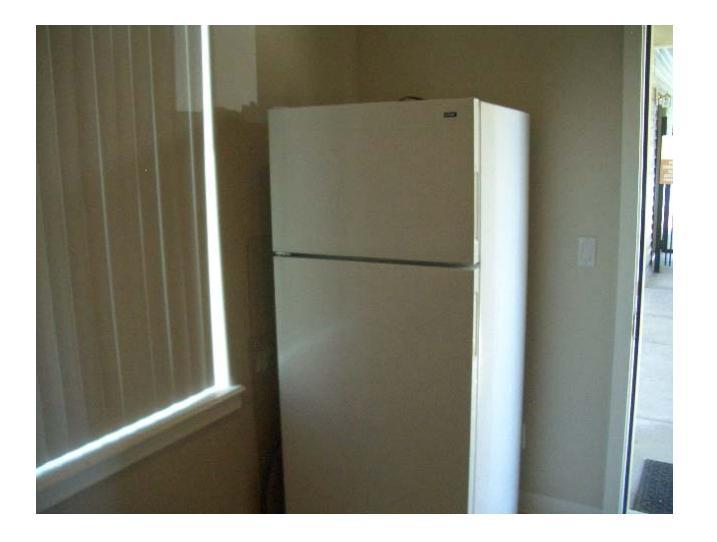
This is the refrigerator located in the fitness center, office/storage room:

1 refrigerator	@	\$800.00	=	\$800.00
		TOTAL	=	\$800.00

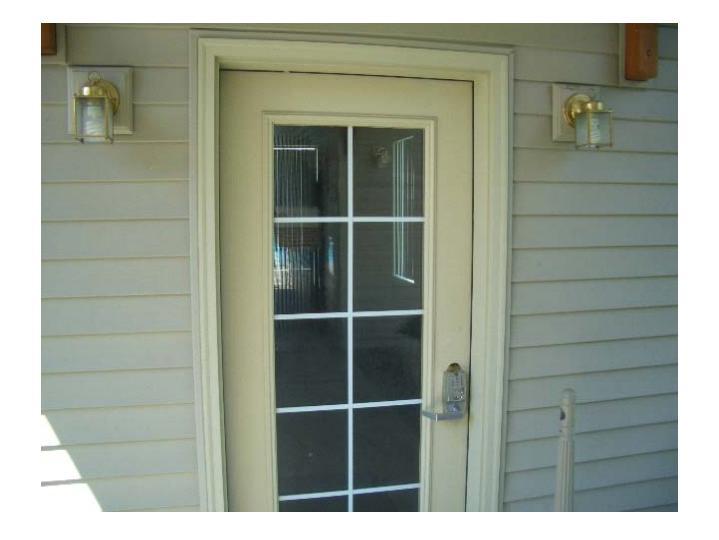
These are the exterior doors located at the fitness center and pool house:

3	- 3' x 6'8" metal doors	@	\$350.00	=	\$1,050.00
2	- 3' x 6'8" fiberglass doors	@	\$600.00	=	\$1,200.00
			TOTAL	=	\$2,250.00

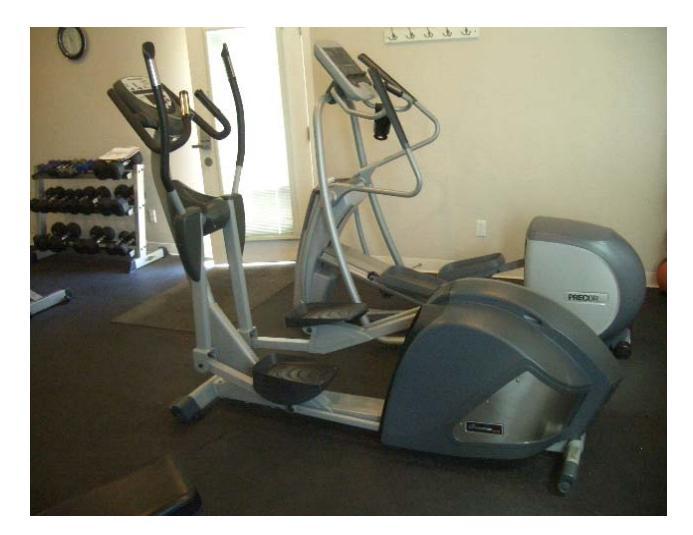
These are the exercise equipment located in the fitness center:

- 1 Precor EFX534i Elliptical
- 1 Nautilus NE 3000 Elliptical
- 1 Sports Art 530R Bike
- 1 True PS900 Tread Mill
- 1 Tuff Stuff Apollo 5 Weight Station

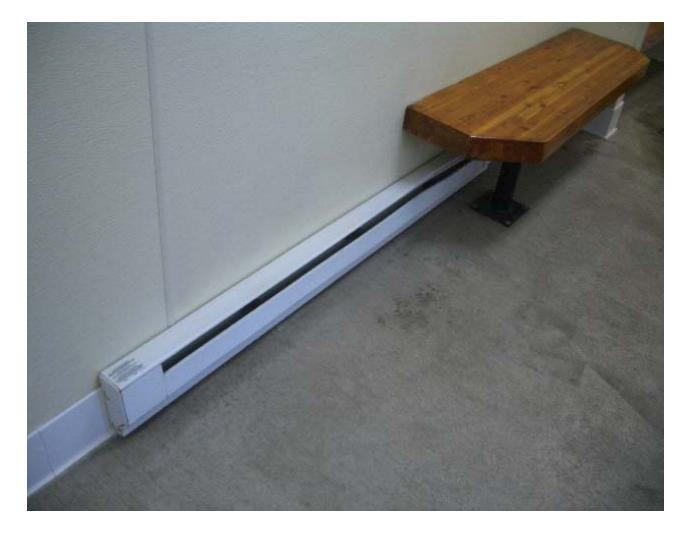
These are the electric heaters located in the fitness center and pool house:

3	- cadet electric heaters	@	\$300.00	=	\$900.00
2	- baseboard electric heaters	@	\$250.00	=	\$500.00
			TOTAL	=	\$1,400.00

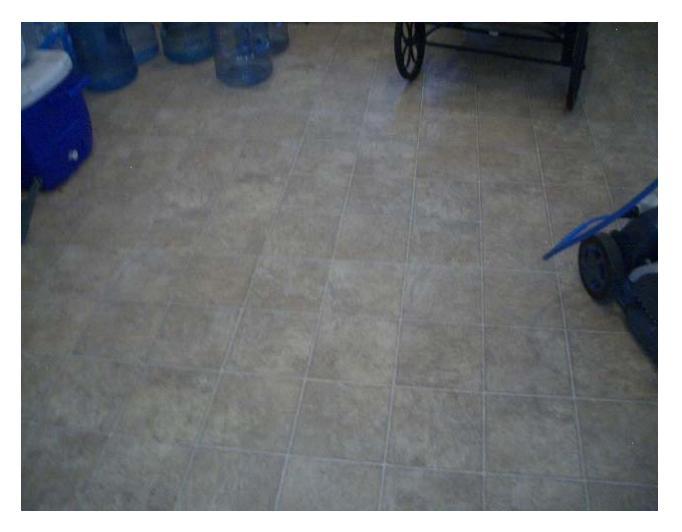
This is the vinyl flooring located at the office/storage in the fitness center.

The remaining life of this component has been extended due to its apparent infrequent use.

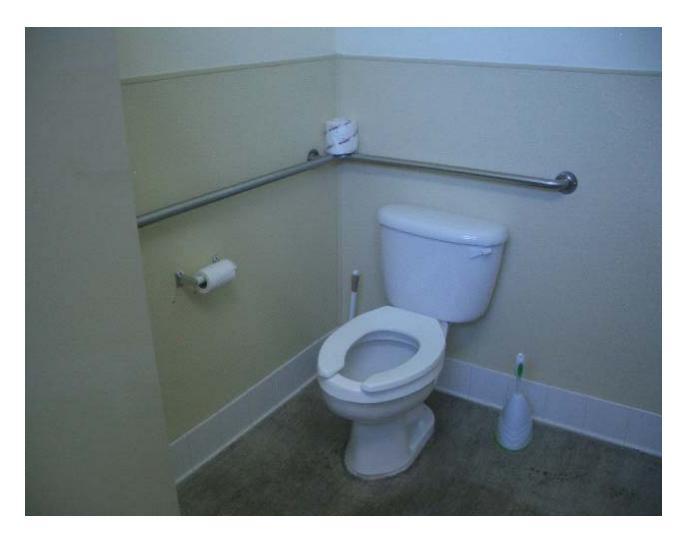
These are the plumbing fixtures located at the pool house restrooms:

2	- toilets, tank type	@	\$525.00	=	\$1,050.00
2	- sinks, wall hung	@	\$550.00	=	\$1,100.00
2	- showers, ada	@	\$2,100.00	=	\$4,200.00
			TOTAL	=	\$6.350.00

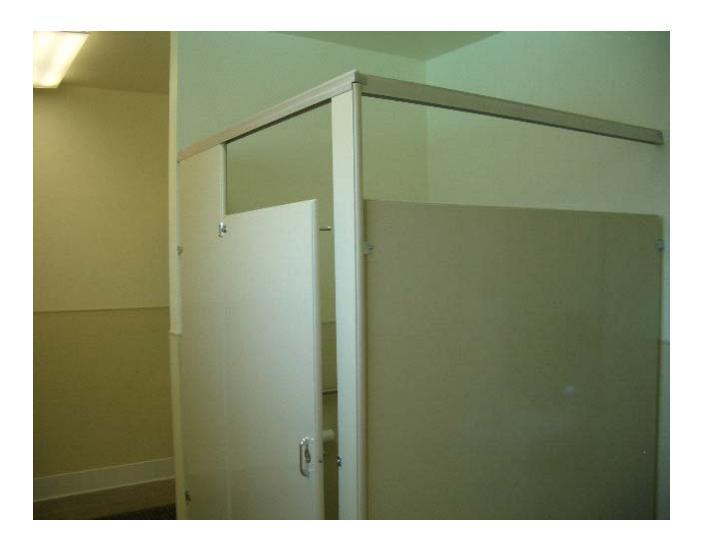
These are restroom partitions located in the pool house:

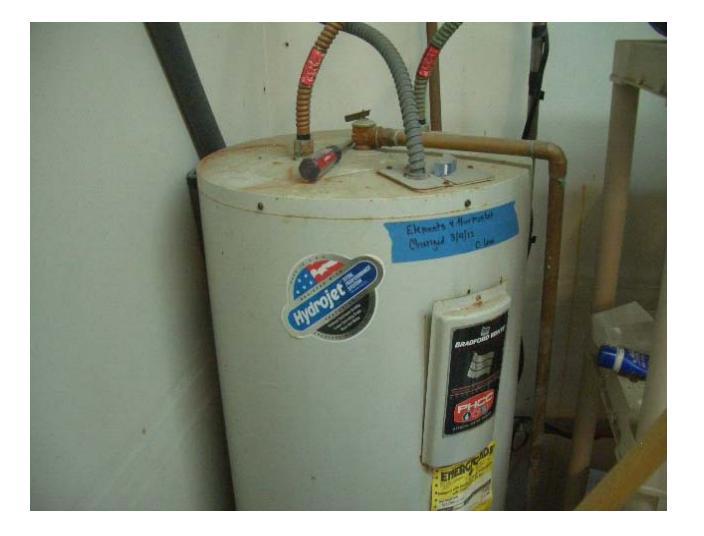
This is the electric water heater located in the pool house mechanical room:

1 - 52 gallon electric wa	ater heater	@	\$950.00	=	\$950.00
			TOTAL	=	\$950.00

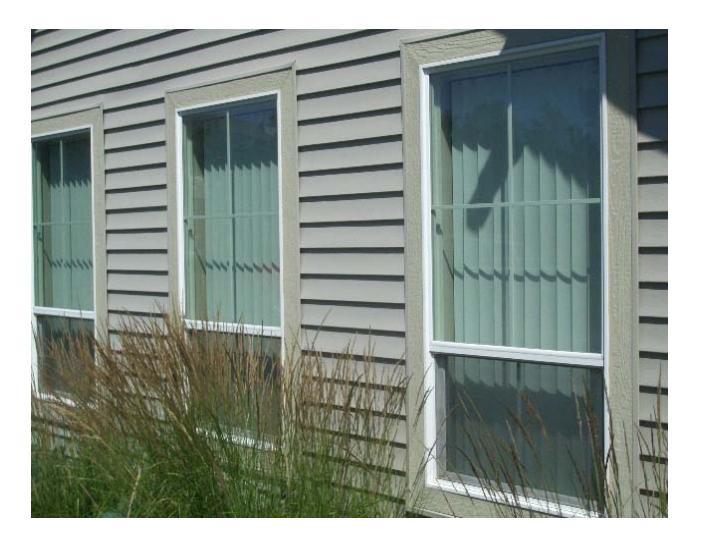
This is for the fitness/pool house windows. Cost is based off of an average of the window dimensions. Labor replacement is included in replacement cost.

Vinyl windows are considered to be a lifetime component if properly installed and maintained. Periodic window inspections and ongoing maintenance may prevent the necessity of a total building window replacement.

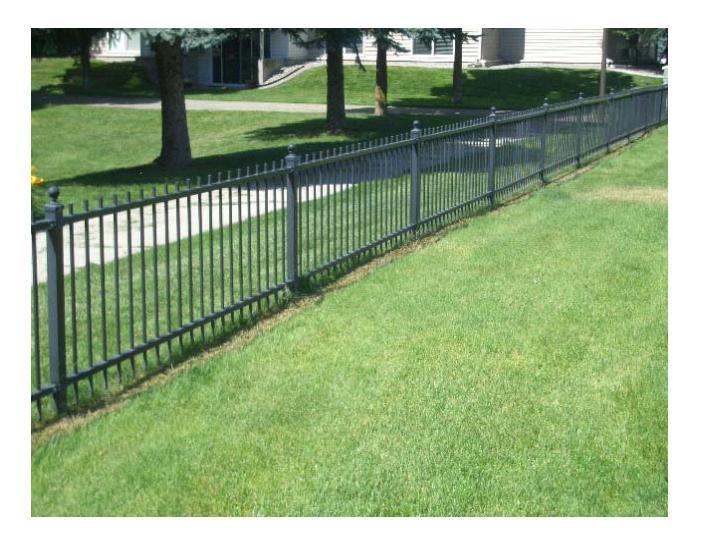
This is the metal fencing located throughout the community:

243	- lin. ft. of 5 ft. fence - pool area	@	\$28.00	=	\$6,804.00
1,675	- lin. ft. of 3 ft. fence - property line	@	\$26.00	=	\$43,550.00
			TOTAL	=	\$50,354.00

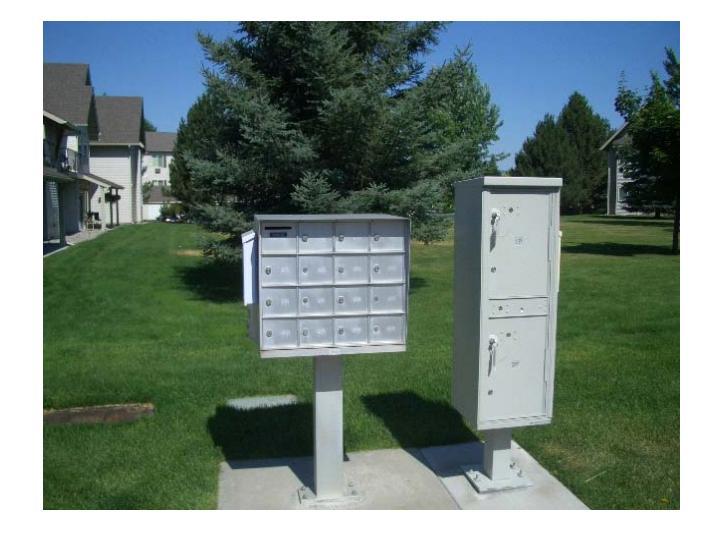
These are the pedestal metal mailbox sets located throughout the community:

12 - 16 box units	@	\$1,400.00	=	\$16,800.00
4 - 12 box units	@	\$1,250.00	=	\$5,000.00
		TOTAL	=	\$21,800.00

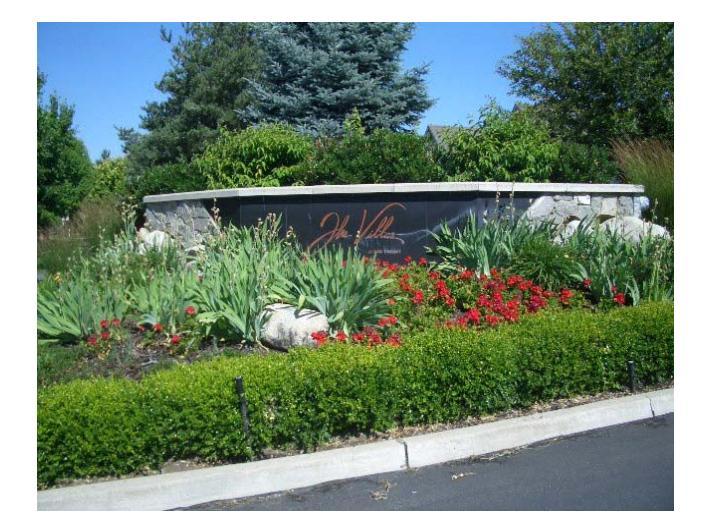
These are the various signs located throughout the community:

2	- entry monuments - refurbish	@	\$2,500.00	=	\$5,000.00
			TOTAL	=	\$5,000.00

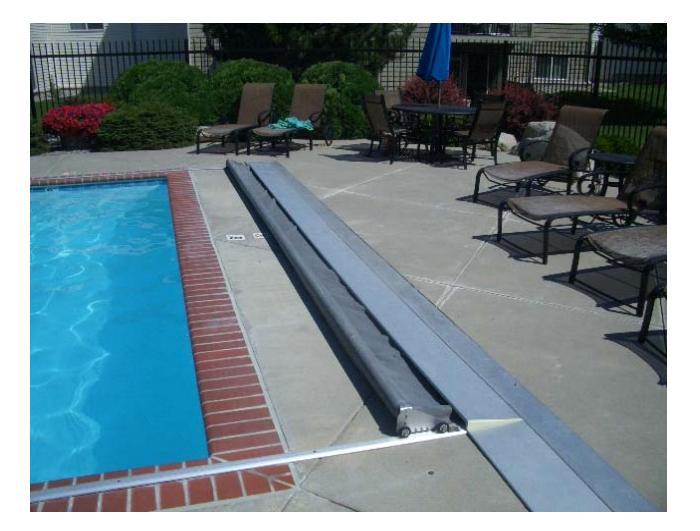
This is for the winter pool cover.

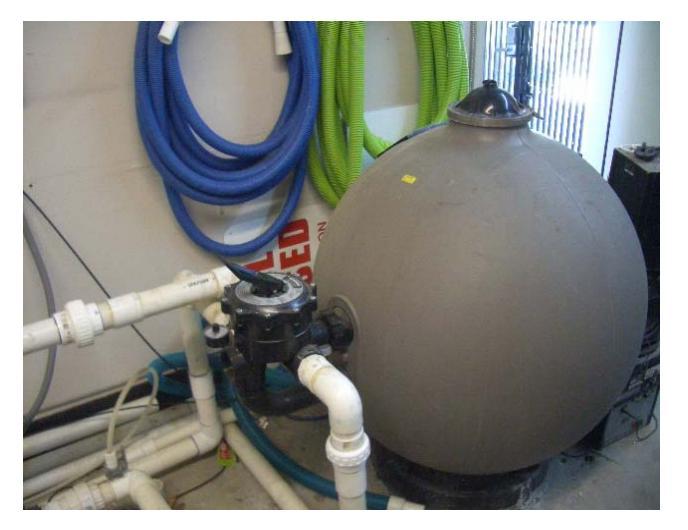
This is the Hayward Pro S360SX Sand Filter.

The association had the sand/gravel replaced in 2012 for a total of \$783.06

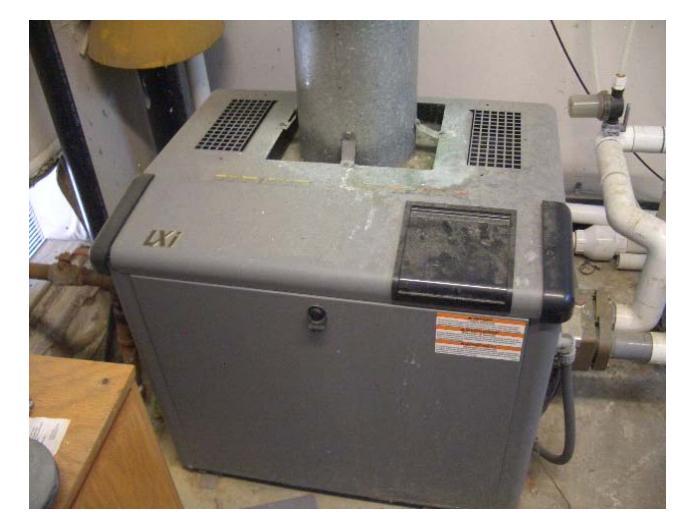
This is the Jandy LRZ400ENC 399,000 BTU pool heater.

The pool heater was replaced in 2012 at a cost of \$4,000.16.

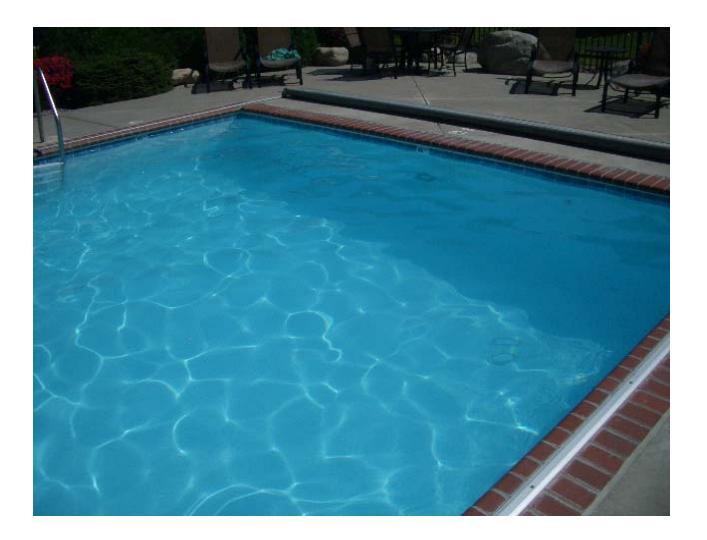
This is for the replaster and retile of the pool:

1,630	- sq. ft. of replaster	@	\$12.00	=	\$19,560.00
140	- lin. ft. of trim tile	@	\$15.00	=	\$2,100.00
			TOTAL	=	\$21,660.00

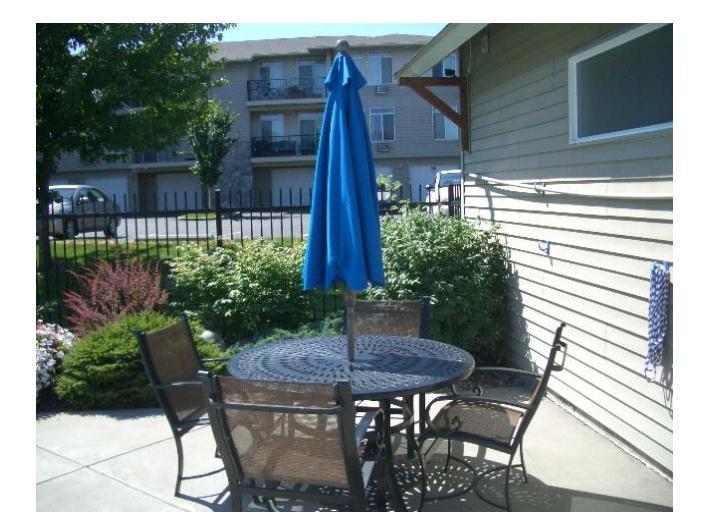
This is the furniture located at the pool area:

16	- brunch chairs	@	\$110.00	=	\$1,760.00
12	- chaise lounges	@	\$240.00	=	\$2,880.00
4	- tea tables	@	\$85.00	=	\$340.00
3	- brunch tables	@	\$85.00	=	\$255.00
3	- garbage containers	@	\$150.00	=	\$450.00
2	- gas barbeques	@	\$762.00	=	\$1,524.00
1	- table umbrella	@	\$270.00	=	\$270.00
			TOTAL	=	\$7,479.00

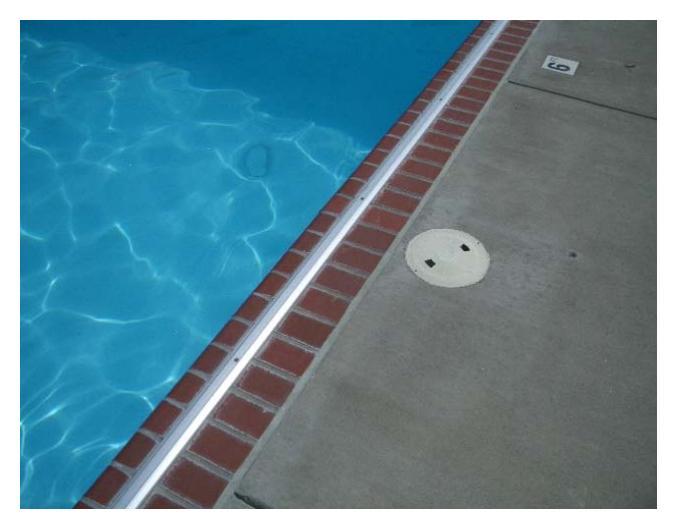
The pool was originally built without an expansion joint between the pool coping and concrete pool deck. Part of the pool refurbishing in 2013 was cutting in an expansion joint in the pool deck.

Mastic material (deck caulking) prevents moisture from seeping through the expansion joints in the concrete pool deck, which otherwise could result in cracking these surfaces. The mastic material should be carefully monitored for deterioration and replaced as soon as waterproofing integrity is lost.

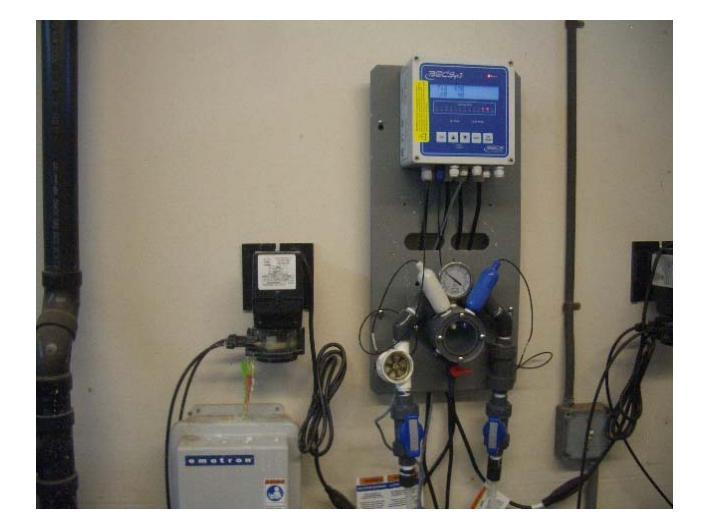
The association replaced the spa chemical controller in 2016 at a cost of \$4,208.00.

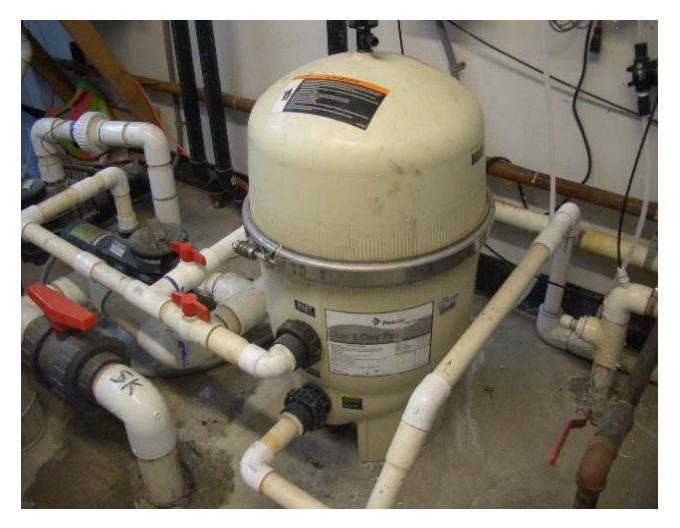
This is the Pentair CCP 320 spa filter.

The spa filter was replaced in 2012 at a cost of \$1,400.00.

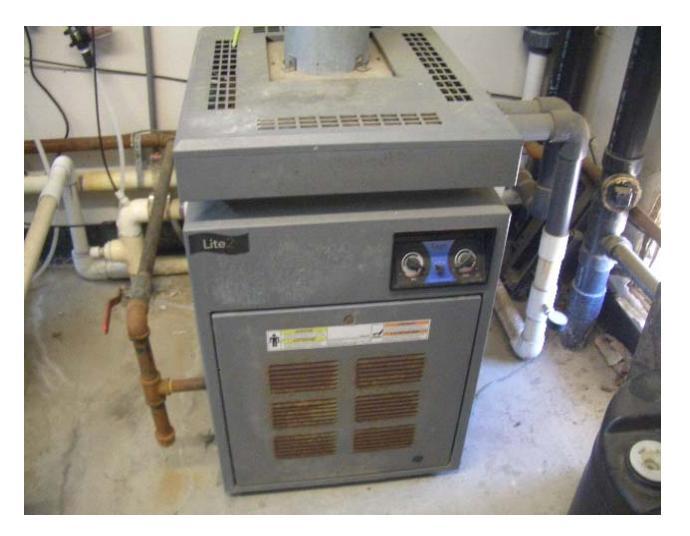
This is the Laars Lite 2 LD250NX spa heater.

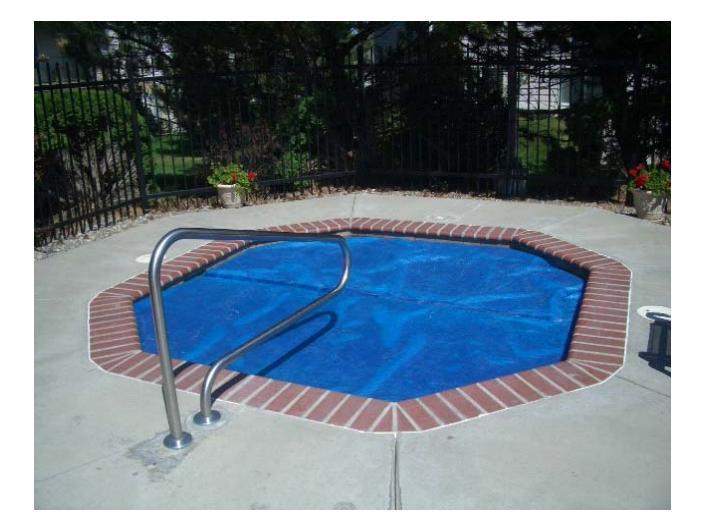
This is for the retile of the spa.

The tile and grout lines should be periodically inspected and any damaged grout lines refilled and sealed to help maintain the integrety of the component.

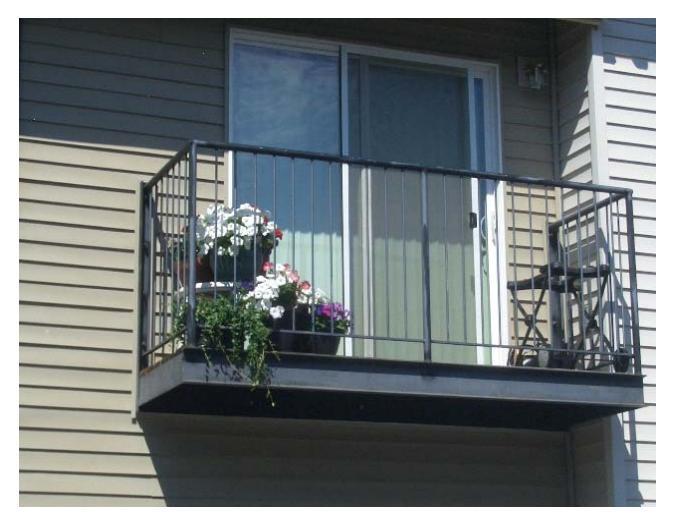
At our July 6, 2017 site visit many of the metal balconies need to be painted to protect the metal.

Balconies are considered a Limited Common Area. Big Trout Condominiums Association CC&Rs Article 3 section 3.5. Repair and Maintenance states "to the extent that the Limited Common Elements are maintained by individual Unit Owners pursuant to Section 5.2

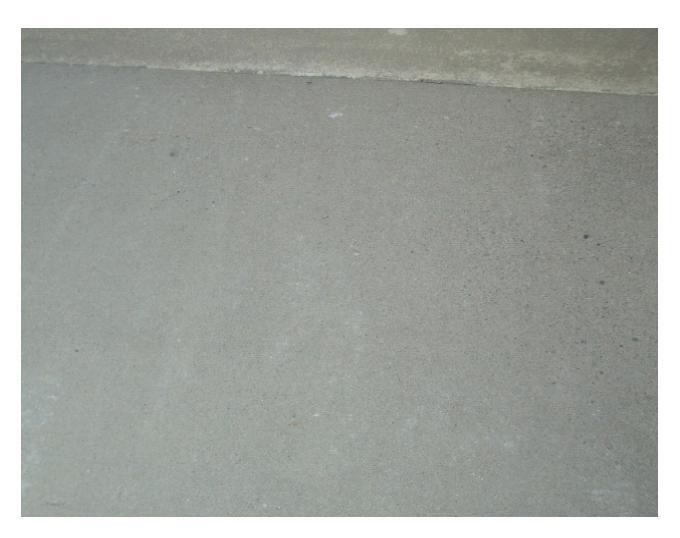
These are the typical sidewalks, curbs, and drainage swales located throughout the community.

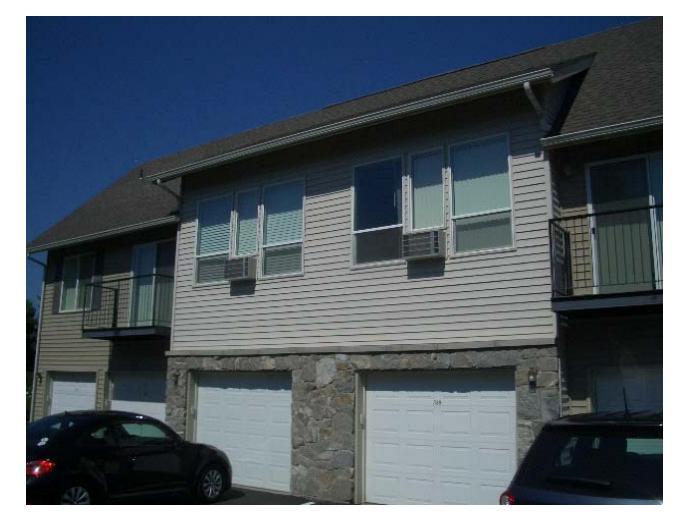
Windows are considered a Limited Common Area. Big Trout Condominiums Association CC&Rs Article 3 section 3.5. Repair and Maintenance states "to the extent that the Limited Common Elements are maintained by individual Unit Owners pursuant to Section 5.2
