RESERVE ANALYSIS REPORT

Connecticut Condominium Association

Sample, Connecticut

September 29, 2017

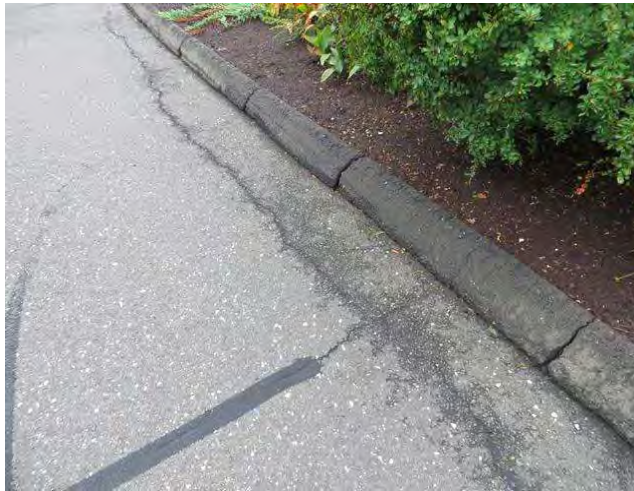
Asphalt curb/berm was installed during 2003 complete asphalt rebuild per client. Curb is in fair condition with many cracks evident during site inspection. It is wearing more quickly than typical likely due to challenging snow plowing conditions with steep grades in the community. Poor soil conditions may be another factor.

It is difficult to predict service life of curb/berm. Plowing and other mechanical damage may shorten life span. Additional landscaping repair will be required if curbs are replaced. Replacement of damaged sections should be considered when overlaying asphalt.

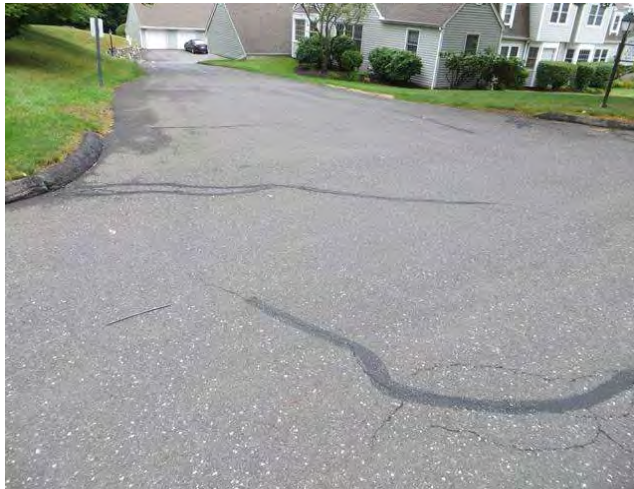
Component is for regular maintenance of asphalt areas before asphalt overlay. Two year cycle is recommended due to current pavement condition. Asphalt is in fair condition. Many cracks in asphalt were evident during site inspection. Most cracks have been sealed. Pavement is degrading more quickly than typical. This is likely due to challenging snow plowing conditions with steep grades in community. High salt useage is also likely contributor.

Crack sealing and repair maintenaince should be evaluated annually. Sealing is recommended as cracks develop to reduce water penetration under asphalt and reduce freeze/thaw damage. Crack sealing this year is recommended.

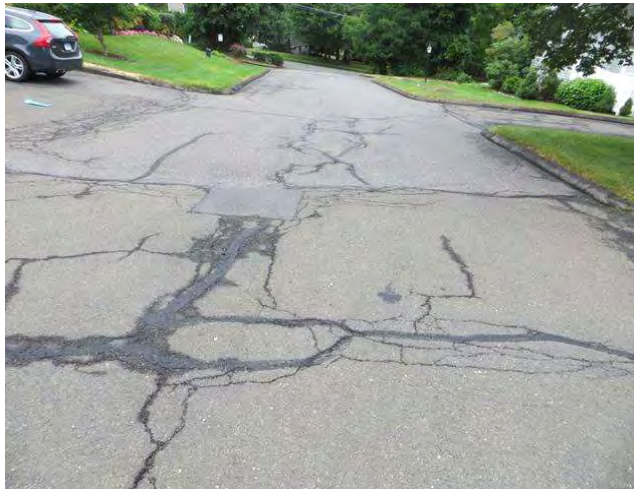
Asphalt was completely replaced in 2003 per client. Asphalt is in fair condition with many cracks evident during site inspection. Pavement is degrading more quickly than typical. This is likely due to challenging snow plowing conditions with steep grades in community. High salt usage is also likely contributor.

Overlay is recommended in next 2-4 years depending on winter weather. Repairs in damaged areas will be required in addition to overlay. Overlay will be more costly if delayed too long. Overlaying all streets and parking areas in one mobilization will save \$3000 per mobilization. No significant puddling was observed. Therefore, no significant regrading of streets and parking lots will be required.

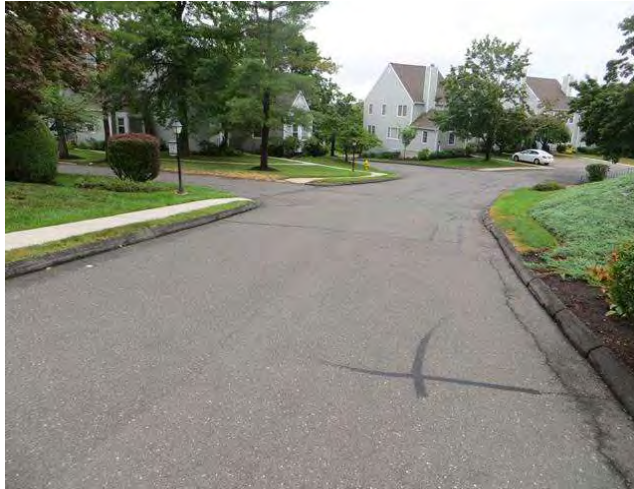
Component is for regular maintenance of asphalt areas before asphalt overlay. Two year cycle is recommended due to current pavement condition. Asphalt is in fair condition. Many cracks in asphalt were evident during site inspection. Most cracks have been sealed. Pavement is degrading more quickly than typical. This is likely due to challenging snow plowing conditions with steep grades in community. High salt useage is also likely contributor.

Crack sealing and repair maintenaince should be evaluated annually. Sealing is recommended as cracks develop to reduce water penetration under asphalt and reduce freeze/thaw damage. Crack sealing this year is recommended.

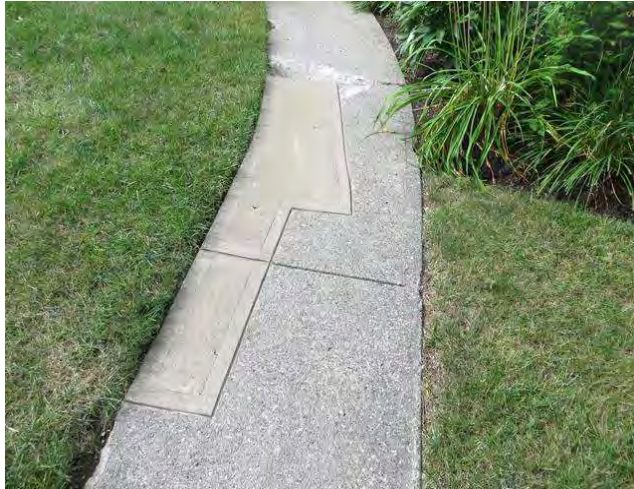
Original sidewalks are in fair condition with a percentage needing replacment every year. This percentage is currently estimated at 5%. Many cracks and spalling were evident during site inspection. Total concrete area is about 14,050 sq. ft. including mail box area. Approximately 22% of sidewalks have been replaced in recent years. It is recommended to replace an entire section or length of sidewalk so as not to create a patchwork. Partially replaced sections will need further repair in near future typically.

Component is for allowance to continue replacements on a 2-year cycle. Included are site-formed steps in sidewalks.

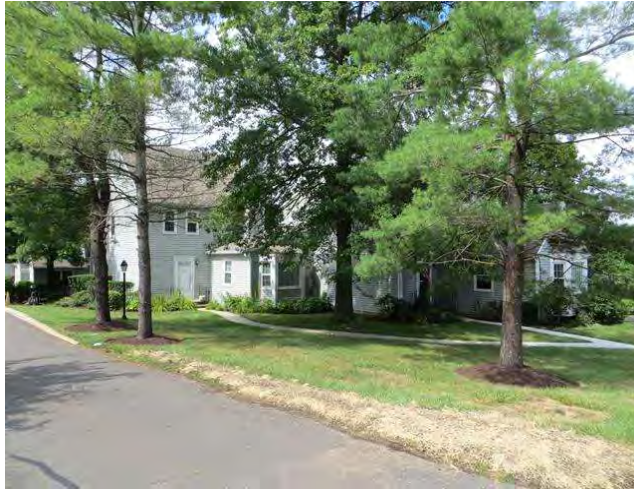
Component covers removal of trees/overgrown landscaping and replacement with new landscaping on three year interval. Cost allowance provided by client.

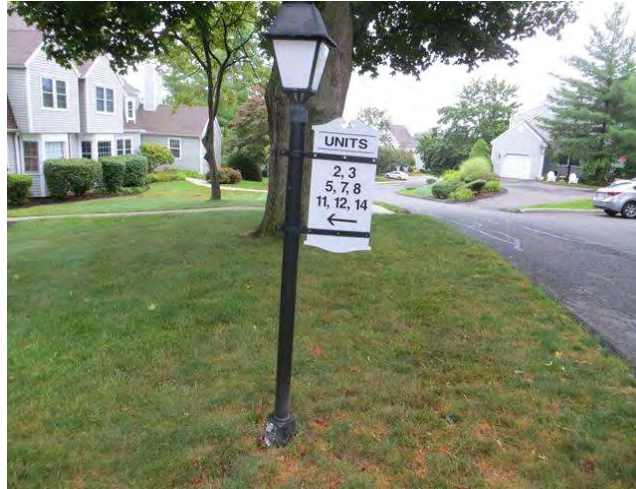
Component covers replacement of 41 post lights around association. Post lights are original per client. Pricing assumes that concrete bases and wiring does not have to be replaced.

The remaining life of this component has been extended due to lack of current problems.

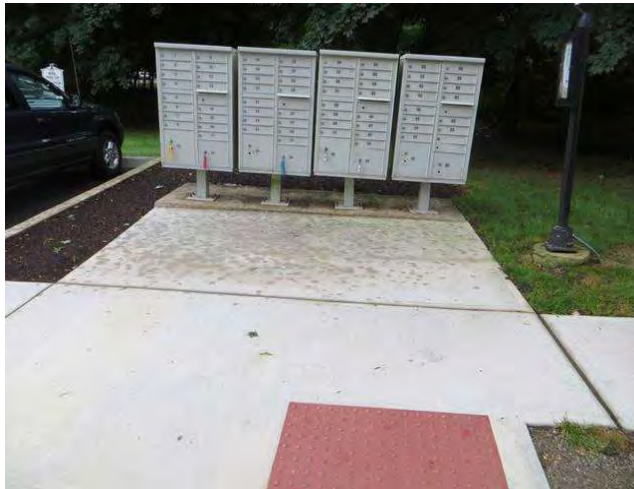
Component covers (4) 16-unit pedestal mail boxes. Pricing assumes concrete base can be reused.

4 16 door cluster mailbox with pedestal	@	\$1,350.00	=	\$5,400.00
1 installation	@	\$350.00	=	\$350.00
		TOTAL	=	<u>\$5,750.00</u>

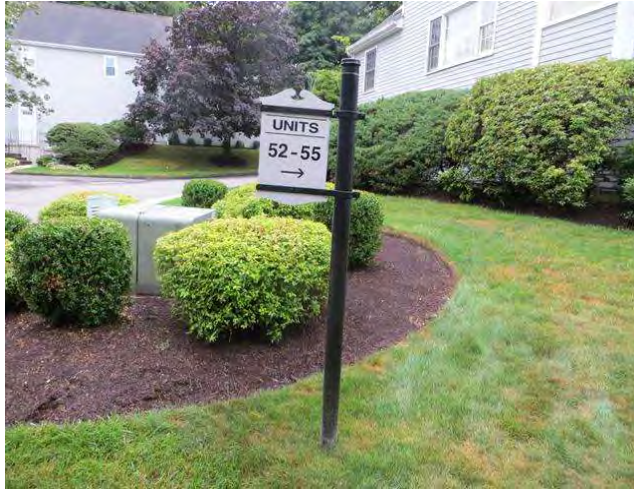
Component covers replacement of signs and posts around association. Sign posts were painted in 2013 per client.

9 unit post signs	@	\$200.00	=	\$1,800.00
7 miscellaneous signs	@	\$100.00	=	\$700.00
		TOTAL	=	\$2,500.00

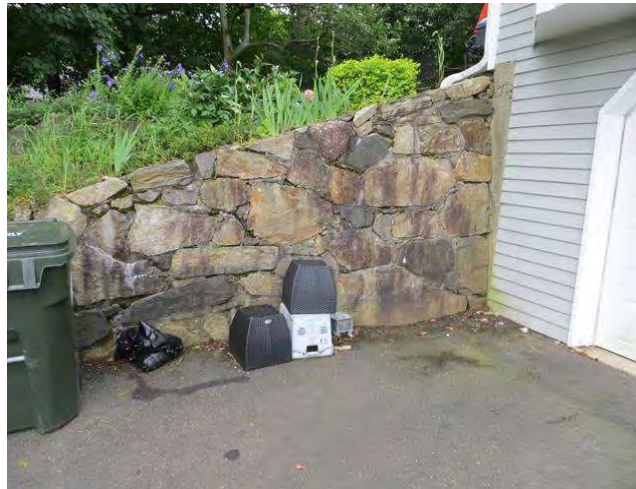
Component covers repair of stone retaining walls around association. Component is set up to repair 10% of retaining wall area every 3 years. Stones are reused so cost is essentially labor and minor materials.

Cost per square foot determined from similar projects and client experience.

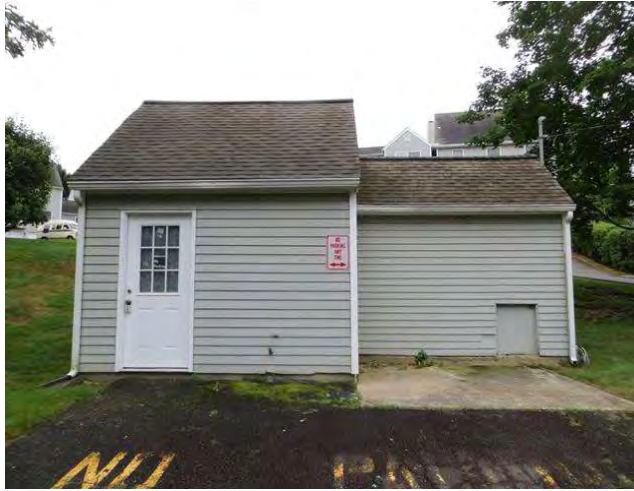
Component covers pool house and maintenance building exterior windows and doors. Exterior siding and roofing are covered by other components.

The remaining life of this component has been extended due to its apparent infrequent use.

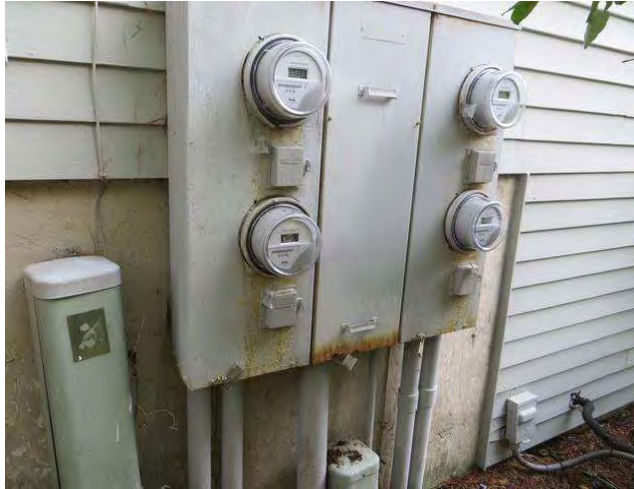
Component covers replacement of electric meter cabinets on three year interval. Some of the (20) cabinets have corroded in the 35 years since their original installation. Client identified (8) corroded cabinets in 2014 and has been replacing these over the last three years. Cabinet condition will be monitored and it is anticipated that 3 panels (15% of total) will need to be replaced every three years. Component should be monitored and allowance updated as meter cabinets are replaced.

Service contractor:
 Waterman Electric
 Pricing for 2, 3, and 4 meter cabinets from Waterman Electric proposal

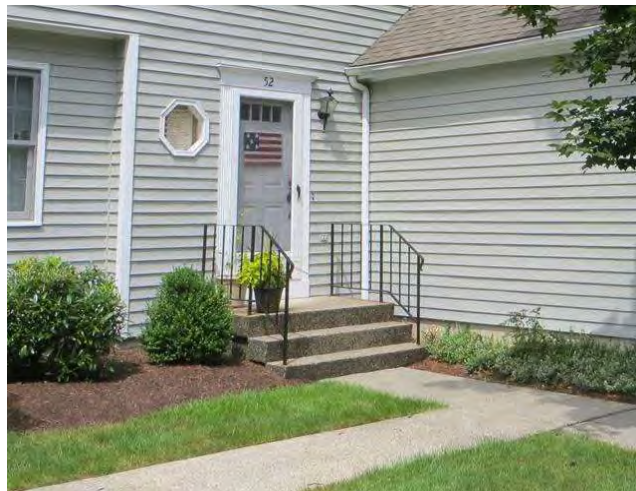
Component covers solid precast concrete front steps for units. Concrete steps appear to be original to construction of association. No cracked steps were observed during site visit and none have been replaced per client. However, concrete has been eroded by salt usage and aggregate is exposed. Demolition cost will likely be high for these solid steps. Exact demolition cost is hard to predict and will likely need to be modified as association gains experience.

Useful life has been extended because no immediate need for replacement was observed in spite of age of steps.

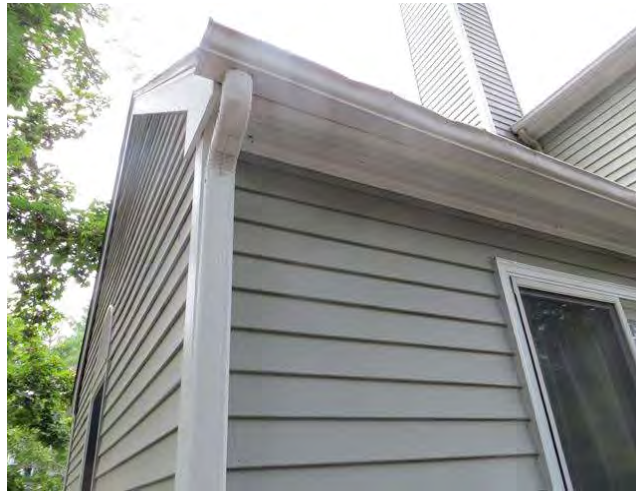
Component covers gutters on all buildings in association. Gutters were not replaced with roofs between 2007 and 2010 per client.

The actual date this component was placed into service is not available. For budgeting purposes, this date has been estimated based on its condition at our most recent site visit. The remaining life of this component has been extended in order to schedule this replacement in conjunction with reroofing.

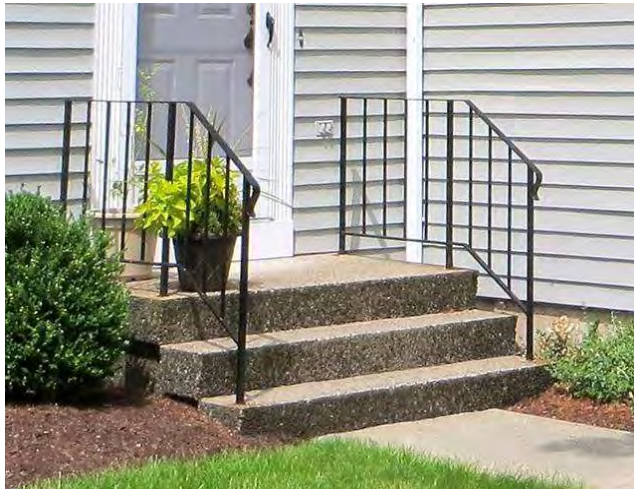
Component covers painted wrought iron railings for concrete front steps and some sidewalks. Railings appear to be original to construction of association. Minor corrosion at bottom of rail posts was observed during site visit. Railings are in remarkably good condition for high salt usage eroded by salt usage and aggregate is exposed. Railings with corroded posts have been repaired by welding new base plates on the posts. This strategy will extend railing life. Painting is part of operating budget.

Useful life has been extended because no immediate need for railing replacement was observed in spite of age of railings.

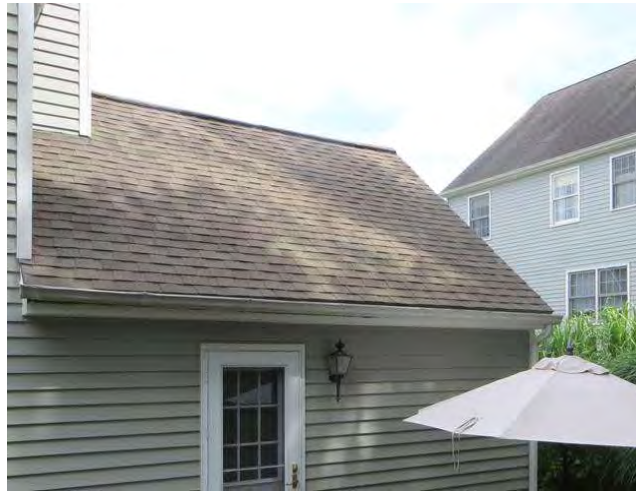
Component covers 1/3 of asphalt shingle roofs on all buildings in association. All roofs were replaced between 2007 and 2010 per client. Average placed-in-service date of January 1, 2009 used. Useful life set at 25 years for architectural shingles installed and experience with original new construction shingles installed.

units 1-14	17,500 sq. ft.
units 15-18	4,200 sq. ft.
units 19-20	3,300 sq. ft.
units 21-23	4,100 sq. ft.
unit 24	1,550 sq. ft.
unit 25	1,400 sq. ft.
units 26-28	4,900 sq. ft.
units 29-32	5,900 sq. ft.
units 33-35	5,000 sq. ft.
unit 36	2,150 sq. ft.
units 37-42	8,300 sq. ft.
units 43-45	5,200 sq. ft.
unit 46	2,150 sq. ft.

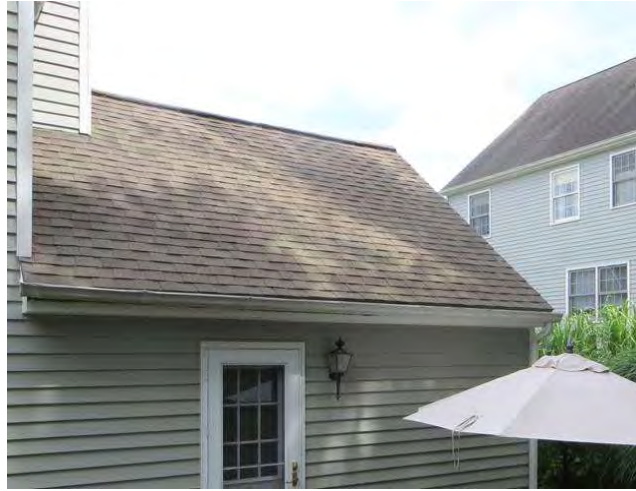
Component covers 1/3 of asphalt shingle roofs on all buildings in association. All roofs were replaced between 2007 and 2010 per client. Average placed-in-service date of January 1, 2009 used. Useful life set at 25 years for architectural shingles installed and experience with original new construction shingles installed.

units 1-14	17,500 sq. ft.
units 15-18	4,200 sq. ft.
units 19-20	3,300 sq. ft.
units 21-23	4,100 sq. ft.
unit 24	1,550 sq. ft.
unit 25	1,400 sq. ft.
units 26-28	4,900 sq. ft.
units 29-32	5,900 sq. ft.
units 33-35	5,000 sq. ft.
unit 36	2,150 sq. ft.
units 37-42	8,300 sq. ft.
units 43-45	5,200 sq. ft.
unit 46	2,150 sq. ft.

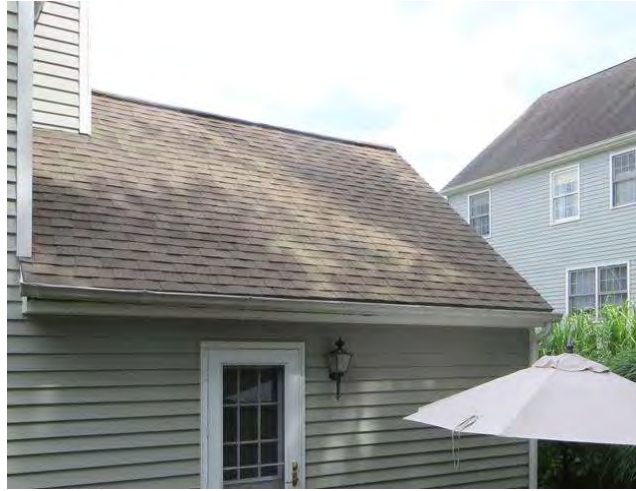
Component covers 1/3 of asphalt shingle roofs on all buildings in association. All roofs were replaced between 2007 and 2010 per client. Average placed-in-service date of January 1, 2009 used. Useful life set at 25 years for architectural shingles installed and experience with original new construction shingles installed.

units 1-14	17,500 sq. ft.
units 15-18	4,200 sq. ft.
units 19-20	3,300 sq. ft.
units 21-23	4,100 sq. ft.
unit 24	1,550 sq. ft.
unit 25	1,400 sq. ft.
units 26-28	4,900 sq. ft.
units 29-32	5,900 sq. ft.
units 33-35	5,000 sq. ft.
unit 36	2,150 sq. ft.
units 37-42	8,300 sq. ft.
units 43-45	5,200 sq. ft.
unit 46	2,150 sq. ft.

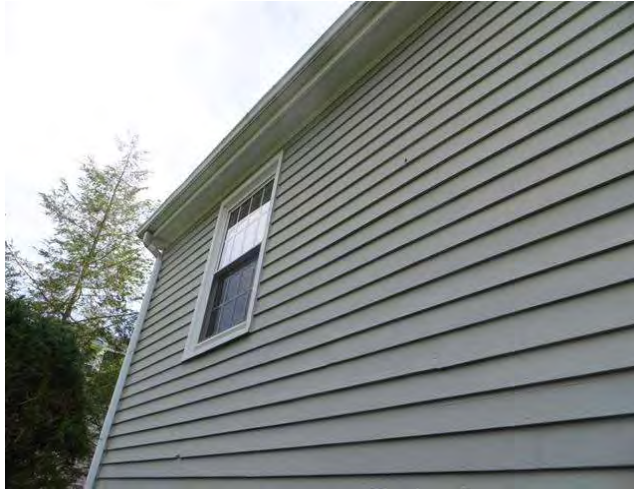
Component covers wood clapboard siding and trim on all buildings in association. Siding is original and has been maintained carefully per client. Useful life set at 10 years for major maintenance interval. Component assumes that 3% of siding will need to be replaced every 10 years. Recent maintenance includes replacing wood trim with PVC composite that should have lower life cycle costs. Typically, most major repairs will occur on south and west-facing elevations. Painting is part of operating budget.

units 1-14	19,290 sq. ft.
units 15-18	6,720 sq. ft.
units 19-20	5,380 sq. ft.
units 21-23	6,140 sq. ft.
unit 24	2,840 sq. ft.
unit 25	3,240 sq. ft.
units 26-28	8,320 sq. ft.
units 29-32	9,000 sq. ft.
units 33-35	6,520 sq. ft.
unit 36	3,200 sq. ft.
units 37-42	12,770 sq. ft.

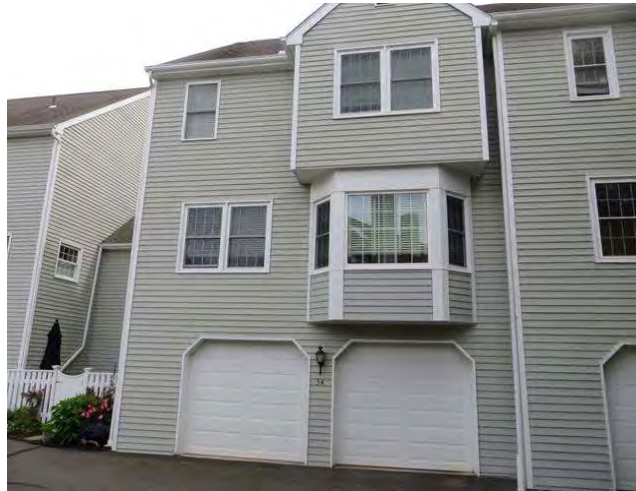
Component covers wood clapboard siding and trim on all buildings in association. All is original and has been maintained carefully per client. Useful life set at 2 years for minor maintenance interval. Recent maintenance includes replacing wood trim with PVC composite that should have lower life cycle costs. Typically, most minor repairs will occur in high moisture areas. Painting is part of operating budget. Minor repair costs should be monitored and allowance adjusted over time based on association experience.

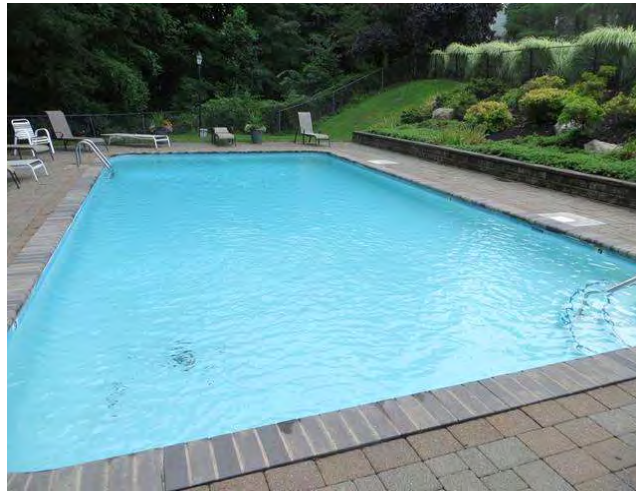
Component covers pool winter cover. Cover was not available during site visit. Pool cover was purchased in about 2014 per client.

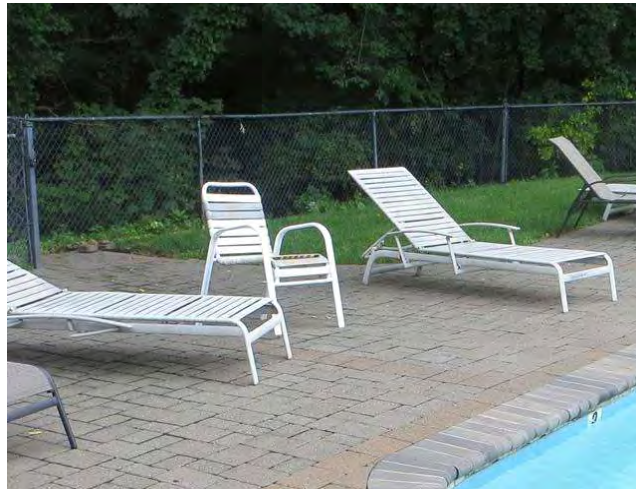
Component covers removal and replacement of black chain link pool fence.

Fence was in generally good condition during site visit. Section of fence at rear near gate needs repair.

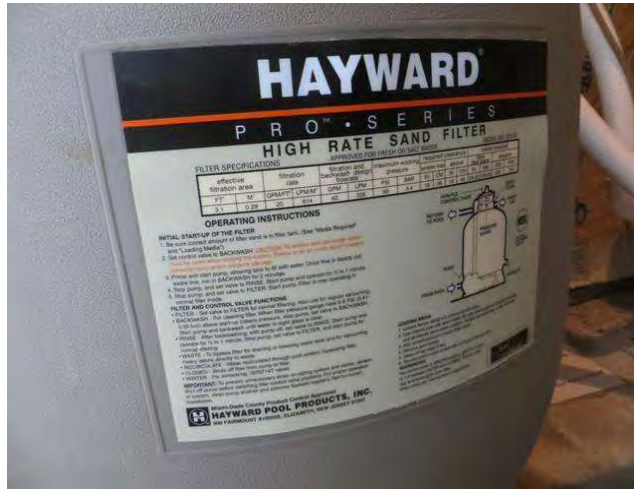
Component allowance covers pool filter. Pool filter will be replaced in early 2018 per client.

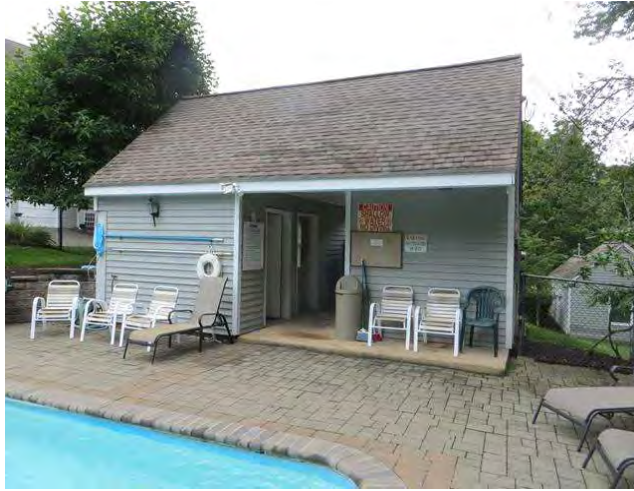
Component covers pool area furnishings.

The remaining life of this component has been extended due to its apparent infrequent use.

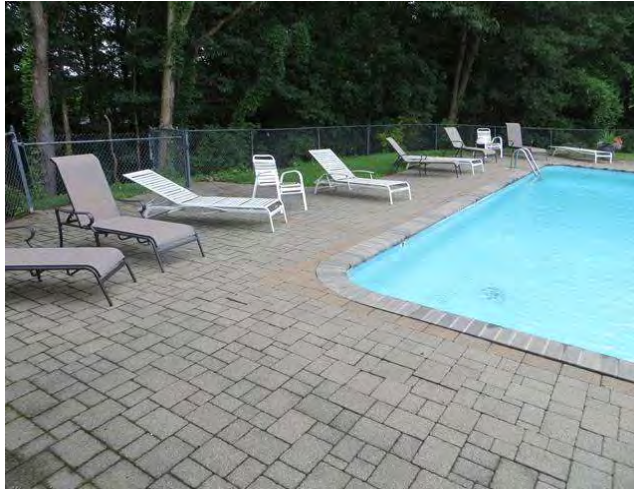
Component covers re-setting paver pool deck. Pavers themselves will likely have long life due to lack of salt exposure and apparent low pool usage. Low pool usage will result in less chlorine on pavers and retaining wall.

Area of pavers near rear fence by pool house currently needs to be reset.

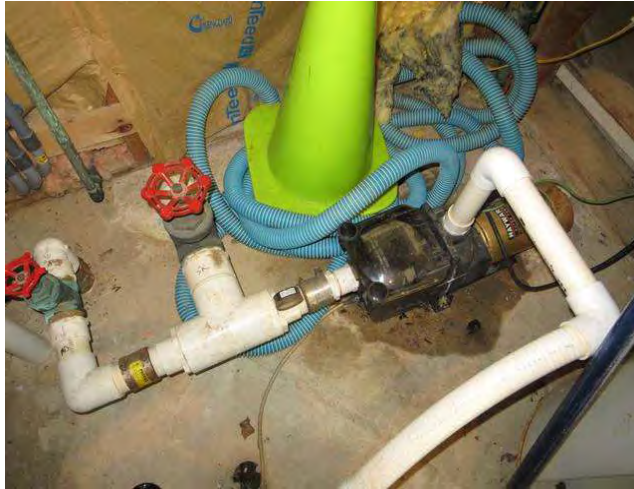
Component allowance covers pool pump. Pool pump was replaced in 2015-2016 per client.

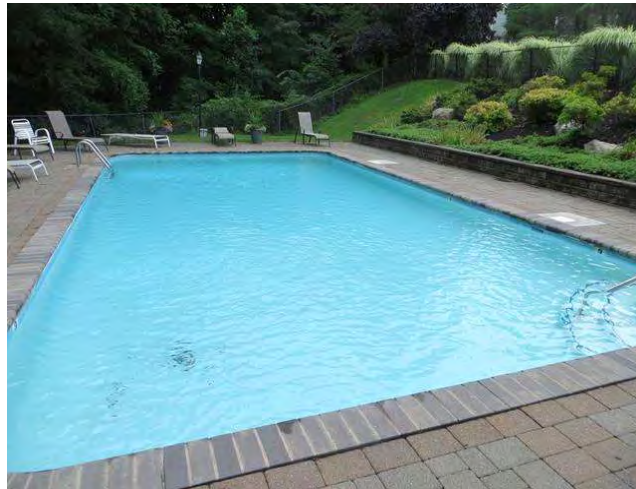
Component allowance covers plaster pool surface. No defects were noted in plaster during site visit, but it is difficult to judge without being in the pool. It has been about 15 years since traditional plaster was applied. Pool surface seems to have worn well. Per client, pool was resurfaced in 2004-2005 by company run by John Allen. Mr. Allen confirmed that traditional plaster was used. He thought the resurfacing was done in about 2002. In 2012, pool surface was examined based on questions from Shoreline Pools and estimate for resurfacing for about \$21,000 was received. It was determined that surface was acceptable at that time. Minor patching repairs were done per Mr. Allen.

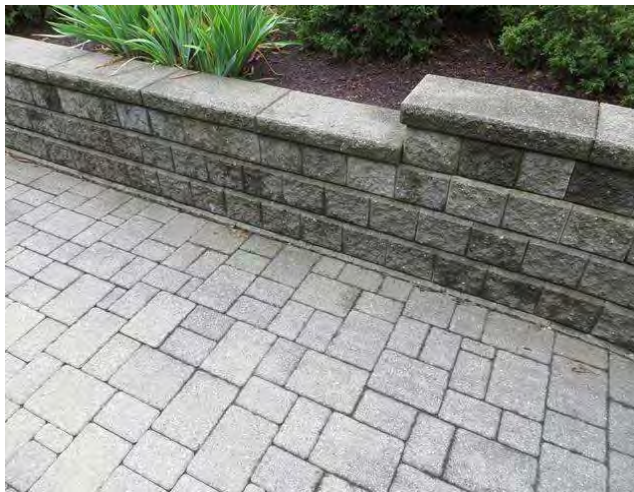
Component covers re-setting decorative concrete block interlocking retaining wall. Concrete blocks themselves will likely have long life due to lack of salt exposure and apparent low pool usage. Low pool usage will result in less chlorine on pavers and retaining wall.

Retaining wall is approximately 60 ft long and 20" tall on average.
Retaining wall was in good condition during site visit.

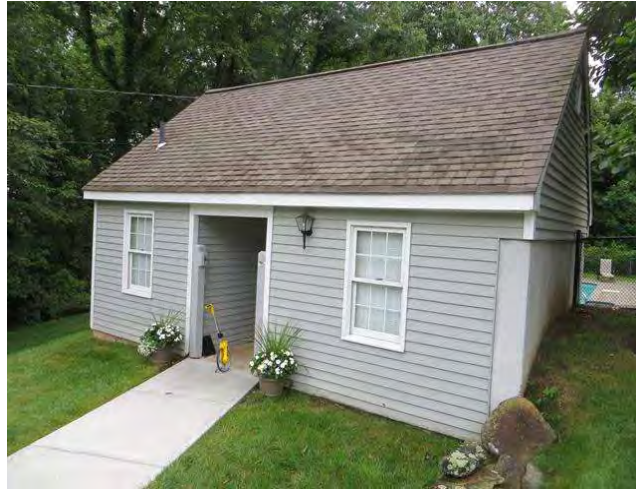
Component covers remodeling of pool house interior. Paver pool deck, retaining wall, pool house exterior, equipment, and furnishings covered by other components. Painting is part of operating budget. The remaining life of this component has been extended due to its apparent infrequent use.

2 interior 36"x80" doors	@	\$250.00	=	\$500.00
2 toilets	@	\$400.00	=	\$800.00
1 urinal	@	\$400.00	=	\$400.00
2 sink & faucet	@	\$400.00	=	\$800.00
2 36"x36" fiberglass shower & valve	@	\$1,000.00	=	\$2,000.00
2 shower door	@	\$300.00	=	\$600.00
175 sq. ft. tile walls	@	\$7.00	=	\$1,225.00
170 sq. ft tile floors	@	\$10.00	=	\$1,700.00
1 lighting allowance	@	\$500.00	=	\$500.00
1 misc. carpentry & supervision	@	\$5,475.00	=	\$5,475.00
1 electric water heater	@	\$1,000.00	=	\$1,000.00
		TOTAL	=	\$15,000.00
